## Profile/Photo Observation Report

Street:	<b>Hobart</b>	Flow Control:	<b>Not Controlled</b>
City:	<b>Hobart, IN</b>	Year Renewed:	
Location:	<b>Light Highway</b>	Tape/Media #:	
Purpose:	<b>Maintenance Related</b>	Dia/Height:	<b>8"</b>
Use:	<b>Sanitary</b>	Material:	<b>PVC</b>
Drain Area:	<b>NA</b>	Lining:	<b>Cured in Place</b>
Category:	<b>NA</b>		
Comment:	<b>Flow direction wrong.</b>

Location Details:		Direction of Survey:	<b>Upstream</b>
US MH:	<b>M-807-006</b>	DS MH:	<b>M-807-005</b>
		Total Length Surveyed (ft):	<b>346.5</b>

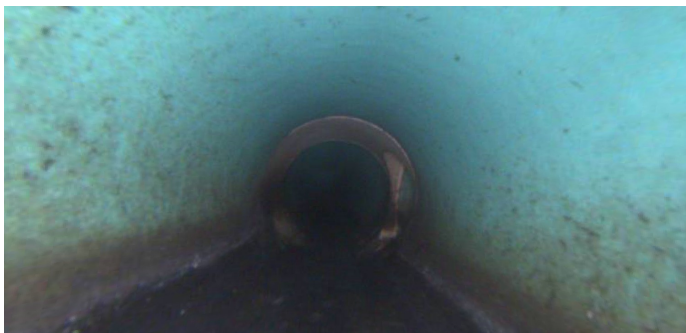
Code: **AMH**  
Description: **Manhole**

Distance (ft): **.0**  
Structural Grade: **0**  
O&M Grade: **0**  
Clock Start/From:  
Clock To:  
1st Value:  
2nd Value:  
Value Percent:  
Continuous Index:  
Within 8" of Joint: **NO**  
Remarks: **M-807-005**

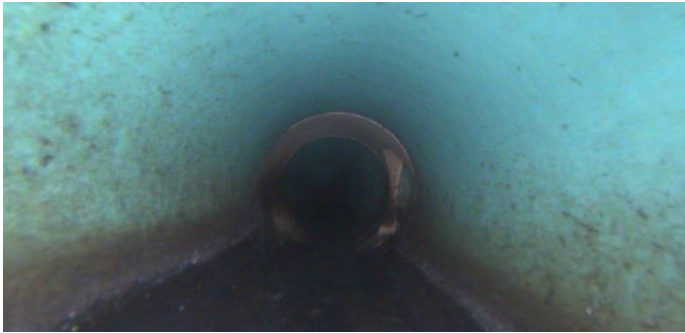
Code:	<b>MWL</b>
Description:	<b>Water Level</b>

Distance (ft):	<b>.0</b>
Structural Grade:	<b>0</b>
O&M Grade:	<b>0</b>
Clock Start/From:	
Clock To:	
1st Value:	
2nd Value:	
Value Percent:	<b>5.000</b>
Continuous Index:	
Within 8" of Joint:	<b>NO</b>
Remarks:

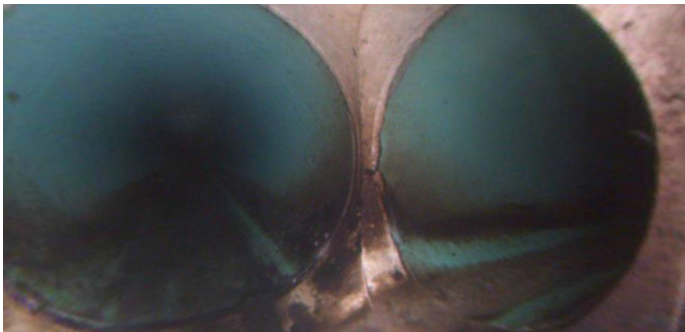
Code:	<b>TF</b>
Description:	<b>Tap Factory</b>

Distance (ft):	<b>2.0</b>
Structural Grade:	<b>0</b>
O&M Grade:	<b>0</b>
Clock Start/From:	<b>3</b>
Clock To:	
1st Value:	<b>4.000</b>
2nd Value:	
Value Percent:	
Continuous Index:	
Within 8" of Joint:	
Remarks:

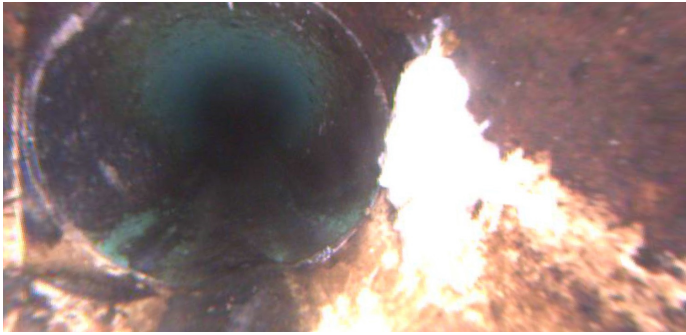
Code: **DAZ**  
Description: **Deposits Attached Other**

Distance (ft): **85.7**  
Structural Grade: **0**  
O&M Grade: **2**  
Clock Start/From: **2**  
Clock To: **4**  
1st Value:  
2nd Value:  
Value Percent: **5.000**  
Continuous Index:  
Within 8" of Joint: **NO**  
Remarks: **PAPER PRODUCTS**

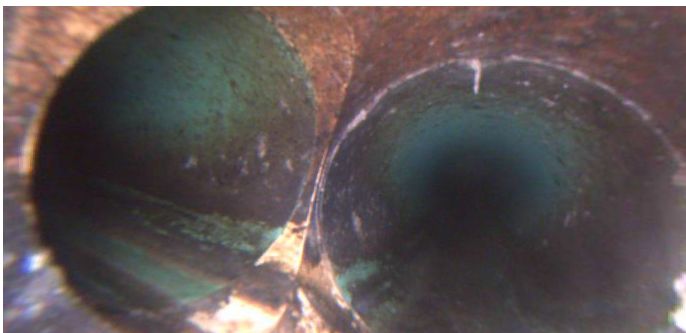
Code: **TF**  
Description: **Tap Factory**

Distance (ft): **85.7**  
Structural Grade: **0**  
O&M Grade: **0**  
Clock Start/From: **9**  
Clock To:  
1st Value: **4.000**  
2nd Value:  
Value Percent:  
Continuous Index:  
Within 8" of Joint:  
Remarks:

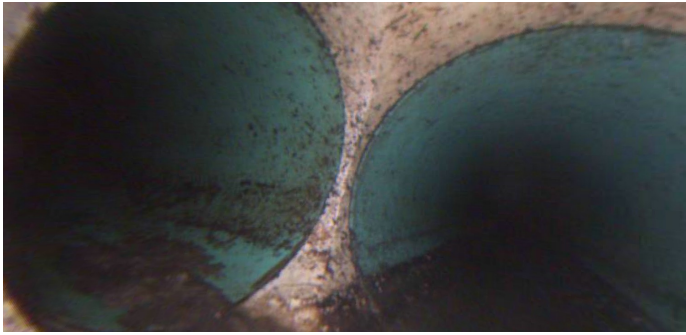
Code: **TF**  
Description: **Tap Factory**

Distance (ft): **96.0**  
Structural Grade: **0**  
O&M Grade: **0**  
Clock Start/From: **9**  
Clock To:  
1st Value: **4.000**  
2nd Value:  
Value Percent:  
Continuous Index:  
Within 8" of Joint:  
Remarks:

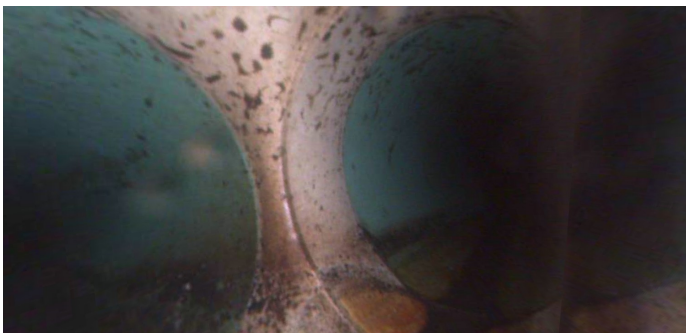
Code: **TFA**  
Description: **Tap Factory Active**

Distance (ft): **163.7**  
Structural Grade: **0**  
O&M Grade: **0**  
Clock Start/From: **3**  
Clock To:  
1st Value: **4.000**  
2nd Value:  
Value Percent:  
Continuous Index:  
Within 8" of Joint:  
Remarks:

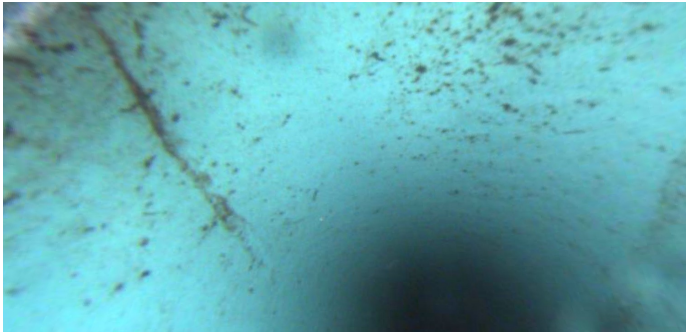
Code: **RFJ**  
Description: **Roots Fine Joint**

Distance (ft): **204.8**  
Structural Grade: **0**  
O&M Grade: **1**  
Clock Start/From: **10**  
Clock To:  
1st Value:  
2nd Value:  
Value Percent:  
Continuous Index:  
Within 8" of Joint: **YES**  
Remarks:

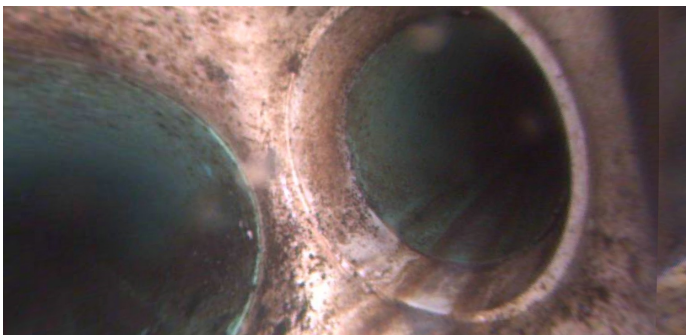
Code: **TF**  
Description: **Tap Factory**

Distance (ft): **219.1**  
Structural Grade: **0**  
O&M Grade: **0**  
Clock Start/From: **3**  
Clock To:  
1st Value: **4.000**  
2nd Value:  
Value Percent:  
Continuous Index:  
Within 8" of Joint:  
Remarks:

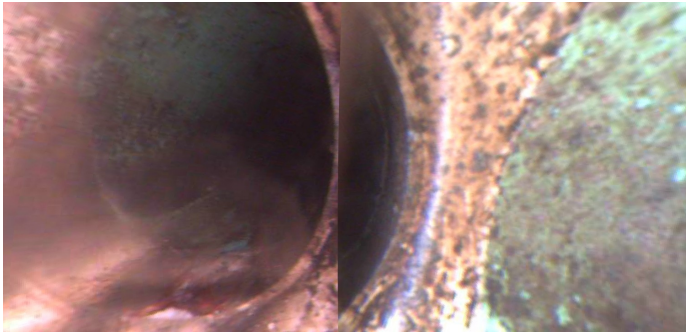
Code: **TFA**  
Description: **Tap Factory Active**

Distance (ft): **229.9**  
Structural Grade: **0**  
O&M Grade: **0**  
Clock Start/From: **9**  
Clock To:  
1st Value: **4.000**  
2nd Value:  
Value Percent:  
Continuous Index:  
Within 8" of Joint:  
Remarks:

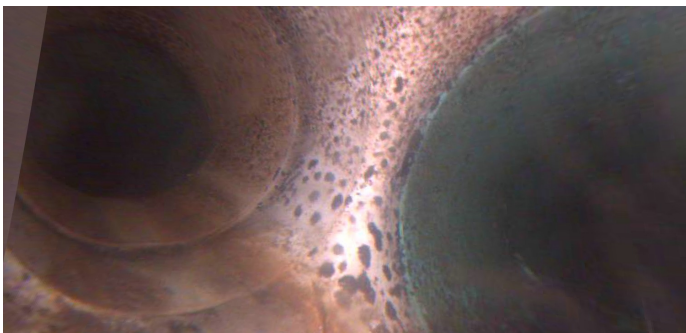
Code: **TFA**  
Description: **Tap Factory Active**

Distance (ft): **269.4**  
Structural Grade: **0**  
O&M Grade: **0**  
Clock Start/From: **3**  
Clock To:  
1st Value: **4.000**  
2nd Value:  
Value Percent:  
Continuous Index:  
Within 8" of Joint:  
Remarks:

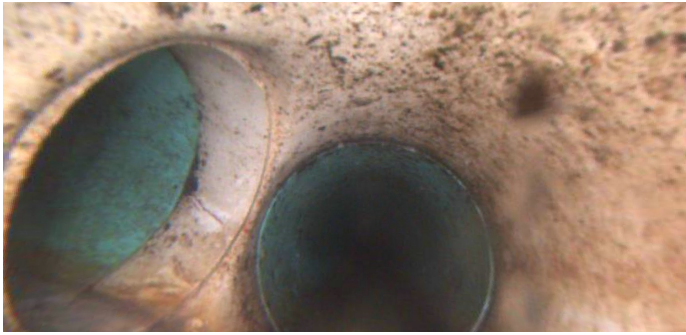
Code: **TF**  
Description: **Tap Factory**

Distance (ft): **278.0**  
Structural Grade: **0**  
O&M Grade: **0**  
Clock Start/From: **9**  
Clock To:  
1st Value: **4.000**  
2nd Value:  
Value Percent:  
Continuous Index:  
Within 8" of Joint:  
Remarks:

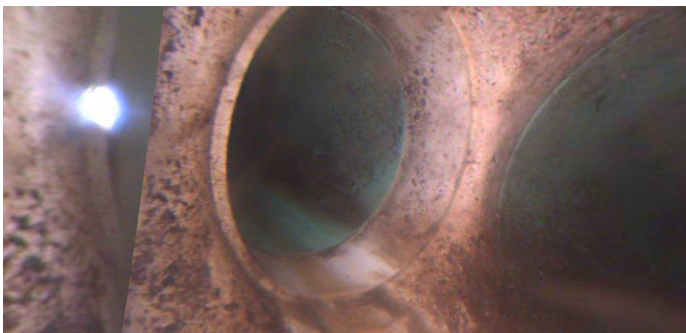
Code: **TFA**  
Description: **Tap Factory Active**

Distance (ft): **296.7**  
Structural Grade: **0**  
O&M Grade: **0**  
Clock Start/From: **3**  
Clock To:  
1st Value: **4.000**  
2nd Value:  
Value Percent:  
Continuous Index:  
Within 8" of Joint:  
Remarks:

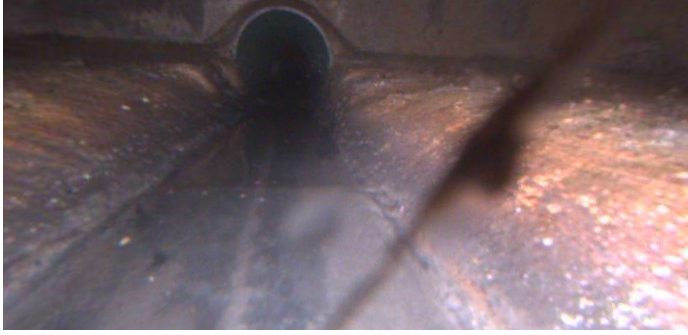
Code:	<b>AMH</b>
Description:	<b>Manhole</b>
Distance (ft):	<b>346.5</b>
Structural Grade:	<b>0</b>
O&M Grade:	<b>0</b>
Clock Start/From:	
Clock To:	
1st Value:	
2nd Value:	
Value Percent:	
Continuous Index:	
Within 8" of Joint:	<b>NO</b>
Remarks:	<b>M-807-006</b>
