## Profile/Photo Observation Report

Street:	<b>E 13TH ST &amp; S ILLINOIS ST</b>	Flow Control:	<b>Not Controlled</b>
City:	<b>Hobart, IN</b>	Year Renewed:	
Location:	<b>Light Highway</b>	Tape/Media #:	
Purpose:	<b>Maintenance Related</b>	Dia/Height:	<b>8"</b>
Use:	<b>Sanitary</b>	Material:	<b>PVC</b>
Drain Area:	<b>NA</b>	Lining:	<b>Cured in Place</b>
Category:	<b>NA</b>		
Comment:	<b>Flow direction wrong.</b>

Location Details:		Direction of Survey:	<b>Downstream</b>
US MH:	<b>M-807-007</b>	DS MH:	<b>M-807-006</b>
		Total Length Surveyed (ft):	<b>347.8</b>

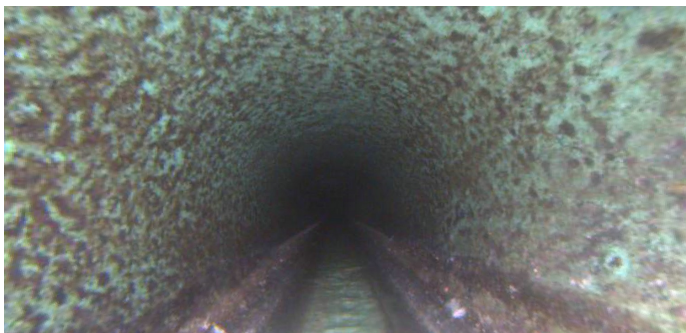
Code: **AMH**  
Description: **Manhole**

Distance (ft): **.0**  
Structural Grade: **0**  
O&M Grade: **0**  
Clock Start/From:  
Clock To:  
1st Value:  
2nd Value:  
Value Percent:  
Continuous Index:  
Within 8" of Joint: **NO**  
Remarks: **M-807-007**

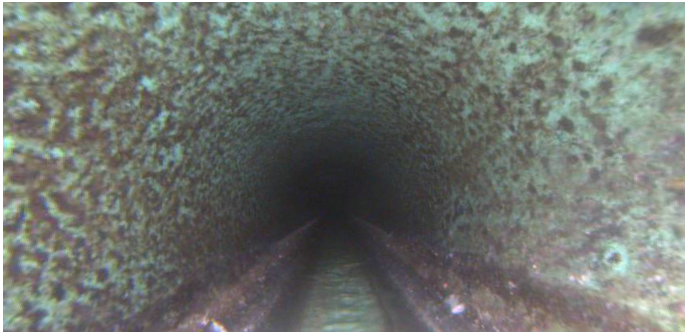
Code:	<b>MWL</b>
Description:	<b>Water Level</b>

Distance (ft):	<b>.0</b>
Structural Grade:	<b>0</b>
O&M Grade:	<b>0</b>
Clock Start/From:	
Clock To:	
1st Value:	
2nd Value:	
Value Percent:	<b>5.000</b>
Continuous Index:	
Within 8" of Joint:	<b>NO</b>
Remarks:

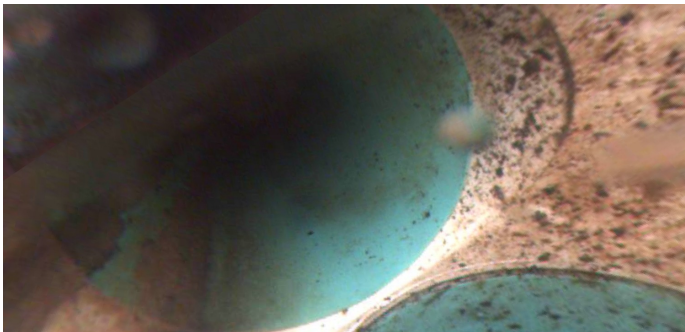
Code:	<b>TF</b>
Description:	<b>Tap Factory</b>

Distance (ft):	<b>46.6</b>
Structural Grade:	<b>0</b>
O&M Grade:	<b>0</b>
Clock Start/From:	<b>11</b>
Clock To:	
1st Value:	<b>4.000</b>
2nd Value:	
Value Percent:	
Continuous Index:	
Within 8" of Joint:	
Remarks:

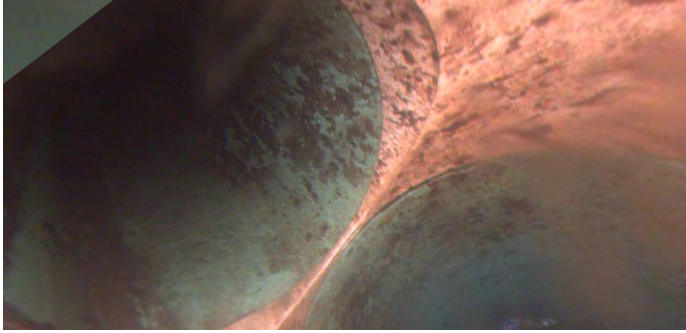
Code: **TF**  
Description: **Tap Factory**

Distance (ft): **75.8**  
Structural Grade: **0**  
O&M Grade: **0**  
Clock Start/From: **1**  
Clock To:  
1st Value: **4.000**  
2nd Value:  
Value Percent:  
Continuous Index:  
Within 8" of Joint:  
Remarks:

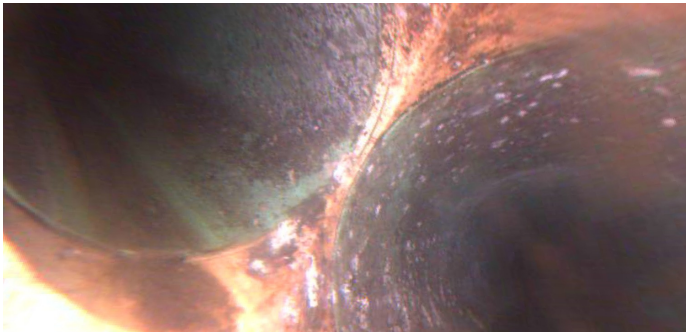
Code: **TF**  
Description: **Tap Factory**

Distance (ft): **152.7**  
Structural Grade: **0**  
O&M Grade: **0**  
Clock Start/From: **2**  
Clock To:  
1st Value: **4.000**  
2nd Value:  
Value Percent:  
Continuous Index:  
Within 8" of Joint:  
Remarks:

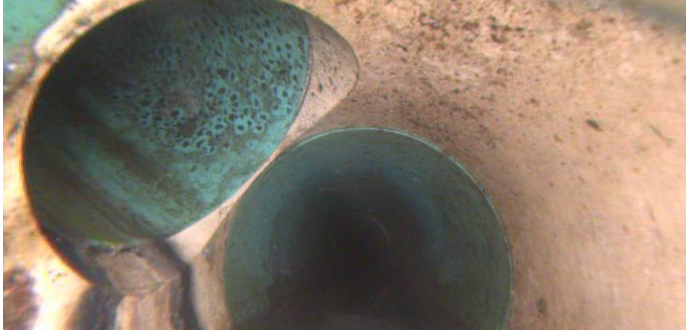
Code: **TF**  
Description: **Tap Factory**

Distance (ft): **155.1**  
Structural Grade: **0**  
O&M Grade: **0**  
Clock Start/From: **10**  
Clock To:  
1st Value: **4.000**  
2nd Value:  
Value Percent:  
Continuous Index:  
Within 8" of Joint:  
Remarks:

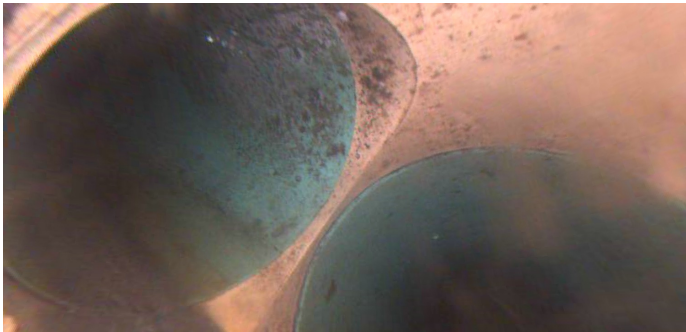
Code: **TF**  
Description: **Tap Factory**

Distance (ft): **158.6**  
Structural Grade: **0**  
O&M Grade: **0**  
Clock Start/From: **2**  
Clock To:  
1st Value: **4.000**  
2nd Value:  
Value Percent:  
Continuous Index:  
Within 8" of Joint:  
Remarks:

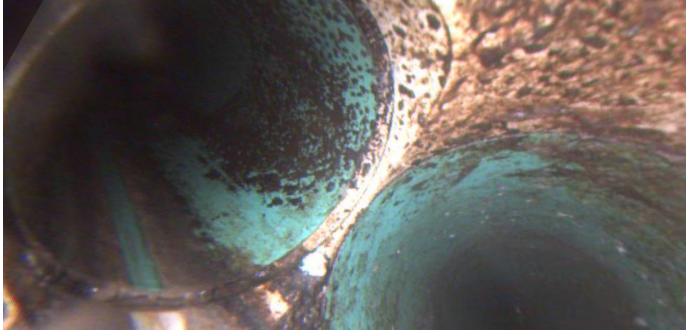
Code: **TF**  
Description: **Tap Factory**

Distance (ft): **212.4**  
Structural Grade: **0**  
O&M Grade: **0**  
Clock Start/From: **10**  
Clock To:  
1st Value: **4.000**  
2nd Value:  
Value Percent:  
Continuous Index:  
Within 8" of Joint:  
Remarks:

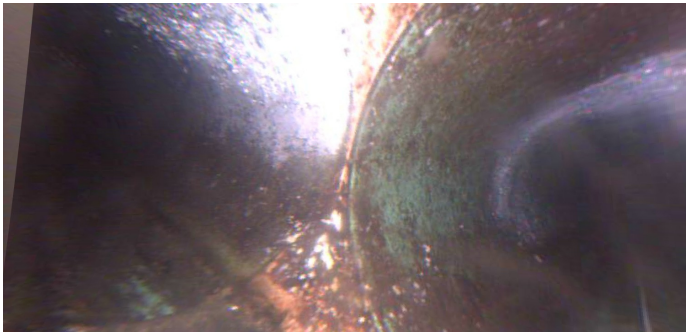
Code: **TF**  
Description: **Tap Factory**

Distance (ft): **228.5**  
Structural Grade: **0**  
O&M Grade: **0**  
Clock Start/From: **3**  
Clock To:  
1st Value: **4.000**  
2nd Value:  
Value Percent:  
Continuous Index:  
Within 8" of Joint:  
Remarks:

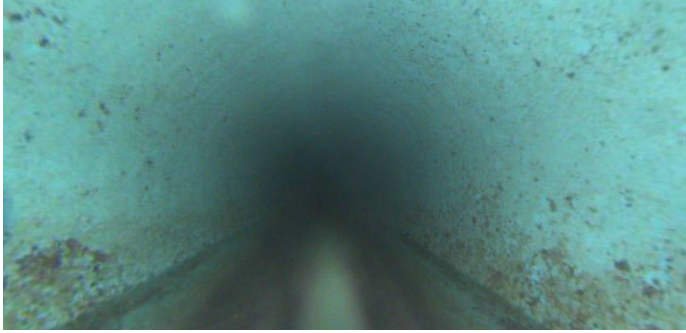
Code: **MWL**  
Description: **Water Level**

Distance (ft): **235.2**  
Structural Grade: **0**  
O&M Grade: **0**  
Clock Start/From:  
Clock To:  
1st Value:  
2nd Value:  
Value Percent: **20.000**  
Continuous Index:  
Within 8" of Joint: **NO**  
Remarks:

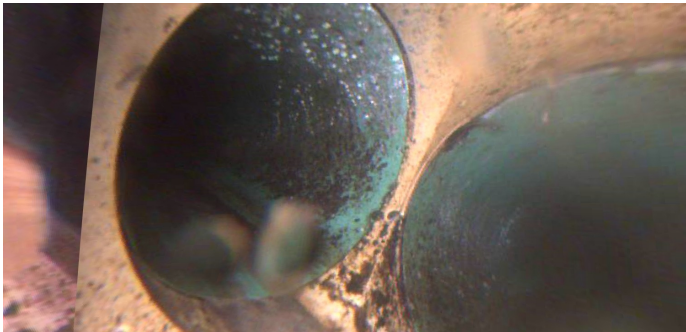
Code: **TF**  
Description: **Tap Factory**

Distance (ft): **272.0**  
Structural Grade: **0**  
O&M Grade: **0**  
Clock Start/From: **9**  
Clock To:  
1st Value: **4.000**  
2nd Value:  
Value Percent:  
Continuous Index:  
Within 8" of Joint:  
Remarks:

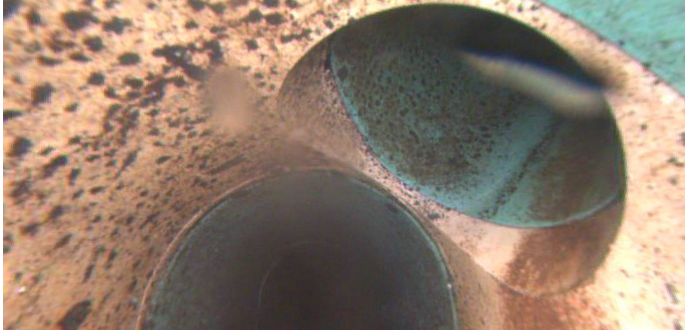
Code: **TF**  
Description: **Tap Factory**

Distance (ft): **279.6**  
Structural Grade: **0**  
O&M Grade: **0**  
Clock Start/From: **1**  
Clock To:  
1st Value: **4.000**  
2nd Value:  
Value Percent:  
Continuous Index:  
Within 8" of Joint:  
Remarks:

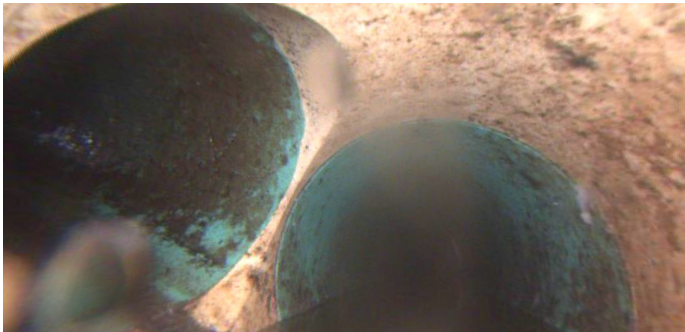
Code: **TF**  
Description: **Tap Factory**

Distance (ft): **337.6**  
Structural Grade: **0**  
O&M Grade: **0**  
Clock Start/From: **9**  
Clock To:  
1st Value: **4.000**  
2nd Value:  
Value Percent:  
Continuous Index:  
Within 8" of Joint:  
Remarks:

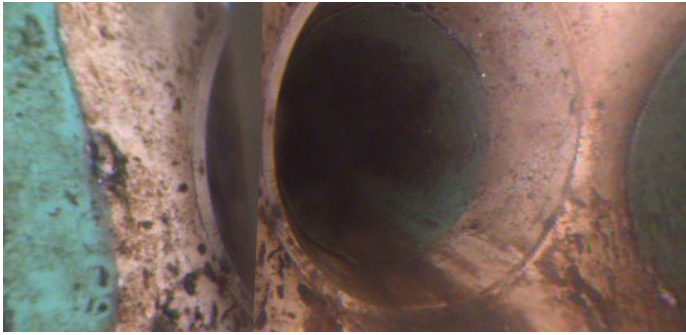
Code: **TF**  
Description: **Tap Factory**

Distance (ft): **340.9**  
Structural Grade: **0**  
O&M Grade: **0**  
Clock Start/From: **3**  
Clock To:  
1st Value: **4.000**  
2nd Value:  
Value Percent:  
Continuous Index:  
Within 8" of Joint:  
Remarks:

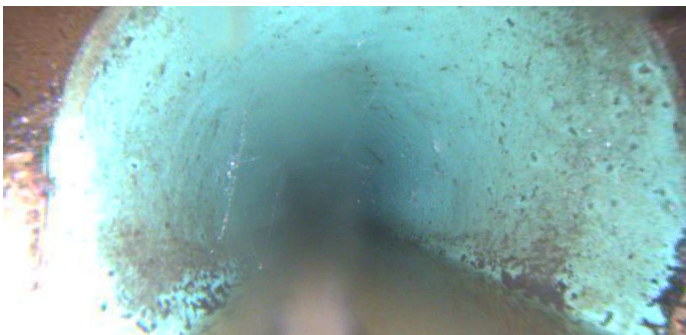
Code: **AMH**  
Description: **Manhole**

Distance (ft): **347.8**  
Structural Grade: **0**  
O&M Grade: **0**  
Clock Start/From:  
Clock To:  
1st Value:  
2nd Value:  
Value Percent:  
Continuous Index:  
Within 8" of Joint: **NO**  
Remarks: **M-807-006**
