Profile/Photo Observation Report

Date:	04/05/2018	Weather:		Coding:	PACP 6.0
Pipe Length (ft):	364.0	Owner:	NA	Pre Clean:	Not Known
P.O.#:		Surveyor:	Jen Costello	PSR:	P-807-006-007
Customer:		Clean Date:	01/01/1900	Shape:	C

Street:	Illinois	Flow Control:	Not Controlled
City:	Hobart, IN	Year Renewed:	
Location:	Light Highway	Tape/Media #:	
Purpose:	Maintenance Related	Dia/Height:	8"
Use:	Sanitary	Material:	PVC
Drain Area:	NA	Lining:	Cured in Place
Category:	NA		
Comment:	Flow direction wrong.

Location Details:		Direction of Survey:	Downstream
US MH:	M-807-007	DS MH:	M-807-006
		Total Length Surveyed (ft):	347.8

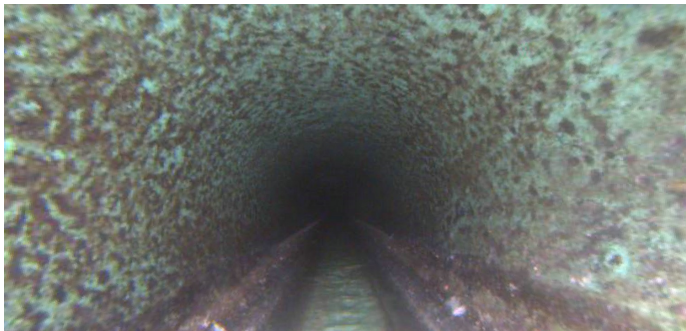
Code: **AMH**
Description: **Manhole**

Distance (ft): **.0**
Structural Grade: **0**
O&M Grade: **0**
Clock Start/From:
Clock To:
1st Value:
2nd Value:
Value Percent:
Continuous Index:
Within 8" of Joint: **NO**
Remarks: **M-807-007**

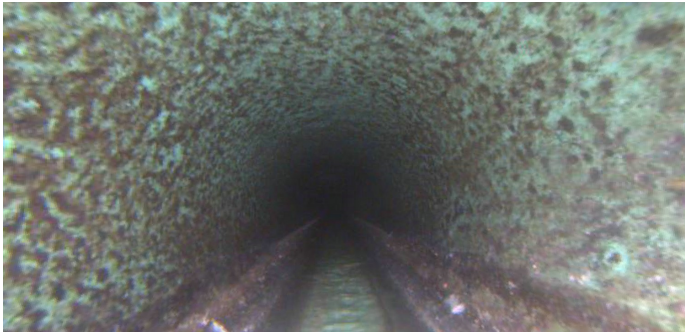
Code:	MWL
Description:	Water Level

Distance (ft):	.0
Structural Grade:	0
O&M Grade:	0
Clock Start/From:	
Clock To:	
1st Value:	
2nd Value:	
Value Percent:	5.000
Continuous Index:	
Within 8" of Joint:	NO
Remarks:

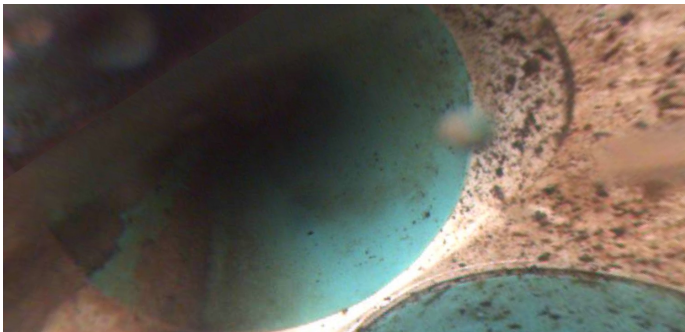
Code:	TF
Description:	Tap Factory

Distance (ft):	46.6
Structural Grade:	0
O&M Grade:	0
Clock Start/From:	11
Clock To:	
1st Value:	4.000
2nd Value:	
Value Percent:	
Continuous Index:	
Within 8" of Joint:	
Remarks:

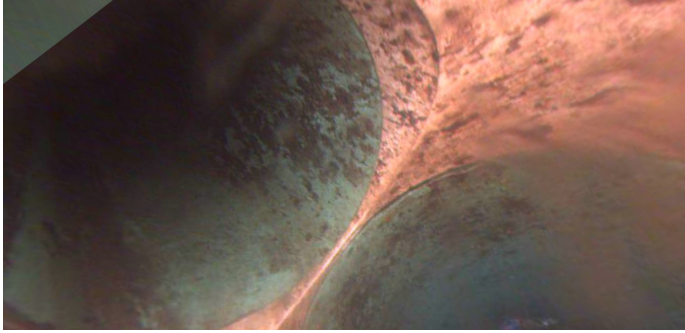
Code: **TF**
Description: **Tap Factory**

Distance (ft): **75.8**
Structural Grade: **0**
O&M Grade: **0**
Clock Start/From: **1**
Clock To:
1st Value: **4.000**
2nd Value:
Value Percent:
Continuous Index:
Within 8" of Joint:
Remarks:

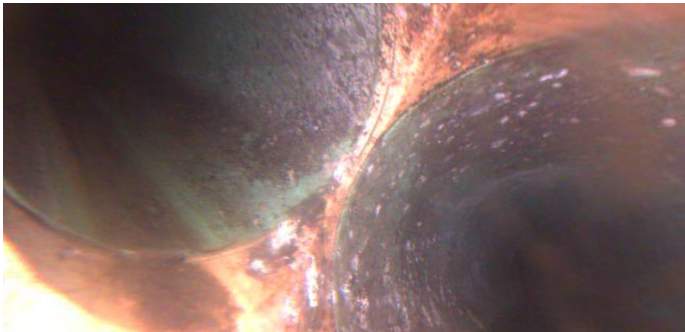
Code: **TF**
Description: **Tap Factory**

Distance (ft): **152.7**
Structural Grade: **0**
O&M Grade: **0**
Clock Start/From: **2**
Clock To:
1st Value: **4.000**
2nd Value:
Value Percent:
Continuous Index:
Within 8" of Joint:
Remarks:

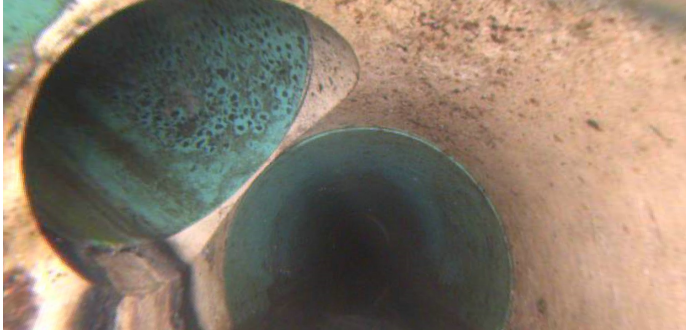
Code: **TF**
Description: **Tap Factory**

Distance (ft): **155.1**
Structural Grade: **0**
O&M Grade: **0**
Clock Start/From: **10**
Clock To:
1st Value: **4.000**
2nd Value:
Value Percent:
Continuous Index:
Within 8" of Joint:
Remarks:

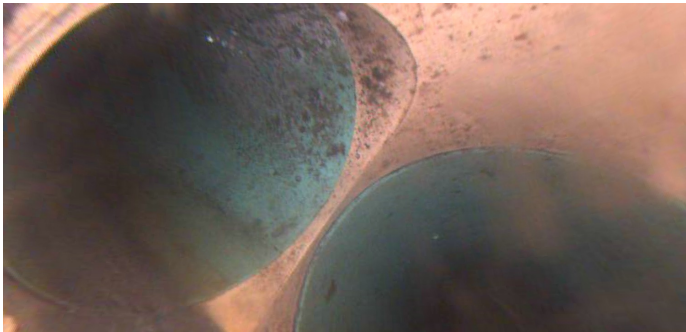
Code: **TF**
Description: **Tap Factory**

Distance (ft): **158.6**
Structural Grade: **0**
O&M Grade: **0**
Clock Start/From: **2**
Clock To:
1st Value: **4.000**
2nd Value:
Value Percent:
Continuous Index:
Within 8" of Joint:
Remarks:

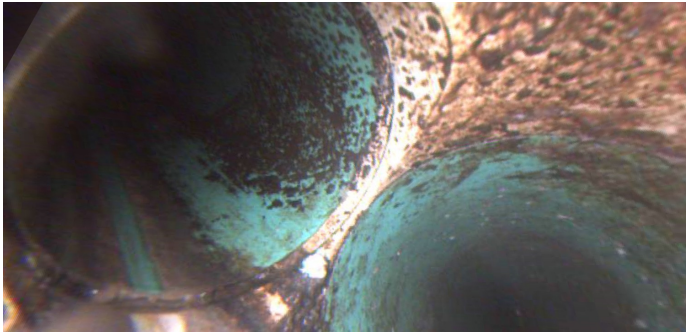
Code: **TF**
Description: **Tap Factory**

Distance (ft): **212.4**
Structural Grade: **0**
O&M Grade: **0**
Clock Start/From: **10**
Clock To:
1st Value: **4.000**
2nd Value:
Value Percent:
Continuous Index:
Within 8" of Joint:
Remarks:

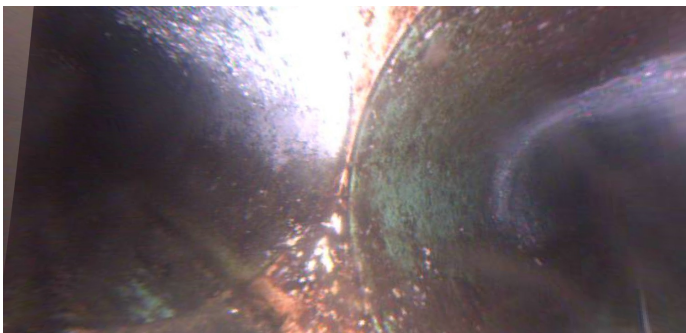
Code: **TF**
Description: **Tap Factory**

Distance (ft): **228.5**
Structural Grade: **0**
O&M Grade: **0**
Clock Start/From: **3**
Clock To:
1st Value: **4.000**
2nd Value:
Value Percent:
Continuous Index:
Within 8" of Joint:
Remarks:

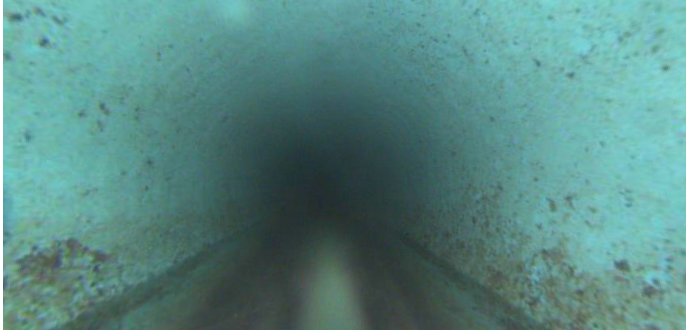
Code: **MWL**
Description: **Water Level**

Distance (ft): **235.2**
Structural Grade: **0**
O&M Grade: **0**
Clock Start/From:
Clock To:
1st Value:
2nd Value:
Value Percent: **20.000**
Continuous Index:
Within 8" of Joint: **NO**
Remarks:

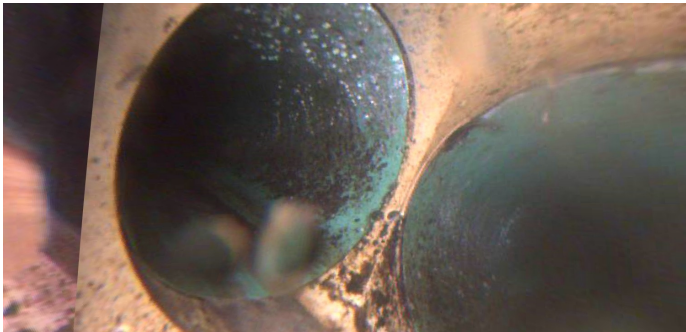
Code: **TF**
Description: **Tap Factory**

Distance (ft): **272.0**
Structural Grade: **0**
O&M Grade: **0**
Clock Start/From: **9**
Clock To:
1st Value: **4.000**
2nd Value:
Value Percent:
Continuous Index:
Within 8" of Joint:
Remarks:

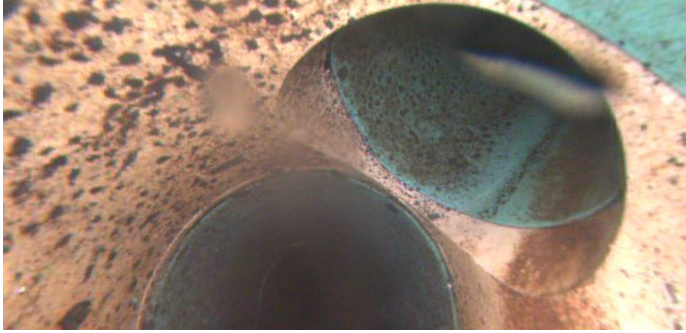
Code: **TF**
Description: **Tap Factory**

Distance (ft): **279.6**
Structural Grade: **0**
O&M Grade: **0**
Clock Start/From: **1**
Clock To:
1st Value: **4.000**
2nd Value:
Value Percent:
Continuous Index:
Within 8" of Joint:
Remarks:

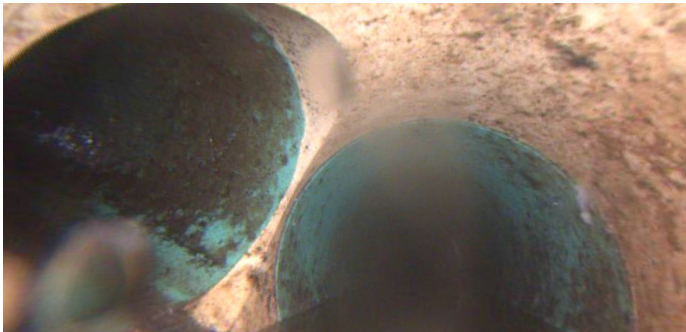
Code: **TF**
Description: **Tap Factory**

Distance (ft): **337.6**
Structural Grade: **0**
O&M Grade: **0**
Clock Start/From: **9**
Clock To:
1st Value: **4.000**
2nd Value:
Value Percent:
Continuous Index:
Within 8" of Joint:
Remarks:

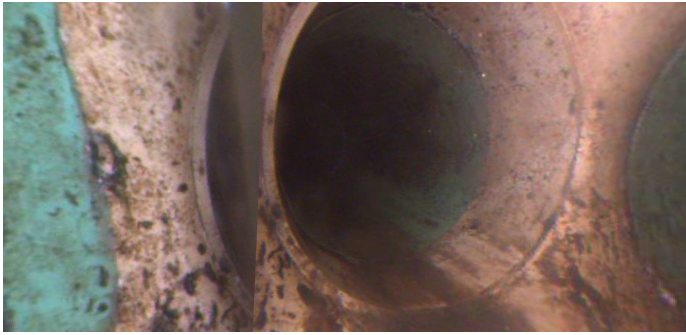
Code: **TF**
Description: **Tap Factory**

Distance (ft): **340.9**
Structural Grade: **0**
O&M Grade: **0**
Clock Start/From: **3**
Clock To:
1st Value: **4.000**
2nd Value:
Value Percent:
Continuous Index:
Within 8" of Joint:
Remarks:

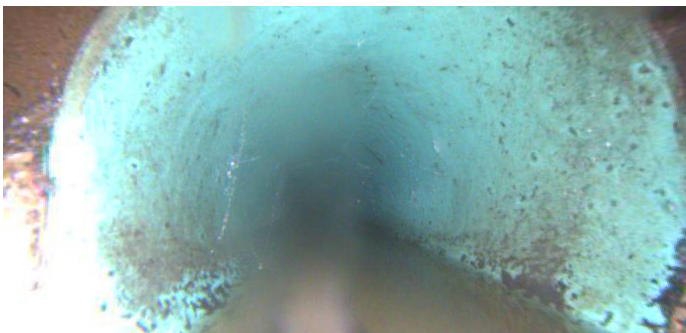
Code: **AMH**
Description: **Manhole**

Distance (ft): **347.8**
Structural Grade: **0**
O&M Grade: **0**
Clock Start/From:
Clock To:
1st Value:
2nd Value:
Value Percent:
Continuous Index:
Within 8" of Joint: **NO**
Remarks: **M-807-006**
