## Profile/Photo Observation Report

Date:	<b>04/15/2018</b>	Weather:		Coding:	<b>PACP 6.0</b>
Pipe Length (ft):	<b>188.8</b>	Owner:	<b>NA</b>	Pre Clean:	<b>Not Known</b>
P.O.#:		Surveyor:	<b>Selasie Honu</b>	PSR:	<b>P-907-004-012</b>
Customer:		Clean Date:	<b>01/01/1900</b>	Shape:	<b>C</b>

Street:	<b>S HOBART RD</b>	Flow Control:	<b>Not Controlled</b>
City:	<b>Hobart, IN</b>	Year Renewed:	
Location:	<b>Light Highway</b>	Tape/Media #:	
Purpose:	<b>Maintenance Related</b>	Dia/Height:	<b>12"</b>
Use:	<b>Sanitary</b>	Material:	<b>PVC</b>
Drain Area:	<b>NA</b>	Lining:	<b>Cured in Place</b>
Category:	<b>NA</b>		
Comment:	<b>battery at 257'. longer than mapped</b>		
Location Details:		Direction of Survey:	<b>Upstream</b>
US MH:	<b>M-807-012</b>	DS MH:	<b>M-907-004</b>
		Total Length Surveyed (ft):	<b>258.8</b>

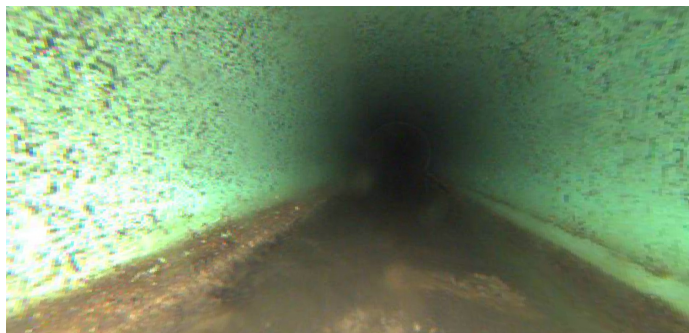
Code: **AMH**  
Description: **Manhole**

Distance (ft): **.0**  
Structural Grade: **0**  
O&M Grade: **0**  
Clock Start/From:  
Clock To:  
1st Value:  
2nd Value:  
Value Percent:  
Continuous Index:  
Within 8" of Joint: **NO**  
Remarks: **M-907-004**

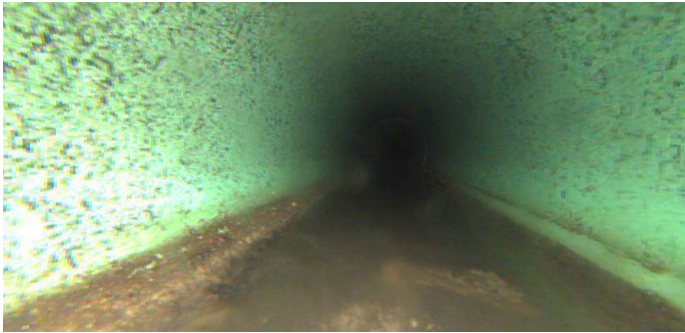
Code:	<b>MWL</b>
Description:	<b>Water Level</b>

Distance (ft):	<b>.0</b>
Structural Grade:	<b>0</b>
O&M Grade:	<b>0</b>
Clock Start/From:	
Clock To:	
1st Value:	
2nd Value:	
Value Percent:	<b>5.000</b>
Continuous Index:	
Within 8" of Joint:	<b>NO</b>
Remarks:

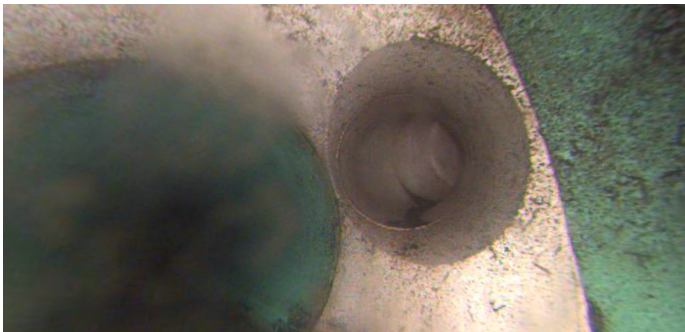
Code:	<b>TF</b>
Description:	<b>Tap Factory</b>

Distance (ft):	<b>57.9</b>
Structural Grade:	<b>0</b>
O&M Grade:	<b>0</b>
Clock Start/From:	<b>10</b>
Clock To:	
1st Value:	<b>4.000</b>
2nd Value:	
Value Percent:	
Continuous Index:	
Within 8" of Joint:	
Remarks:

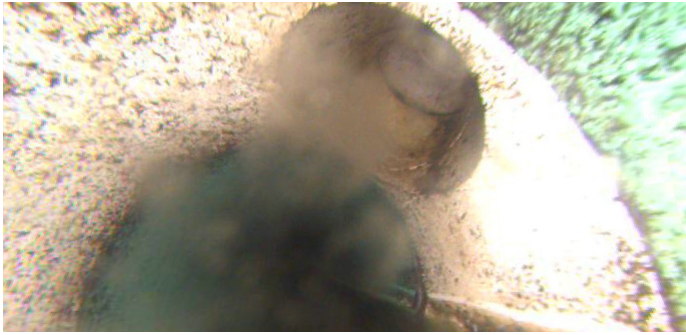
Code: **TFC**  
Description: **Tap Factory Capped**

Distance (ft): **124.1**  
Structural Grade: **0**  
O&M Grade: **0**  
Clock Start/From: **10**  
Clock To:  
1st Value: **4.000**  
2nd Value:  
Value Percent:  
Continuous Index:  
Within 8" of Joint:  
Remarks:

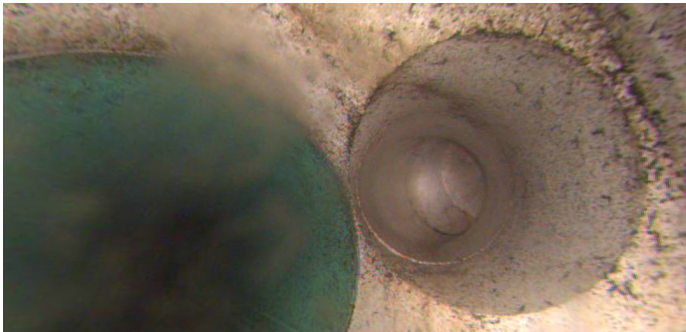
Code: **TF**  
Description: **Tap Factory**

Distance (ft): **177.0**  
Structural Grade: **0**  
O&M Grade: **0**  
Clock Start/From: **10**  
Clock To:  
1st Value: **4.000**  
2nd Value:  
Value Percent:  
Continuous Index:  
Within 8" of Joint:  
Remarks:

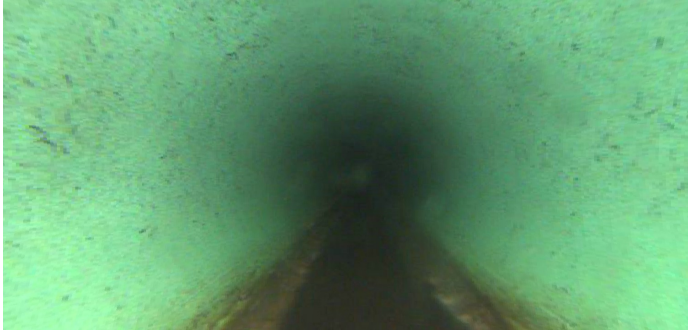
Code:	<b>AMH</b>
Description:	<b>Manhole</b>
Distance (ft):	<b>258.8</b>
Structural Grade:	<b>0</b>
O&M Grade:	<b>0</b>
Clock Start/From:	
Clock To:	
1st Value:	
2nd Value:	
Value Percent:	
Continuous Index:	
Within 8" of Joint:	<b>NO</b>
Remarks:	<b>M-807-012</b>
