Profile/Photo Observation Report

Street:	E 14TH ST & S ILLINOIS ST	Flow Control:	Not Controlled
City:	Hobart, IN	Year Renewed:	
Location:	Light Highway	Tape/Media #:	
Purpose:	Maintenance Related	Dia/Height:	8"
Use:	Sanitary	Material:	PVC
Drain Area:	NA	Lining:	Cured in Place
Category:	NA		
Comment:

Location Details:		Direction of Survey:	Downstream
US MH:	M-807-014	DS MH:	M-807-005
		Total Length Surveyed (ft):	79.3

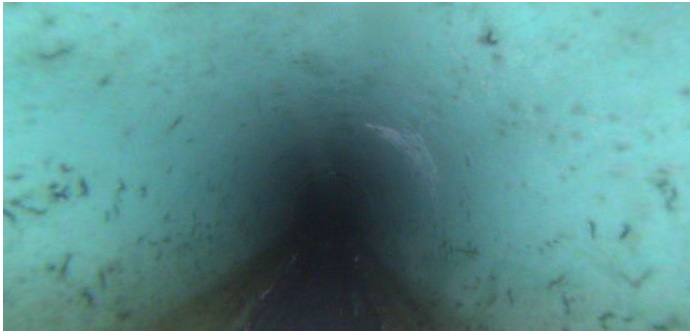
Code: AMH

Description: Manhole

Distance (ft): .0

Remarks: M-807-014

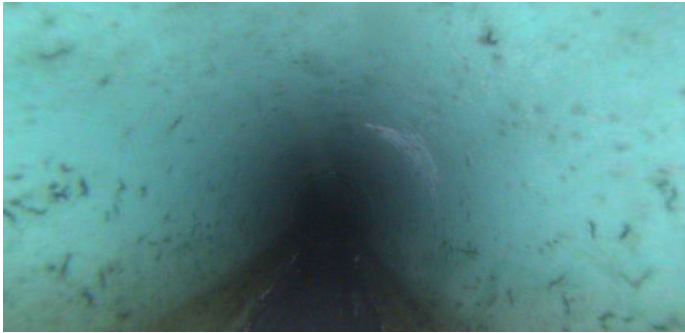
Code:	MWL
Description:	Water Level

Distance (ft):	.0
Structural Grade:	0
O&M Grade:	0
Clock Start/From:	
Clock To:	
1st Value:	
2nd Value:	
Value Percent:	5.000
Continuous Index:	
Within 8" of Joint:	NO
Remarks:

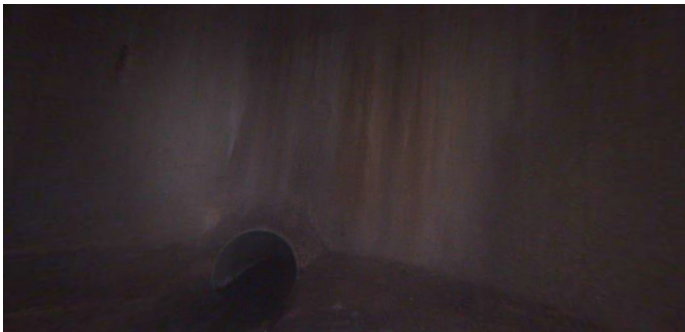
Code:	AMH
Description:	Manhole

Distance (ft):	79.3
Structural Grade:	0
O&M Grade:	0
Clock Start/From:	
Clock To:	
1st Value:	
2nd Value:	
Value Percent:	
Continuous Index:	
Within 8" of Joint:	NO
Remarks:	M-807-005
