Profile/Photo Observation Report

Street:	Capitol	Flow Control:	Not Controlled
City:	Hobart, IN	Year Renewed:	
Location:	Sidewalk	Tape/Media #:	
Purpose:	Maintenance Related	Dia/Height:	12"
Use:	Sanitary	Material:	PVC
Drain Area:	NA	Lining:	Cured in Place
Category:	NA		
Comment:	Flow direction wrong.

Location Details:		Direction of Survey:	Upstream
US MH:	M-808-002	DS MH:	M-808-003
		Total Length Surveyed (ft):	103.7

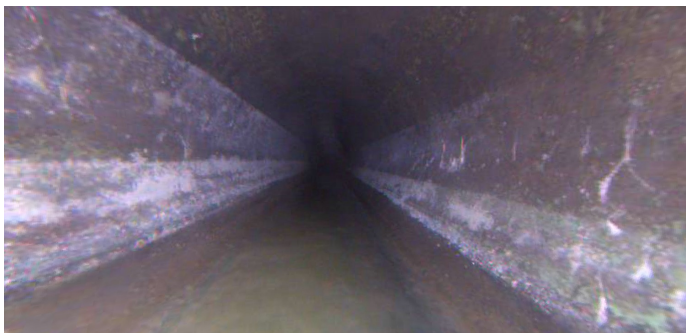
Code: **AMH**
Description: **Manhole**

Distance (ft): **.0**
Structural Grade: **0**
O&M Grade: **0**
Clock Start/From:
Clock To:
1st Value:
2nd Value:
Value Percent:
Continuous Index:
Within 8" of Joint: **NO**
Remarks: **M-808-003**

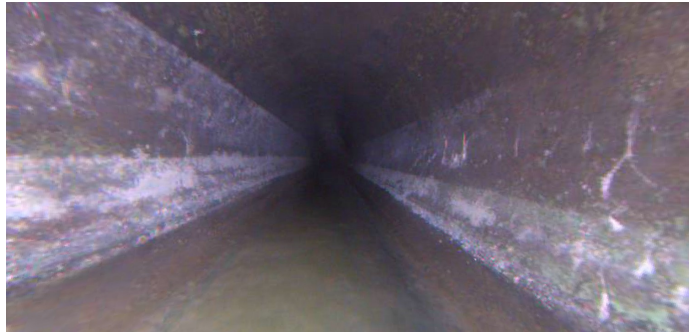
Code:	MWL
Description:	Water Level
Distance (ft):	.0
Structural Grade:	0
O&M Grade:	0
Clock Start/From:	
Clock To:	
1st Value:	
2nd Value:	
Value Percent:	10.000
Continuous Index:	
Within 8" of Joint:	NO
Remarks:

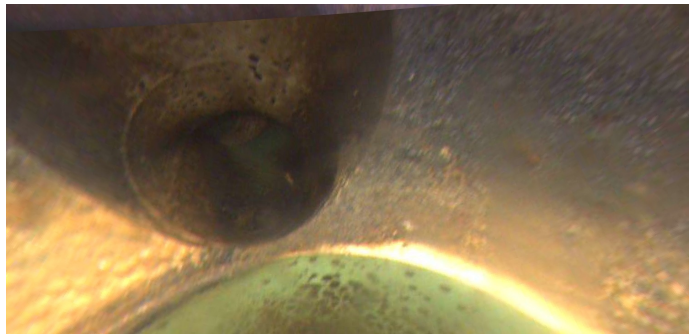
Code:	TF
Description:	Tap Factory
Distance (ft):	42.8
Structural Grade:	0
O&M Grade:	0
Clock Start/From:	1
Clock To:	
1st Value:	4.000
2nd Value:	
Value Percent:	
Continuous Index:	
Within 8" of Joint:	
Remarks:

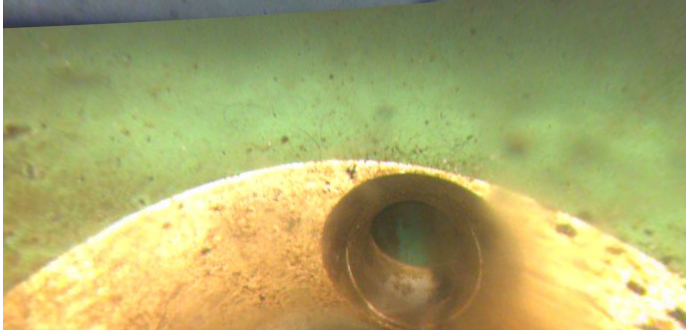
Code: **TF**
Description: **Tap Factory**

Distance (ft): **45.3**
Structural Grade: **0**
O&M Grade: **0**
Clock Start/From: **11**
Clock To:
1st Value: **4.000**
2nd Value:
Value Percent:
Continuous Index:
Within 8" of Joint:
Remarks:

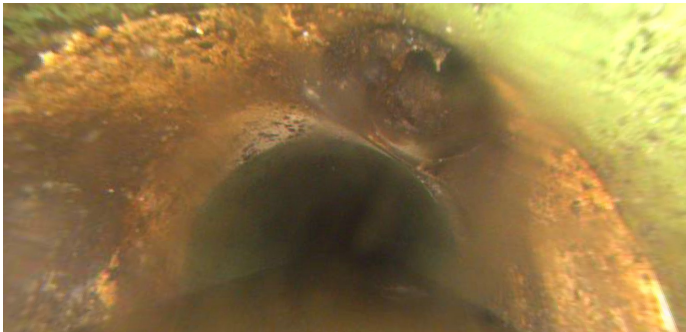
Code: **TF**
Description: **Tap Factory**

Distance (ft): **98.7**
Structural Grade: **0**
O&M Grade: **0**
Clock Start/From: **11**
Clock To:
1st Value: **4.000**
2nd Value:
Value Percent:
Continuous Index:
Within 8" of Joint:
Remarks:

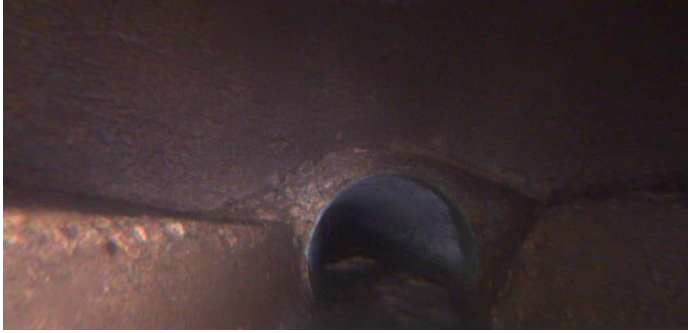
Code:	AMH
Description:	Manhole
Distance (ft):	103.7
Structural Grade:	0
O&M Grade:	0
Clock Start/From:	
Clock To:	
1st Value:	
2nd Value:	
Value Percent:	
Continuous Index:	
Within 8" of Joint:	NO
Remarks:	M-808-002
