## Profile/Photo Observation Report

Street:	<b>CAPITOL DR</b>	Flow Control:	<b>Not Controlled</b>
City:	<b>Hobart, IN</b>	Year Renewed:	
Location:	<b>Sidewalk</b>	Tape/Media #:	
Purpose:	<b>Maintenance Related</b>	Dia/Height:	<b>12"</b>
Use:	<b>Sanitary</b>	Material:	<b>PVC</b>
Drain Area:	<b>NA</b>	Lining:	<b>Cured in Place</b>
Category:	<b>NA</b>		
Comment:	<b>Flow direction wrong.</b>

Location Details:		Direction of Survey:	<b>Downstream</b>
US MH:	<b>M-808-003</b>	DS MH:	<b>M-808-004</b>
		Total Length Surveyed (ft):	<b>104.7</b>

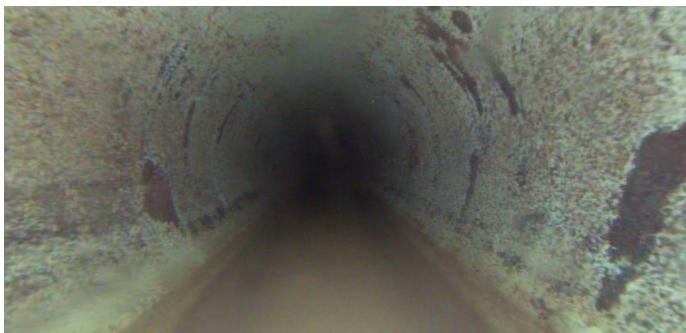
Code: **AMH**  
Description: **Manhole**

Distance (ft): **.0**  
Structural Grade: **0**  
O&M Grade: **0**  
Clock Start/From:  
Clock To:  
1st Value:  
2nd Value:  
Value Percent:  
Continuous Index:  
Within 8" of Joint: **NO**  
Remarks: **M-808-003**

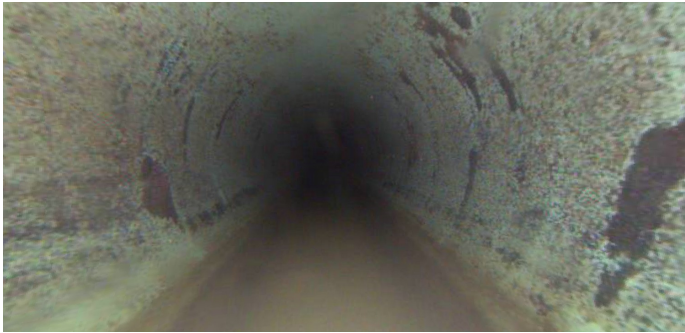
Code:	<b>MWL</b>
Description:	<b>Water Level</b>

Distance (ft):	<b>.0</b>
Structural Grade:	<b>0</b>
O&M Grade:	<b>0</b>
Clock Start/From:	
Clock To:	
1st Value:	
2nd Value:	
Value Percent:	<b>10.000</b>
Continuous Index:	
Within 8" of Joint:	<b>NO</b>
Remarks:

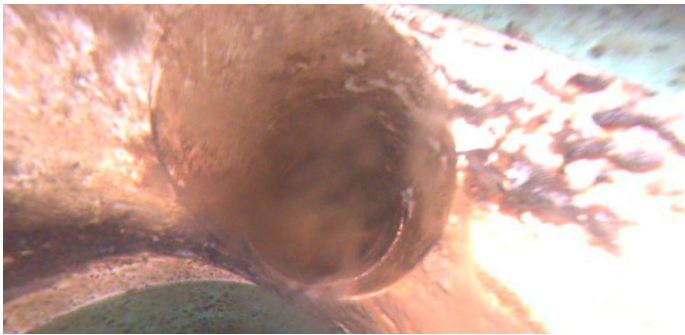
Code:	<b>TF</b>
Description:	<b>Tap Factory</b>

Distance (ft):	<b>17.7</b>
Structural Grade:	<b>0</b>
O&M Grade:	<b>0</b>
Clock Start/From:	<b>1</b>
Clock To:	
1st Value:	<b>4.000</b>
2nd Value:	
Value Percent:	
Continuous Index:	
Within 8" of Joint:	
Remarks:

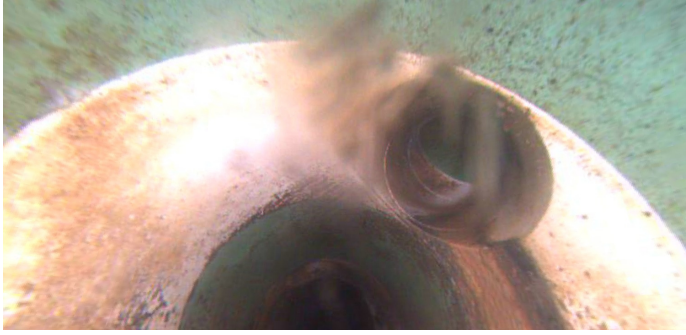
Code: **TF**  
Description: **Tap Factory**

Distance (ft): **70.2**  
Structural Grade: **0**  
O&M Grade: **0**  
Clock Start/From: **1**  
Clock To:  
1st Value: **4.000**  
2nd Value:  
Value Percent:  
Continuous Index:  
Within 8" of Joint:  
Remarks:

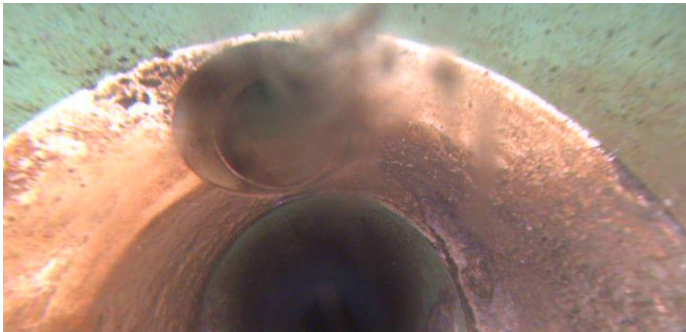
Code: **TF**  
Description: **Tap Factory**

Distance (ft): **72.0**  
Structural Grade: **0**  
O&M Grade: **0**  
Clock Start/From: **12**  
Clock To:  
1st Value: **4.000**  
2nd Value:  
Value Percent:  
Continuous Index:  
Within 8" of Joint:  
Remarks:

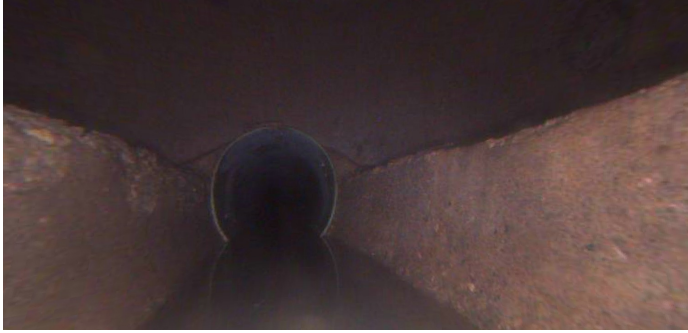
Code:	<b>AMH</b>
Description:	<b>Manhole</b>
Distance (ft):	<b>104.7</b>
Structural Grade:	<b>0</b>
O&M Grade:	<b>0</b>
Clock Start/From:	
Clock To:	
1st Value:	
2nd Value:	
Value Percent:	
Continuous Index:	
Within 8" of Joint:	<b>NO</b>
Remarks:	<b>M-808-004</b>
