Profile/Photo Observation Report

Street:	CAPITOL DR	Flow Control:	Not Controlled
City:	Hobart, IN	Year Renewed:	
Location:	Light Highway	Tape/Media #:	
Purpose:	Maintenance Related	Dia/Height:	8"
Use:	Sanitary	Material:	PVC
Drain Area:	NA	Lining:	Cured in Place
Category:	NA		
Comment:

Location Details:		Direction of Survey:	Downstream
US MH:	M-808-003	DS MH:	M-808-004
		Total Length Surveyed (ft):	258.9

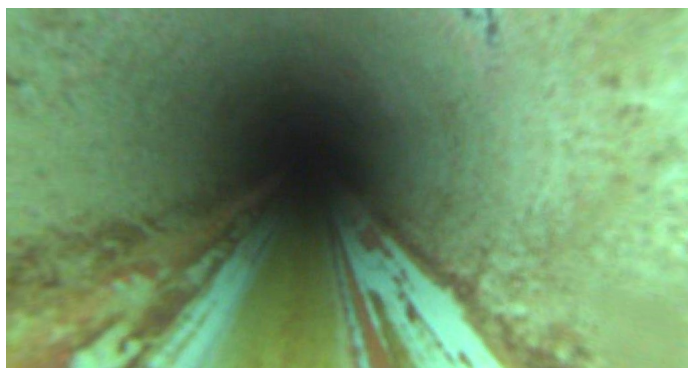
Code: **AMH**
Description: **Manhole**

Distance (ft): **.0**
Structural Grade: **0**
O&M Grade: **0**
Clock Start/From:
Clock To:
1st Value:
2nd Value:
Value Percent:
Continuous Index:
Within 8" of Joint: **NO**
Remarks: **M-808-003**

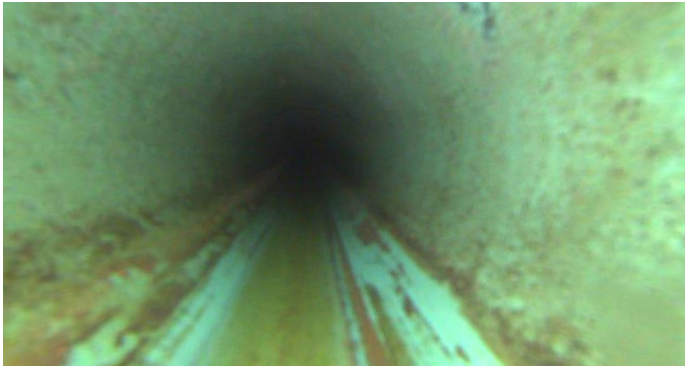
Code:	MWL
Description:	Water Level

Distance (ft):	.0
Structural Grade:	0
O&M Grade:	0
Clock Start/From:	
Clock To:	
1st Value:	
2nd Value:	
Value Percent:	10.000
Continuous Index:	
Within 8" of Joint:	NO
Remarks:

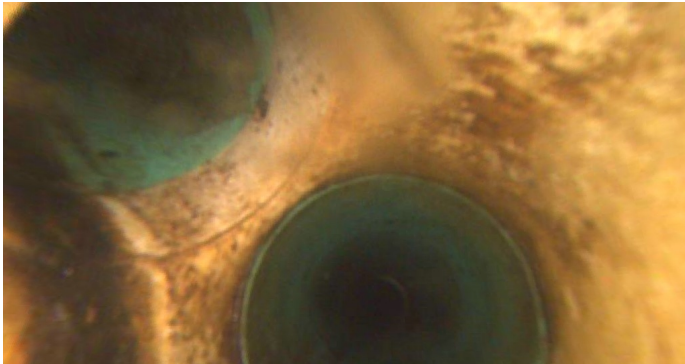
Code:	TF
Description:	Tap Factory

Distance (ft):	72.6
Structural Grade:	0
O&M Grade:	0
Clock Start/From:	10
Clock To:	
1st Value:	4.000
2nd Value:	
Value Percent:	
Continuous Index:	
Within 8" of Joint:	
Remarks:

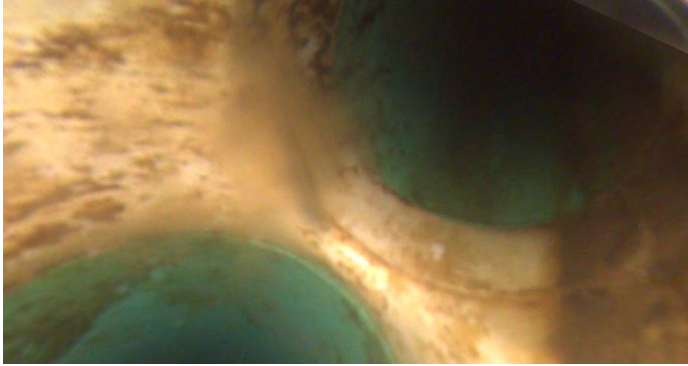
Code: **TF**
Description: **Tap Factory**

Distance (ft): **76.4**
Structural Grade: **0**
O&M Grade: **0**
Clock Start/From: **2**
Clock To:
1st Value: **4.000**
2nd Value:
Value Percent:
Continuous Index:
Within 8" of Joint:
Remarks:

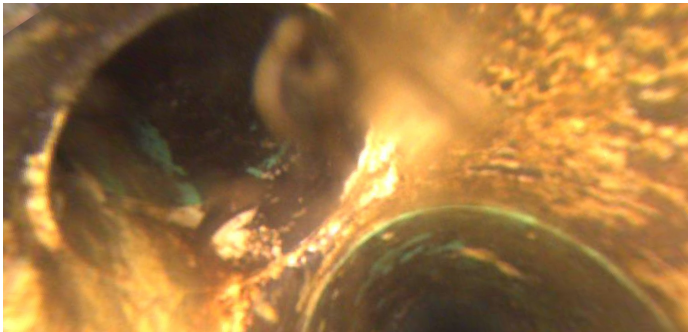
Code: **TF**
Description: **Tap Factory**

Distance (ft): **177.1**
Structural Grade: **0**
O&M Grade: **0**
Clock Start/From: **11**
Clock To:
1st Value: **4.000**
2nd Value:
Value Percent:
Continuous Index:
Within 8" of Joint:
Remarks:

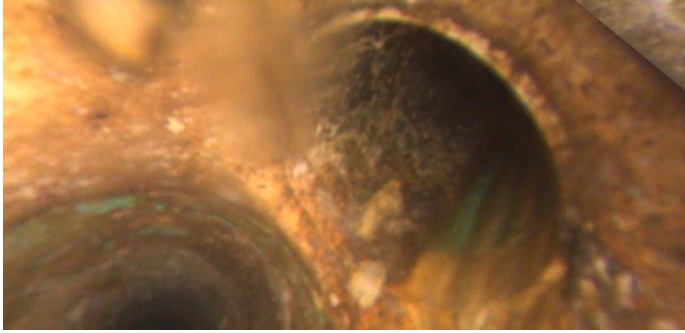
Code: **TF**
Description: **Tap Factory**

Distance (ft): **236.3**
Structural Grade: **0**
O&M Grade: **0**
Clock Start/From: **2**
Clock To:
1st Value: **4.000**
2nd Value:
Value Percent:
Continuous Index:
Within 8" of Joint:
Remarks:

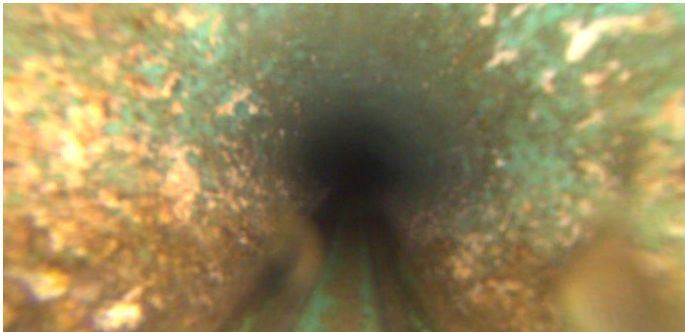
Code: **DAGS**
Description: **Deposits Attached Grease**

Distance (ft): **237.9**
Structural Grade: **0**
O&M Grade: **2**
Clock Start/From: **8**
Clock To: **4**
1st Value:
2nd Value:
Value Percent: **5.000**
Continuous Index:
Within 8" of Joint: **NO**
Remarks:

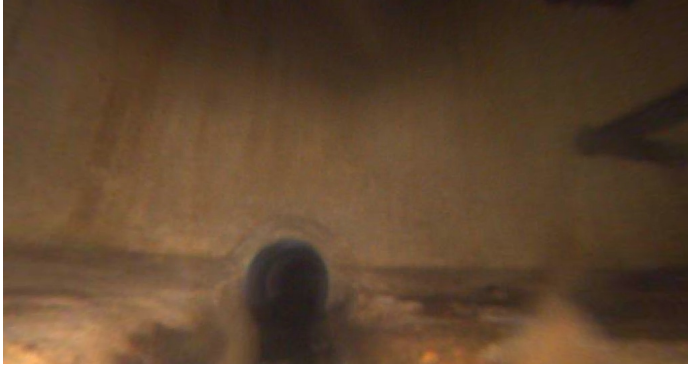
Code:	AMH
Description:	Manhole
Distance (ft):	258.9
Structural Grade:	0
O&M Grade:	0
Clock Start/From:	
Clock To:	
1st Value:	
2nd Value:	
Value Percent:	
Continuous Index:	
Within 8" of Joint:	NO
Remarks:	M-808-004
