Profile/Photo Observation Report

Street:	CAPITOL DR	Flow Control:	Not Controlled
City:	Hobart, IN	Year Renewed:	
Location:	Sidewalk	Tape/Media #:	
Purpose:	Maintenance Related	Dia/Height:	12"
Use:	Sanitary	Material:	PVC
Drain Area:	NA	Lining:	
Category:	NA		
Comment:	flow direction incorrect.

Location Details:		Direction of Survey:	Upstream
US MH:	M-808-005	DS MH:	M-808-006
		Total Length Surveyed (ft):	184.7

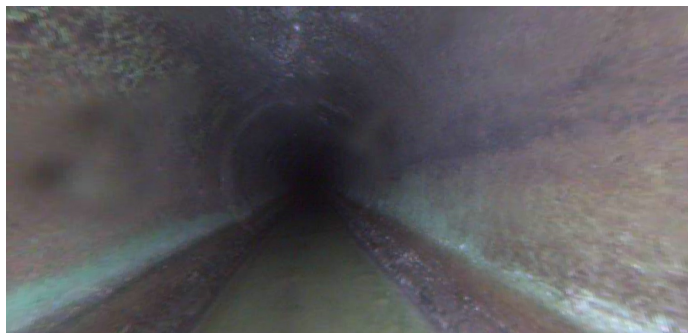
Code: **AMH**
Description: **Manhole**

Distance (ft): **.0**
Structural Grade: **0**
O&M Grade: **0**
Clock Start/From:
Clock To:
1st Value:
2nd Value:
Value Percent:
Continuous Index:
Within 8" of Joint: **NO**
Remarks: **M-808-006**

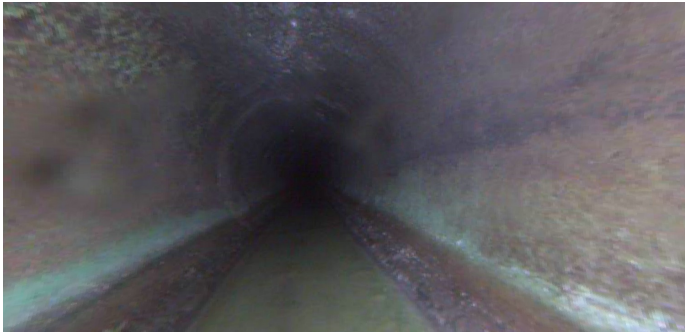
Code:	MWL
Description:	Water Level

Distance (ft):	.0
Structural Grade:	0
O&M Grade:	0
Clock Start/From:	
Clock To:	
1st Value:	
2nd Value:	
Value Percent:	5.000
Continuous Index:	
Within 8" of Joint:	NO
Remarks:

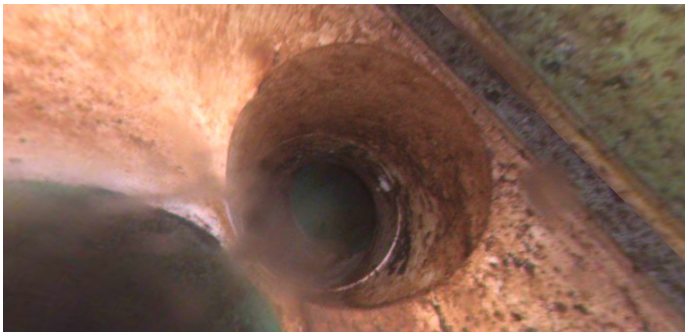
Code:	TF
Description:	Tap Factory

Distance (ft):	22.1
Structural Grade:	0
O&M Grade:	0
Clock Start/From:	10
Clock To:	
1st Value:	4.000
2nd Value:	
Value Percent:	
Continuous Index:	
Within 8" of Joint:	
Remarks:

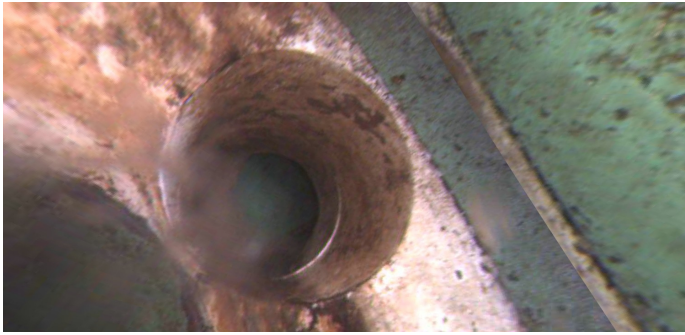
Code: **TF**
Description: **Tap Factory**

Distance (ft): **98.5**
Structural Grade: **0**
O&M Grade: **0**
Clock Start/From: **10**
Clock To:
1st Value: **4.000**
2nd Value:
Value Percent:
Continuous Index:
Within 8" of Joint:
Remarks:

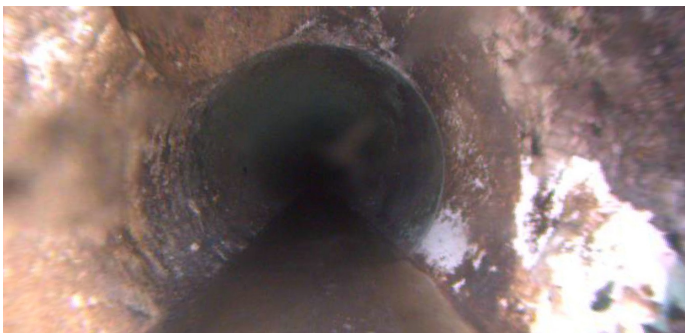
Code: **DAGS**
Description: **Deposits Attached Grease**

Distance (ft): **162.7**
Structural Grade: **0**
O&M Grade: **2**
Clock Start/From: **8**
Clock To: **4**
1st Value:
2nd Value:
Value Percent: **5.000**
Continuous Index:
Within 8" of Joint: **NO**
Remarks:

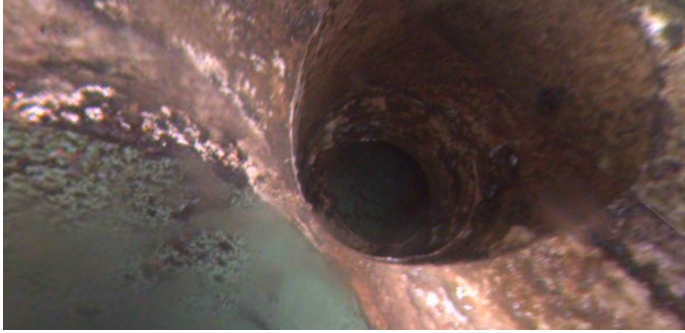
Code: **TF**
Description: **Tap Factory**

Distance (ft): **163.6**
Structural Grade: **0**
O&M Grade: **0**
Clock Start/From: **10**
Clock To:
1st Value: **4.000**
2nd Value:
Value Percent:
Continuous Index:
Within 8" of Joint:
Remarks:

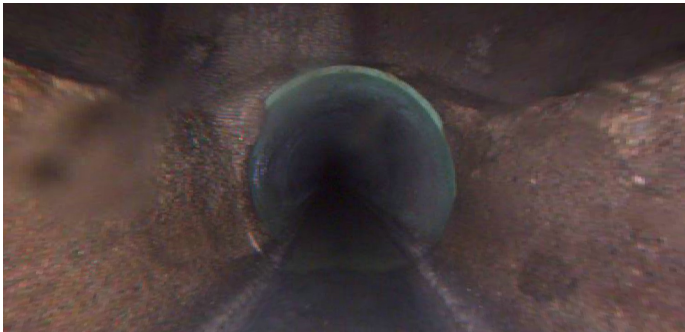
Code: **AMH**
Description: **Manhole**

Distance (ft): **184.7**
Structural Grade: **0**
O&M Grade: **0**
Clock Start/From:
Clock To:
1st Value:
2nd Value:
Value Percent:
Continuous Index:
Within 8" of Joint: **NO**
Remarks: **M-808-005**
