## Profile/Photo Observation Report

Street:	<b>Union Court</b>	Flow Control:	
City:	<b>Hobart, IN</b>	Year Renewed:	
Location:	<b>Light Highway</b>	Tape/Media #:	<b>959</b>
Purpose:	<b>Routine Assessment</b>	Dia/Height:	<b>8"</b>
Use:	<b>Sanitary</b>	Material:	<b>PVC</b>
Drain Area:		Lining:	
Category:	<b>NA</b>		
Comment:

Location Details:		Direction of Survey:	<b>Upstream</b>
US MH:	<b>M-808-5</b>	DS MH:	<b>M-808-22</b>
		Total Length Surveyed (ft):	<b>175.1</b>

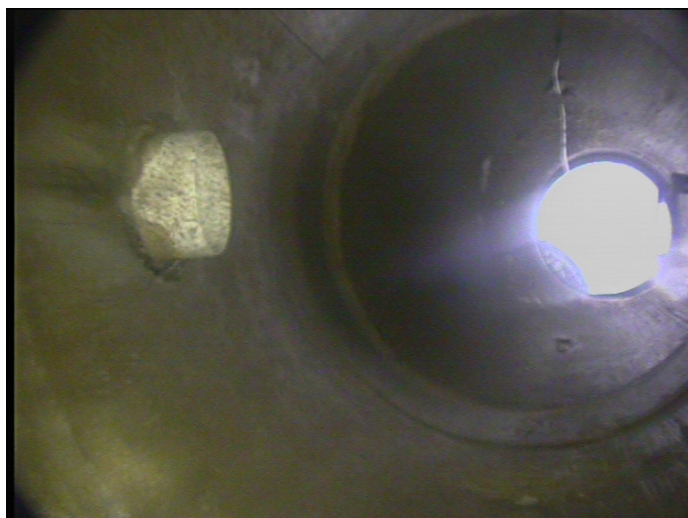
Code: **AMH**  
Description: **Manhole**

Distance (ft): **.0**  
Structural Grade: **0**  
O&M Grade: **0**  
Clock Start/From:  
Clock To:  
1st Value:  
2nd Value:  
Value Percent:  
Continuous Index:  
Within 8" of Joint: **NO**  
Remarks: **M-808-22**

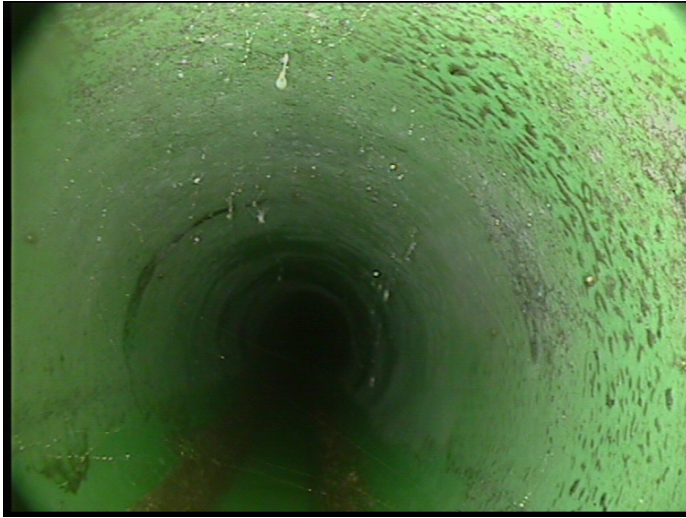
Code:	<b>MWL</b>
Description:	<b>Water Level</b>
Distance (ft):	<b>.0</b>
Structural Grade:	<b>0</b>
O&M Grade:	<b>0</b>
Clock Start/From:	
Clock To:	
1st Value:	
2nd Value:	
Value Percent:	<b>5.000</b>
Continuous Index:	
Within 8" of Joint:	<b>NO</b>
Remarks:

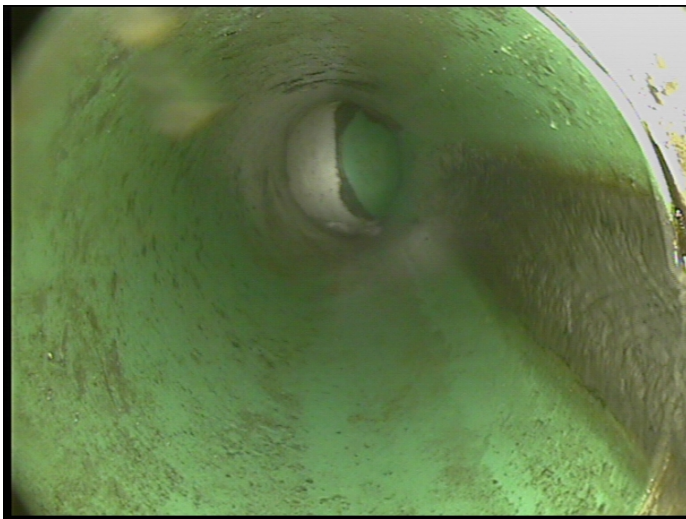
Code:	<b>TF</b>
Description:	<b>Tap Factory</b>
Distance (ft):	<b>95.5</b>
Structural Grade:	<b>0</b>
O&M Grade:	<b>0</b>
Clock Start/From:	<b>2</b>
Clock To:	
1st Value:	<b>4.000</b>
2nd Value:	
Value Percent:	
Continuous Index:	
Within 8" of Joint:	<b>NO</b>
Remarks:

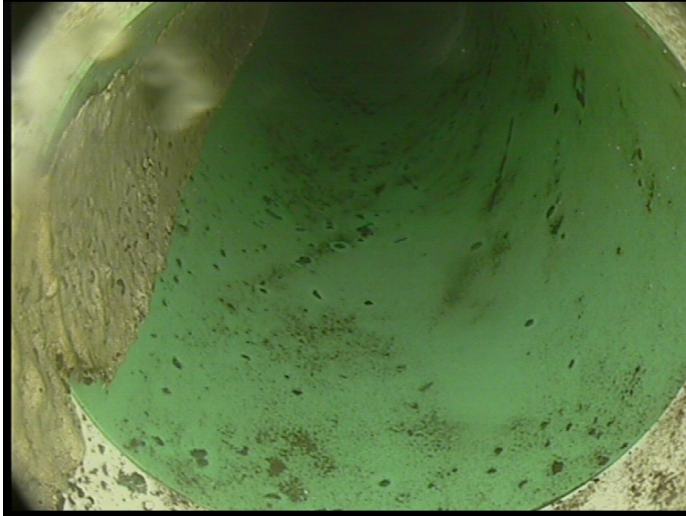
Code: **TF**  
Description: **Tap Factory**

Distance (ft): **97.2**  
Structural Grade: **0**  
O&M Grade: **0**  
Clock Start/From: **10**  
Clock To:  
1st Value: **4.000**  
2nd Value:  
Value Percent:  
Continuous Index:  
Within 8" of Joint: **NO**  
Remarks:

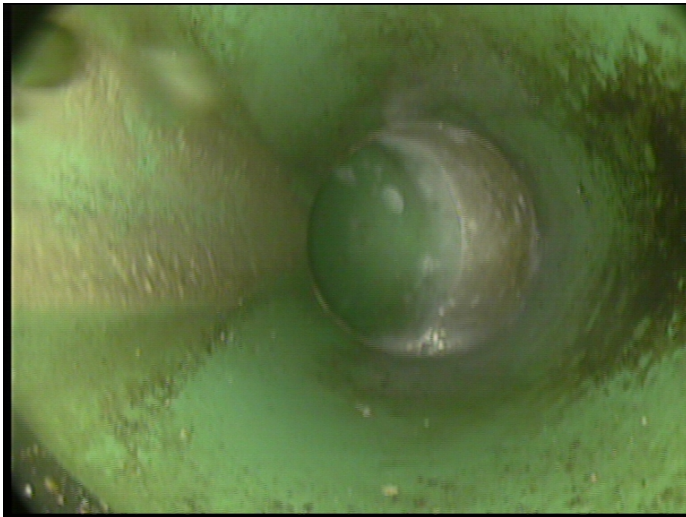
Code: **TF**  
Description: **Tap Factory**

Distance (ft): **111.8**  
Structural Grade: **0**  
O&M Grade: **0**  
Clock Start/From: **10**  
Clock To:  
1st Value: **4.000**  
2nd Value:  
Value Percent:  
Continuous Index:  
Within 8" of Joint: **NO**  
Remarks:

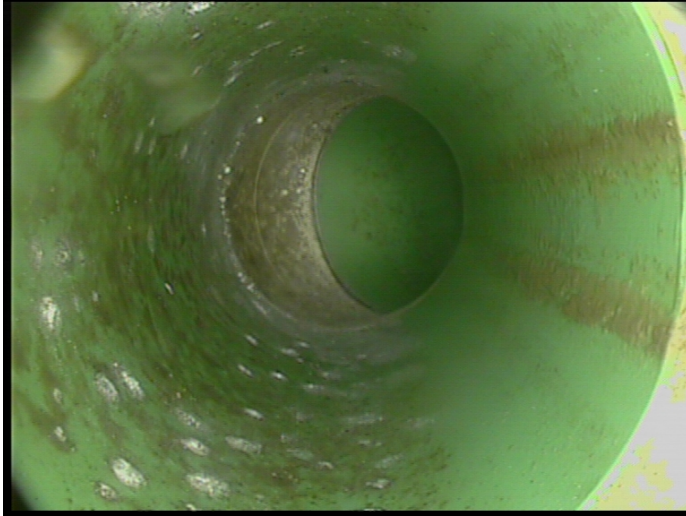
Code: **TF**  
Description: **Tap Factory**

Distance (ft): **147.8**  
Structural Grade: **0**  
O&M Grade: **0**  
Clock Start/From: **3**  
Clock To:  
1st Value: **4.000**  
2nd Value:  
Value Percent:  
Continuous Index:  
Within 8" of Joint: **NO**  
Remarks:

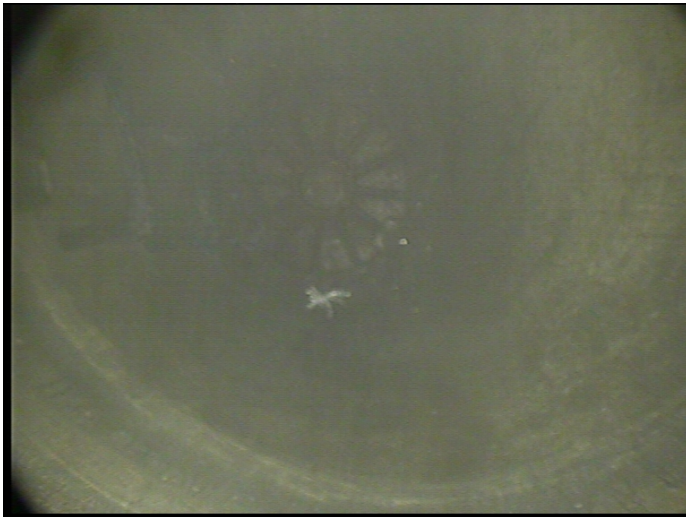
Code: **AMH**  
Description: **Manhole**

Distance (ft): **175.1**  
Structural Grade: **0**  
O&M Grade: **0**  
Clock Start/From:  
Clock To:  
1st Value:  
2nd Value:  
Value Percent:  
Continuous Index:  
Within 8" of Joint: **NO**  
Remarks: **M-808-5**
