Profile/Photo Observation Report

Street:	CAPITOL DR	Flow Control:	Not Controlled
City:	Hobart, IN	Year Renewed:	
Location:	Sidewalk	Tape/Media #:	
Purpose:	Maintenance Related	Dia/Height:	12"
Use:	Sanitary	Material:	PVC
Drain Area:	NA	Lining:	
Category:	NA		
Comment:	flow direction incorrect.

Location Details:		Direction of Survey:	Downstream
US MH:	M-808-006	DS MH:	M-808-007
		Total Length Surveyed (ft):	99.2

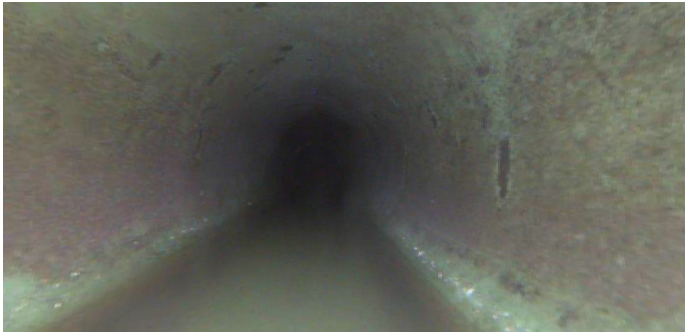
Code:	MWL
Description:	Water Level

Distance (ft):	.0
Structural Grade:	0
O&M Grade:	0
Clock Start/From:	
Clock To:	
1st Value:	
2nd Value:	
Value Percent:	5.000
Continuous Index:	
Within 8" of Joint:	NO
Remarks:

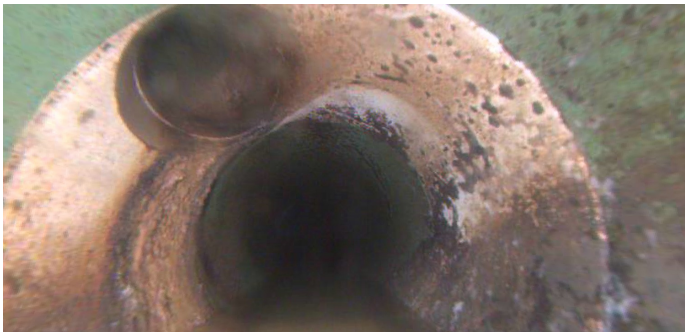
Code:	TF
Description:	Tap Factory

Distance (ft):	5.4
Structural Grade:	0
O&M Grade:	0
Clock Start/From:	11
Clock To:	
1st Value:	4.000
2nd Value:	
Value Percent:	
Continuous Index:	
Within 8" of Joint:	
Remarks:

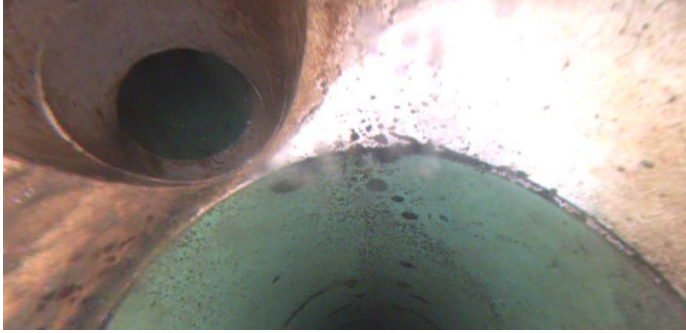
Code: **TF**
Description: **Tap Factory**

Distance (ft): **58.2**
Structural Grade: **0**
O&M Grade: **0**
Clock Start/From: **11**
Clock To:
1st Value: **4.000**
2nd Value:
Value Percent:
Continuous Index:
Within 8" of Joint:
Remarks:

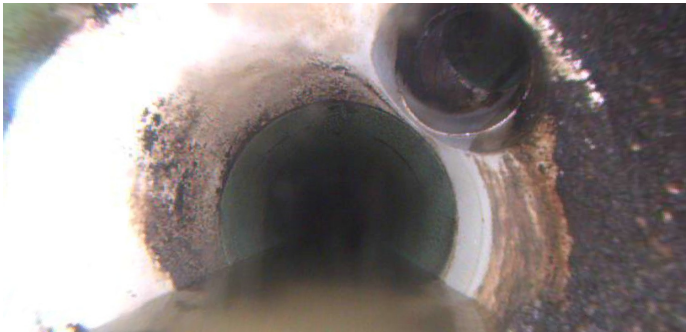
Code: **TF**
Description: **Tap Factory**

Distance (ft): **70.2**
Structural Grade: **0**
O&M Grade: **0**
Clock Start/From: **2**
Clock To:
1st Value: **4.000**
2nd Value:
Value Percent:
Continuous Index:
Within 8" of Joint:
Remarks:

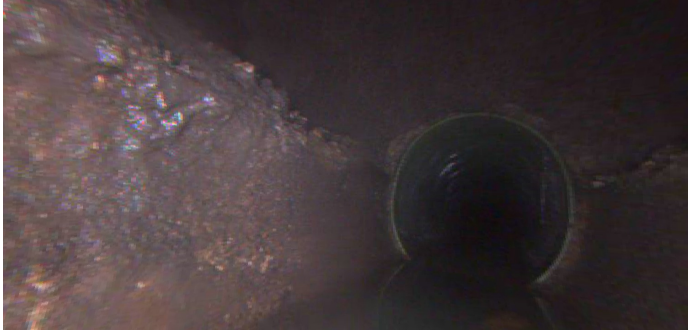
Code:	AMH
Description:	Manhole
Distance (ft):	99.2
Structural Grade:	0
O&M Grade:	0
Clock Start/From:	
Clock To:	
1st Value:	
2nd Value:	
Value Percent:	
Continuous Index:	
Within 8" of Joint:	NO
Remarks:	M-808-007
