Profile/Photo Observation Report

Street:	Oak	Flow Control:	Not Controlled
City:	Hobart, IN	Year Renewed:	
Location:	Sidewalk	Tape/Media #:	
Purpose:	Maintenance Related	Dia/Height:	12"
Use:	Sanitary	Material:	PVC
Drain Area:	NA	Lining:	
Category:	NA		
Comment:	flow direction incorrect.

Location Details:		Direction of Survey:	Downstream
US MH:	M-808-006	DS MH:	M-808-007
		Total Length Surveyed (ft):	99.2

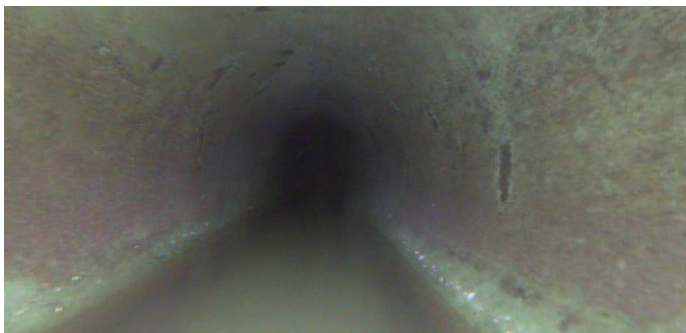
Code: **AMH**
Description: **Manhole**

Distance (ft): **.0**
Structural Grade: **0**
O&M Grade: **0**
Clock Start/From:
Clock To:
1st Value:
2nd Value:
Value Percent:
Continuous Index:
Within 8" of Joint: **NO**
Remarks: **M-808-006**

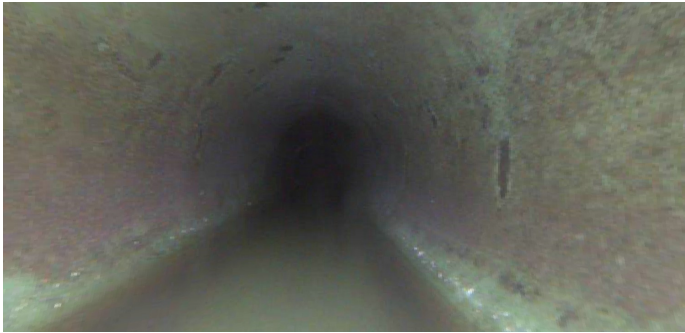
Code:	MWL
Description:	Water Level

Distance (ft):	.0
Structural Grade:	0
O&M Grade:	0
Clock Start/From:	
Clock To:	
1st Value:	
2nd Value:	
Value Percent:	5.000
Continuous Index:	
Within 8" of Joint:	NO
Remarks:

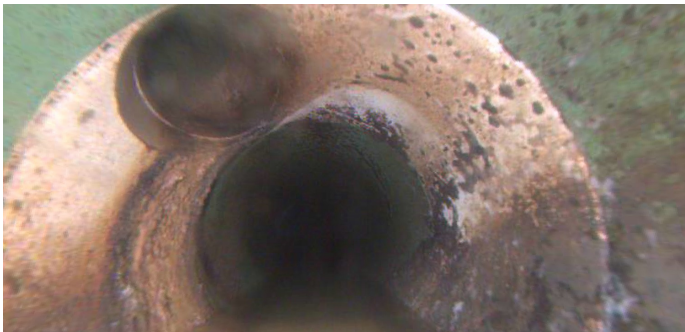
Code:	TF
Description:	Tap Factory

Distance (ft):	5.4
Structural Grade:	0
O&M Grade:	0
Clock Start/From:	11
Clock To:	
1st Value:	4.000
2nd Value:	
Value Percent:	
Continuous Index:	
Within 8" of Joint:	
Remarks:

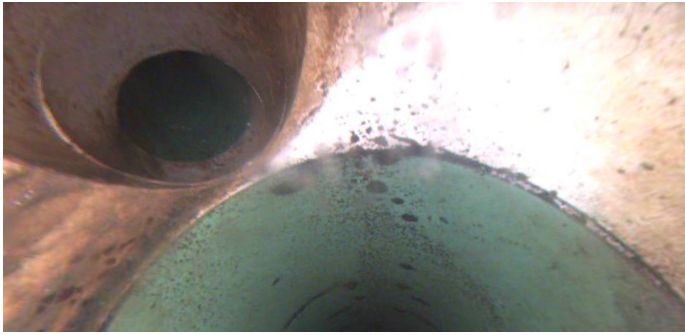
Code: **TF**
Description: **Tap Factory**

Distance (ft): **58.2**
Structural Grade: **0**
O&M Grade: **0**
Clock Start/From: **11**
Clock To:
1st Value: **4.000**
2nd Value:
Value Percent:
Continuous Index:
Within 8" of Joint:
Remarks:

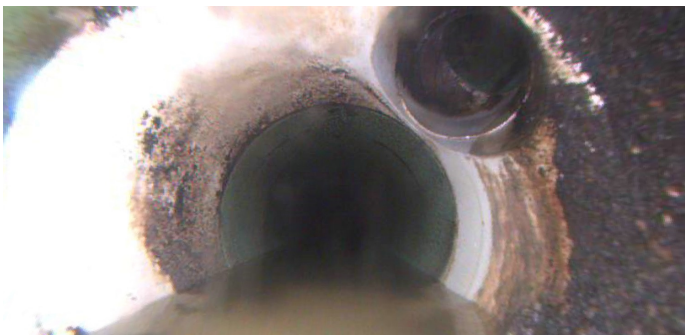
Code: **TF**
Description: **Tap Factory**

Distance (ft): **70.2**
Structural Grade: **0**
O&M Grade: **0**
Clock Start/From: **2**
Clock To:
1st Value: **4.000**
2nd Value:
Value Percent:
Continuous Index:
Within 8" of Joint:
Remarks:

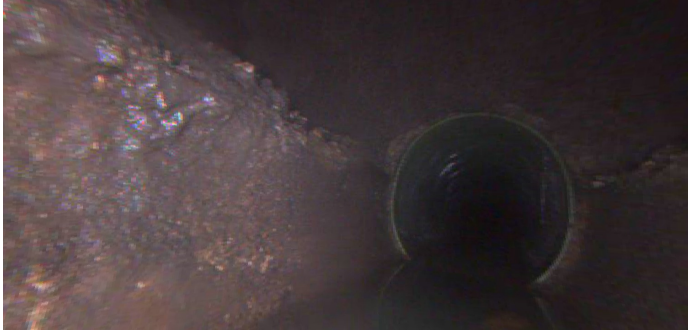
Code:	AMH
Description:	Manhole
Distance (ft):	99.2
Structural Grade:	0
O&M Grade:	0
Clock Start/From:	
Clock To:	
1st Value:	
2nd Value:	
Value Percent:	
Continuous Index:	
Within 8" of Joint:	NO
Remarks:	M-808-007
