Profile/Photo Observation Report

Street:	CAPITOL DR	Flow Control:	Not Controlled
City:	Hobart, IN	Year Renewed:	
Location:	Light Highway	Tape/Media #:	
Purpose:	Maintenance Related	Dia/Height:	12"
Use:	Sanitary	Material:	PVC
Drain Area:	NA	Lining:	
Category:	NA		
Comment:	flow is incorrect.

Location Details:		Direction of Survey:	Upstream
US MH:	M-808-008	DS MH:	M-808-009
		Total Length Surveyed (ft):	249.8

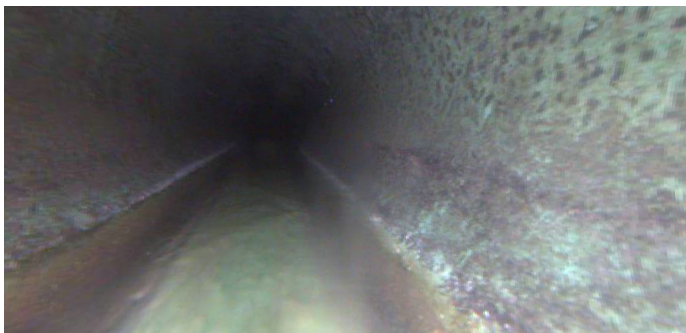
Code: **AMH**
Description: **Manhole**

Distance (ft): **.0**
Structural Grade: **0**
O&M Grade: **0**
Clock Start/From:
Clock To:
1st Value:
2nd Value:
Value Percent:
Continuous Index:
Within 8" of Joint: **NO**
Remarks: **M-808-009**

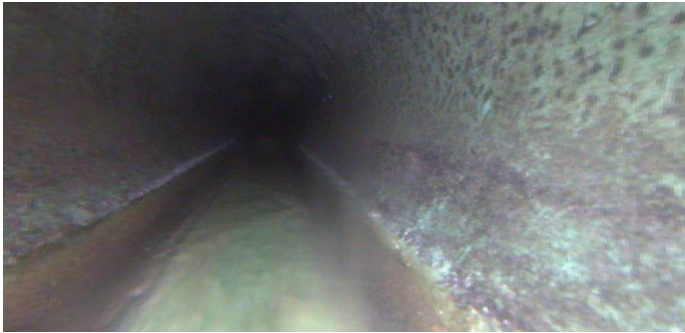
Code:	MWL
Description:	Water Level

Distance (ft):	.0
Structural Grade:	0
O&M Grade:	0
Clock Start/From:	
Clock To:	
1st Value:	
2nd Value:	
Value Percent:	5.000
Continuous Index:	
Within 8" of Joint:	NO
Remarks:

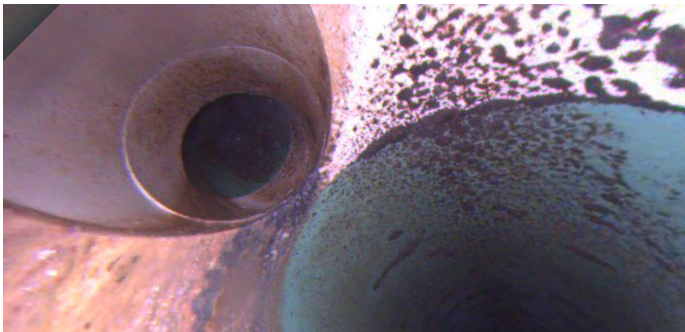
Code:	TF
Description:	Tap Factory

Distance (ft):	39.4
Structural Grade:	0
O&M Grade:	0
Clock Start/From:	2
Clock To:	
1st Value:	4.000
2nd Value:	
Value Percent:	
Continuous Index:	
Within 8" of Joint:	
Remarks:

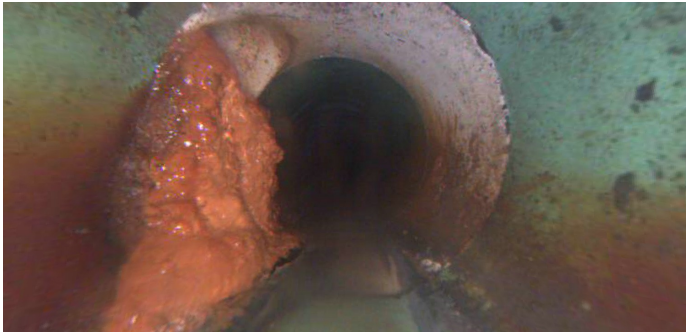
Code: **DAE**
Description: **Deposits Attached Encrustation**

Distance (ft): **52.0**
Structural Grade: **0**
O&M Grade: **3**
Clock Start/From: **7**
Clock To: **10**
1st Value:
2nd Value:
Value Percent: **15.000**
Continuous Index:
Within 8" of Joint: **NO**
Remarks:

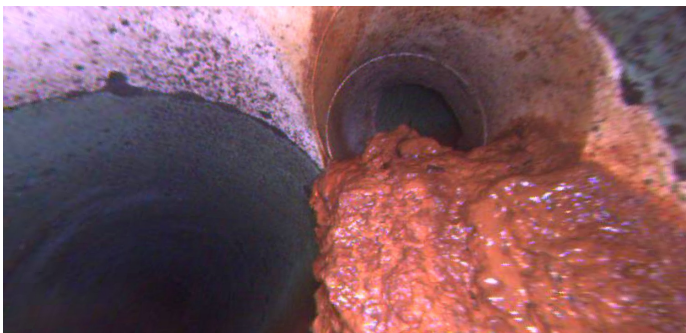
Code: **TFD**
Description: **Tap Factory Defective**

Distance (ft): **53.7**
Structural Grade: **0**
O&M Grade: **2**
Clock Start/From: **10**
Clock To:
1st Value: **4.000**
2nd Value:
Value Percent:
Continuous Index:
Within 8" of Joint:
Remarks: **dae**

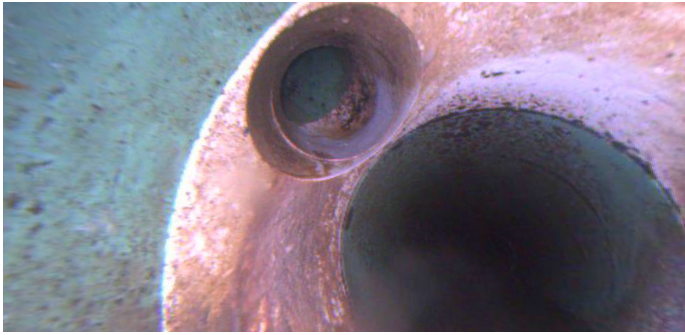
Code: **TF**
Description: **Tap Factory**

Distance (ft): **107.4**
Structural Grade: **0**
O&M Grade: **0**
Clock Start/From: **2**
Clock To:
1st Value: **4.000**
2nd Value:
Value Percent:
Continuous Index:
Within 8" of Joint: **NO**
Remarks:

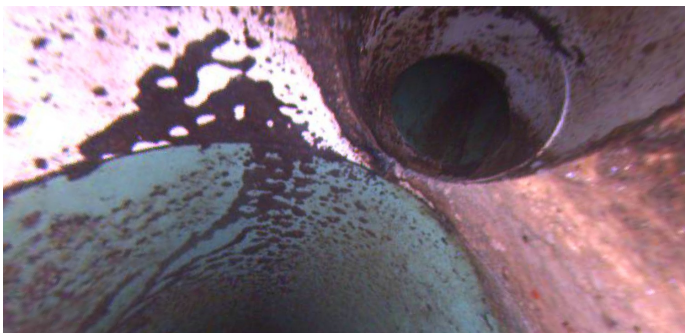
Code: **TF**
Description: **Tap Factory**

Distance (ft): **120.6**
Structural Grade: **0**
O&M Grade: **0**
Clock Start/From: **11**
Clock To:
1st Value: **4.000**
2nd Value:
Value Percent:
Continuous Index:
Within 8" of Joint:
Remarks:

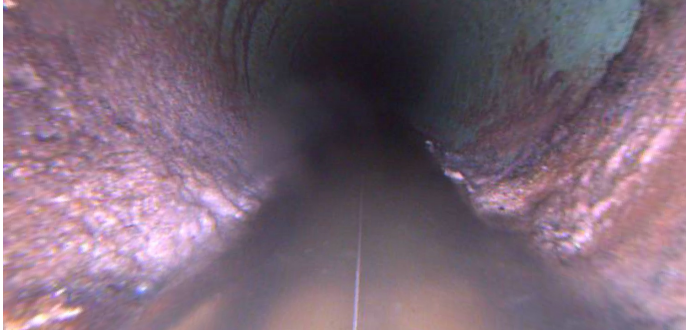
Code: **DAGS**
Description: **Deposits Attached Grease**

Distance (ft): **120.6**
Structural Grade: **0**
O&M Grade: **2**
Clock Start/From: **8**
Clock To: **4**
1st Value:
2nd Value:
Value Percent: **5.000**
Continuous Index:
Within 8" of Joint: **NO**
Remarks:

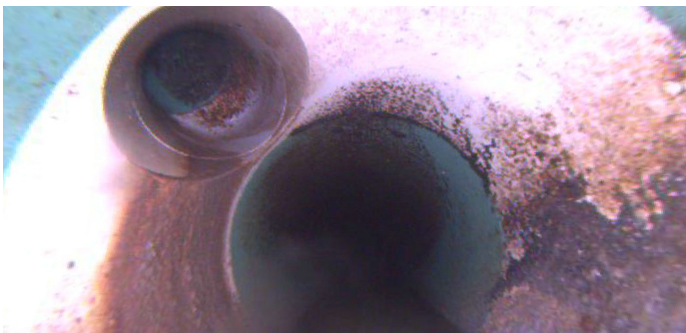
Code: **TF**
Description: **Tap Factory**

Distance (ft): **174.3**
Structural Grade: **0**
O&M Grade: **0**
Clock Start/From: **2**
Clock To:
1st Value: **4.000**
2nd Value:
Value Percent:
Continuous Index:
Within 8" of Joint:
Remarks:

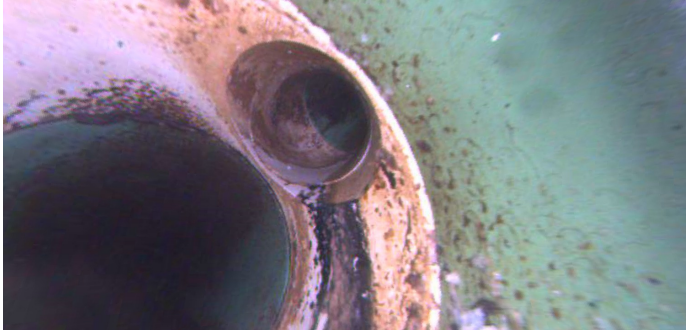
Code: **TF**
Description: **Tap Factory**

Distance (ft): **188.4**
Structural Grade: **0**
O&M Grade: **0**
Clock Start/From: **10**
Clock To:
1st Value: **4.000**
2nd Value:
Value Percent:
Continuous Index:
Within 8" of Joint:
Remarks:

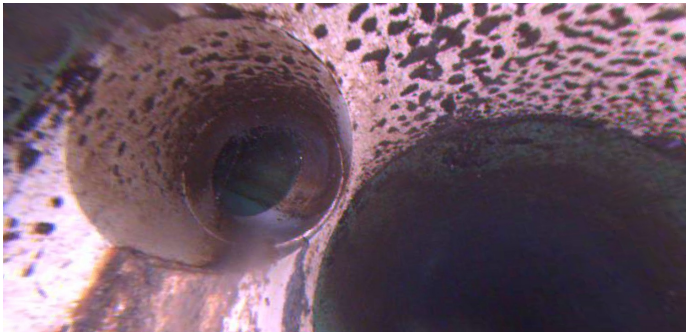
Code: **TF**
Description: **Tap Factory**

Distance (ft): **227.6**
Structural Grade: **0**
O&M Grade: **0**
Clock Start/From: **2**
Clock To:
1st Value: **4.000**
2nd Value:
Value Percent:
Continuous Index:
Within 8" of Joint:
Remarks:

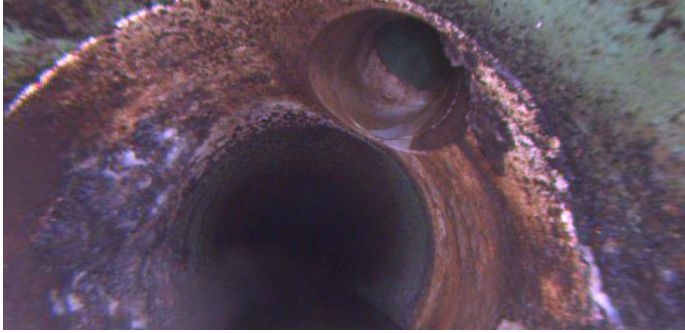
Code: **TF**
Description: **Tap Factory**

Distance (ft): **241.7**
Structural Grade: **0**
O&M Grade: **0**
Clock Start/From: **11**
Clock To:
1st Value: **4.000**
2nd Value:
Value Percent:
Continuous Index:
Within 8" of Joint:
Remarks:

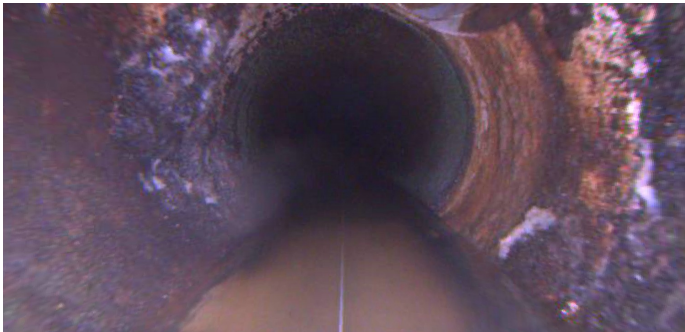
Code: **DAGS**
Description: **Deposits Attached Grease**

Distance (ft): **241.7**
Structural Grade: **0**
O&M Grade: **2**
Clock Start/From: **8**
Clock To: **4**
1st Value:
2nd Value:
Value Percent: **5.000**
Continuous Index:
Within 8" of Joint: **NO**
Remarks:

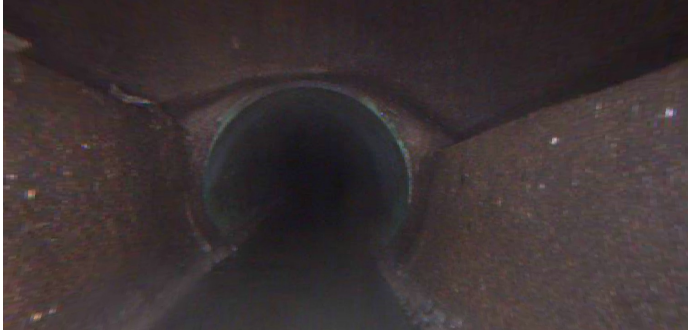
Code:	AMH
Description:	Manhole
Distance (ft):	249.8
Structural Grade:	0
O&M Grade:	0
Clock Start/From:	
Clock To:	
1st Value:	
2nd Value:	
Value Percent:	
Continuous Index:	
Within 8" of Joint:	NO
Remarks:	M-808-008
