Profile/Photo Observation Report

Street:	CAPITOL DR & INDEPENDENCE DR	Flow Control:	Not Controlled
City:	Hobart, IN	Year Renewed:	
Location:	Light Highway	Tape/Media #:	
Purpose:	Maintenance Related	Dia/Height:	12"
Use:	Sanitary	Material:	PVC
Drain Area:	NA	Lining:	
Category:	NA		
Comment:	Reverse setup. false Mh at 163', flow direction incorrect.		
Location Details:		Direction of Survey:	Downstream
US MH:	M-808-011	DS MH:	M-808-010
		Total Length Surveyed (ft):	164.1

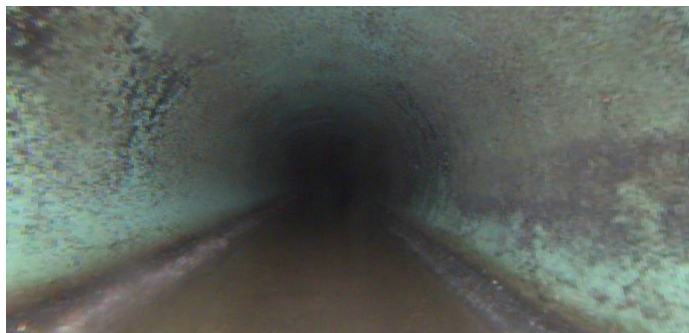
Code: **AMH**
Description: **Manhole**

Distance (ft): **.0**
Structural Grade: **0**
O&M Grade: **0**
Clock Start/From:
Clock To:
1st Value:
2nd Value:
Value Percent:
Continuous Index:
Within 8" of Joint: **NO**
Remarks: **M-808-011**

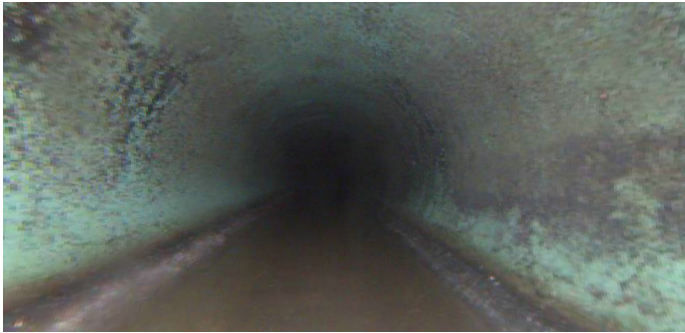
Code:	MWL
Description:	Water Level

Distance (ft):	.0
Structural Grade:	0
O&M Grade:	0
Clock Start/From:	
Clock To:	
1st Value:	
2nd Value:	
Value Percent:	5.000
Continuous Index:	
Within 8" of Joint:	NO
Remarks:

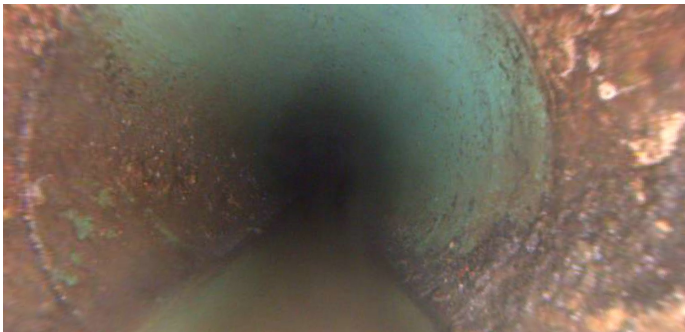
Code:	DAGS
Description:	Deposits Attached Grease

Distance (ft):	80.0
Structural Grade:	0
O&M Grade:	2
Clock Start/From:	8
Clock To:	4
1st Value:	
2nd Value:	
Value Percent:	5.000
Continuous Index:	
Within 8" of Joint:	NO
Remarks:

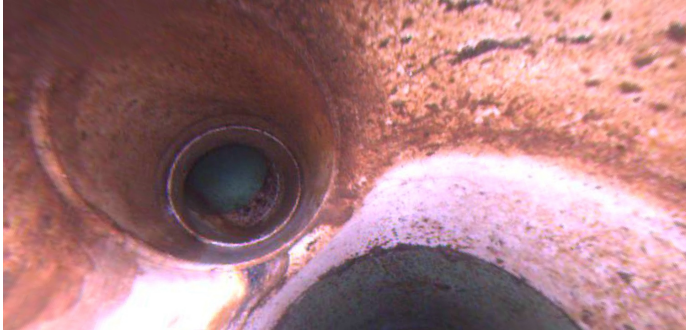
Code: **TF**
Description: **Tap Factory**

Distance (ft): **80.4**
Structural Grade: **0**
O&M Grade: **0**
Clock Start/From: **1**
Clock To:
1st Value: **4.000**
2nd Value:
Value Percent:
Continuous Index:
Within 8" of Joint:
Remarks:

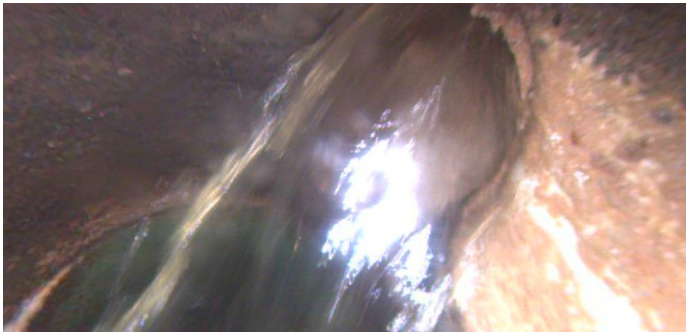
Code: **TFA**
Description: **Tap Factory Active**

Distance (ft): **160.0**
Structural Grade: **0**
O&M Grade: **0**
Clock Start/From: **1**
Clock To:
1st Value: **4.000**
2nd Value:
Value Percent:
Continuous Index:
Within 8" of Joint:
Remarks:

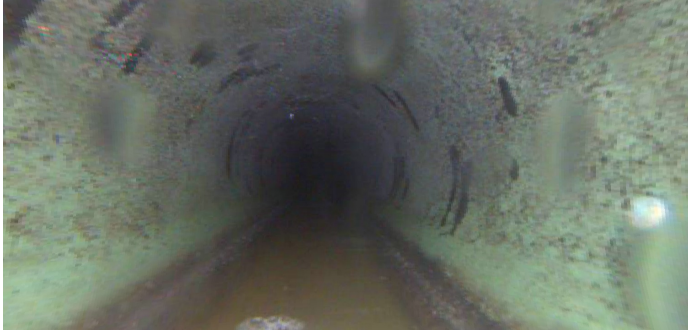
Code:	MSA
Description:	Abandoned Survey
Distance (ft):	164.1
Structural Grade:	0
O&M Grade:	0
Clock Start/From:	
Clock To:	
1st Value:	
2nd Value:	
Value Percent:	
Continuous Index:	
Within 8" of Joint:	NO
Remarks:	camera stopped
