Profile/Photo Observation Report

Street:	CAPITOL DR & INDEPENDENCE DR	Flow Control:	Not Controlled
City:	Hobart, IN	Year Renewed:	
Location:	Light Highway	Tape/Media #:	
Purpose:	Maintenance Related	Dia/Height:	12"
Use:	Sanitary	Material:	PVC
Drain Area:	NA	Lining:	
Category:	NA		
Comment:	debris at 311'.

Location Details:		Direction of Survey:	Upstream
US MH:	M-808-011	DS MH:	M-808-010
		Total Length Surveyed (ft):	312.6

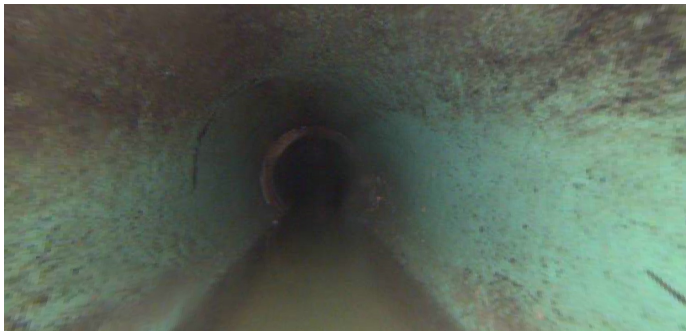
Code: **AMH**
Description: **Manhole**

Distance (ft): **.0**
Structural Grade: **0**
O&M Grade: **0**
Clock Start/From:
Clock To:
1st Value:
2nd Value:
Value Percent:
Continuous Index:
Within 8" of Joint: **NO**
Remarks: **M-808-010**

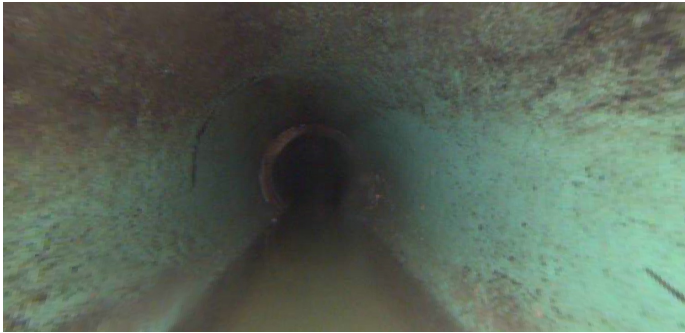
Code:	MWL
Description:	Water Level

Distance (ft):	.0
Structural Grade:	0
O&M Grade:	0
Clock Start/From:	
Clock To:	
1st Value:	
2nd Value:	
Value Percent:	5.000
Continuous Index:	
Within 8" of Joint:	NO
Remarks:

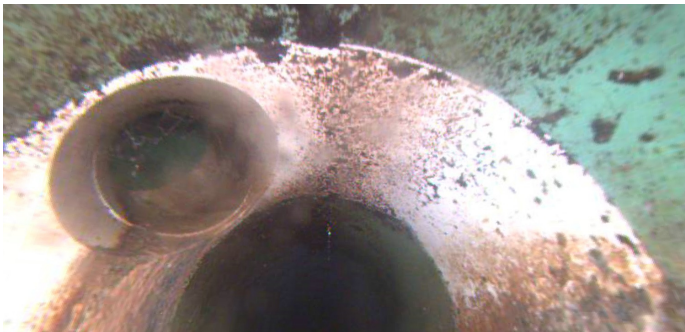
Code:	TF
Description:	Tap Factory

Distance (ft):	3.2
Structural Grade:	0
O&M Grade:	0
Clock Start/From:	11
Clock To:	
1st Value:	4.000
2nd Value:	
Value Percent:	
Continuous Index:	
Within 8" of Joint:	
Remarks:

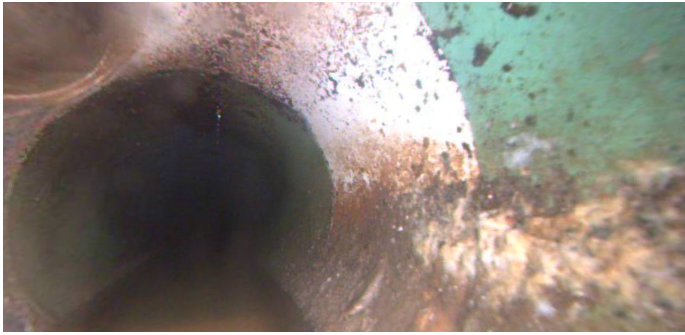
Code: **DAGS**
Description: **Deposits Attached Grease**

Distance (ft): **3.2**
Structural Grade: **0**
O&M Grade: **2**
Clock Start/From: **3**
Clock To: **4**
1st Value:
2nd Value:
Value Percent: **5.000**
Continuous Index:
Within 8" of Joint: **NO**
Remarks:

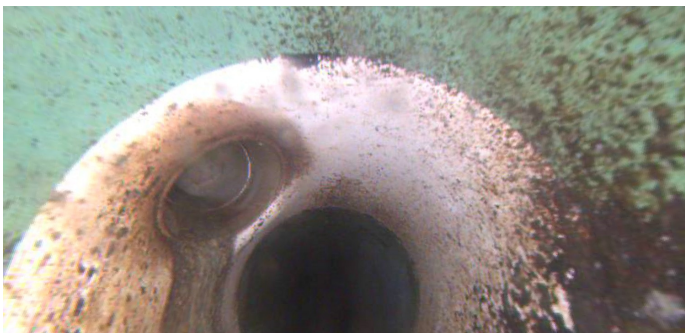
Code: **TF**
Description: **Tap Factory**

Distance (ft): **36.8**
Structural Grade: **0**
O&M Grade: **0**
Clock Start/From: **10**
Clock To:
1st Value: **4.000**
2nd Value:
Value Percent:
Continuous Index:
Within 8" of Joint:
Remarks:

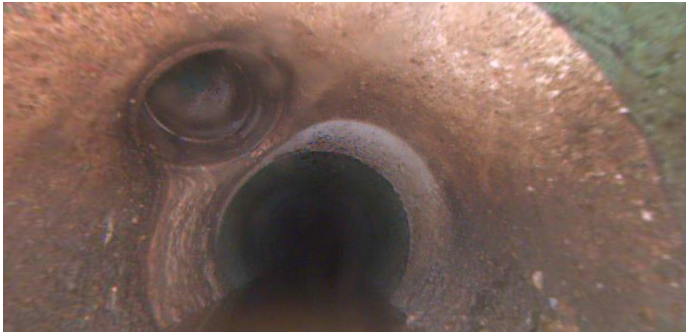
Code: **TF**
Description: **Tap Factory**

Distance (ft): **90.5**
Structural Grade: **0**
O&M Grade: **0**
Clock Start/From: **1**
Clock To:
1st Value: **4.000**
2nd Value:
Value Percent:
Continuous Index:
Within 8" of Joint:
Remarks:

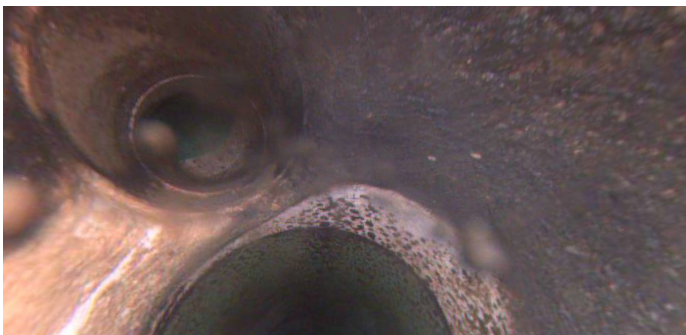
Code: **TF**
Description: **Tap Factory**

Distance (ft): **157.8**
Structural Grade: **0**
O&M Grade: **0**
Clock Start/From: **11**
Clock To:
1st Value: **4.000**
2nd Value:
Value Percent:
Continuous Index:
Within 8" of Joint:
Remarks:

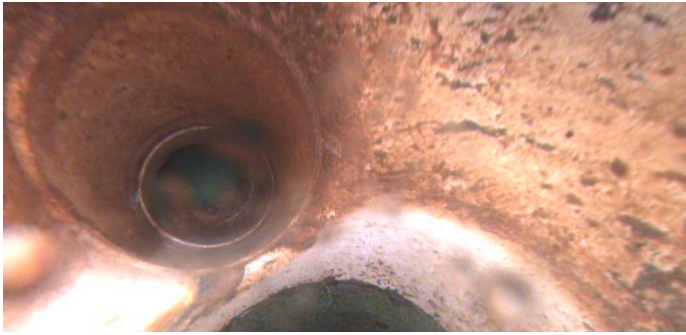
Code: **TF**
Description: **Tap Factory**

Distance (ft): **238.0**
Structural Grade: **0**
O&M Grade: **0**
Clock Start/From: **11**
Clock To:
1st Value: **4.000**
2nd Value:
Value Percent:
Continuous Index:
Within 8" of Joint:
Remarks:

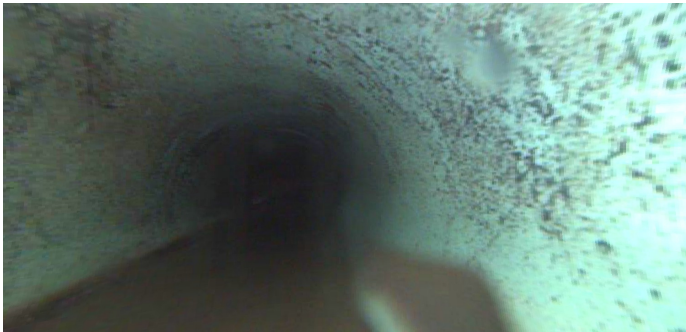
Code: **AMH**
Description: **Manhole**

Distance (ft): **312.6**
Structural Grade: **0**
O&M Grade: **0**
Clock Start/From:
Clock To:
1st Value:
2nd Value:
Value Percent:
Continuous Index:
Within 8" of Joint: **NO**
Remarks: **M-808-011**
