Profile/Photo Observation Report

Date:	03/21/2018	Weather:		Coding:	PACP 6.0
Pipe Length (ft):	136.7	Owner:	NA	Pre Clean:	Not Known
P.O.#:		Surveyor:	Selasie Honu	PSR:	P-808-012-011
Customer:		Clean Date:	01/01/1900	Shape:	C

Street:	INDEPENDENCE DR	Flow Control:	Not Controlled
City:	Hobart, IN	Year Renewed:	
Location:	Sidewalk	Tape/Media #:	
Purpose:	Maintenance Related	Dia/Height:	12"
Use:	Sanitary	Material:	PVC
Drain Area:	NA	Lining:	
Category:	NA		
Comment:	flow direction

Location Details:		Direction of Survey:	Downstream
US MH:	M-808-011	DS MH:	M-808-012
		Total Length Surveyed (ft):	133.3

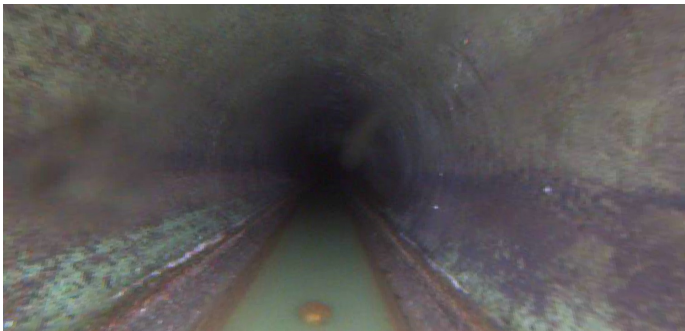
Code: **AMH**
Description: **Manhole**

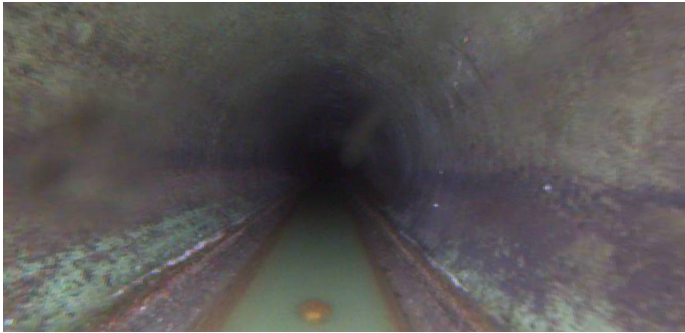
Code:	MWL
Description:	Water Level

Distance (ft):	.0
Structural Grade:	0
O&M Grade:	0
Clock Start/From:	
Clock To:	
1st Value:	
2nd Value:	
Value Percent:	5.000
Continuous Index:	
Within 8" of Joint:	NO
Remarks:

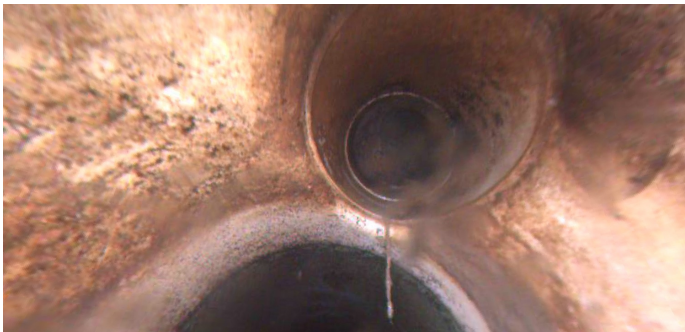
Code:	TFD
Description:	Tap Factory Defective

Distance (ft):	21.3
Structural Grade:	0
O&M Grade:	2
Clock Start/From:	1
Clock To:	
1st Value:	4.000
2nd Value:	
Value Percent:	
Continuous Index:	
Within 8" of Joint:	
Remarks:	rfl

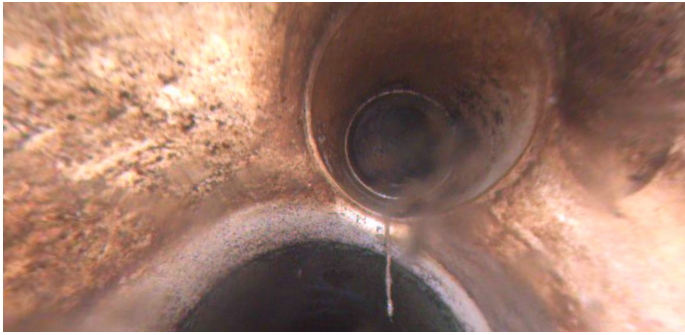
Code: **RFL**
Description: **Roots Fine Lateral**

Distance (ft): **21.3**
Structural Grade: **0**
O&M Grade: **1**
Clock Start/From: **1**
Clock To:
1st Value:
2nd Value:
Value Percent:
Continuous Index:
Within 8" of Joint: **NO**
Remarks:

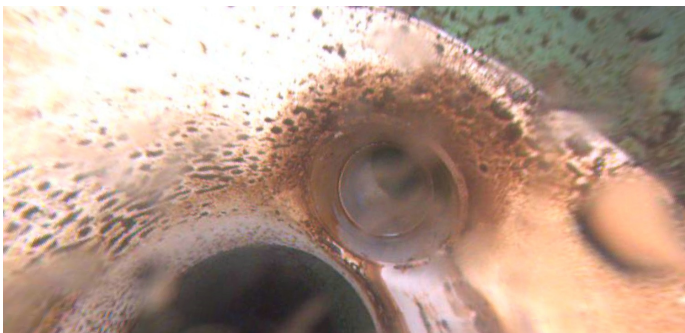
Code: **TF**
Description: **Tap Factory**

Distance (ft): **84.0**
Structural Grade: **0**
O&M Grade: **0**
Clock Start/From: **2**
Clock To:
1st Value: **4.000**
2nd Value:
Value Percent:
Continuous Index:
Within 8" of Joint:
Remarks:

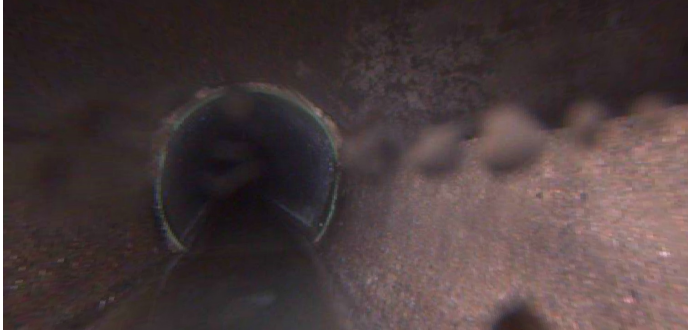
Code:	AMH
Description:	Manhole
Distance (ft):	133.3
Structural Grade:	0
O&M Grade:	0
Clock Start/From:	
Clock To:	
1st Value:	
2nd Value:	
Value Percent:	
Continuous Index:	
Within 8" of Joint:	NO
Remarks:	M-808-012
