## Profile/Photo Observation Report

Street:	<b>INDEPENDENCE DR</b>	Flow Control:	<b>Not Controlled</b>
City:	<b>Hobart, IN</b>	Year Renewed:	
Location:	<b>Light Highway</b>	Tape/Media #:	
Purpose:	<b>Maintenance Related</b>	Dia/Height:	<b>12"</b>
Use:	<b>Sanitary</b>	Material:	<b>PVC</b>
Drain Area:	<b>NA</b>	Lining:	
Category:	<b>NA</b>		
Comment:

Location Details:		Direction of Survey:	<b>Upstream</b>
US MH:	<b>M-808-012</b>	DS MH:	<b>M-808-013</b>
		Total Length Surveyed (ft):	<b>113.6</b>

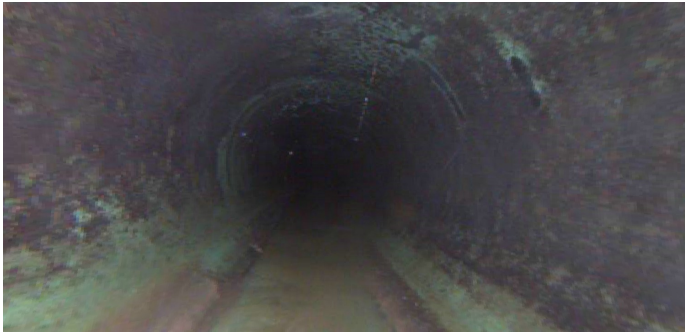
Code:	<b>MWL</b>
Description:	<b>Water Level</b>

Distance (ft):	<b>.0</b>
Structural Grade:	<b>0</b>
O&M Grade:	<b>0</b>
Clock Start/From:	
Clock To:	
1st Value:	
2nd Value:	
Value Percent:	<b>5.000</b>
Continuous Index:	
Within 8" of Joint:	<b>NO</b>
Remarks:

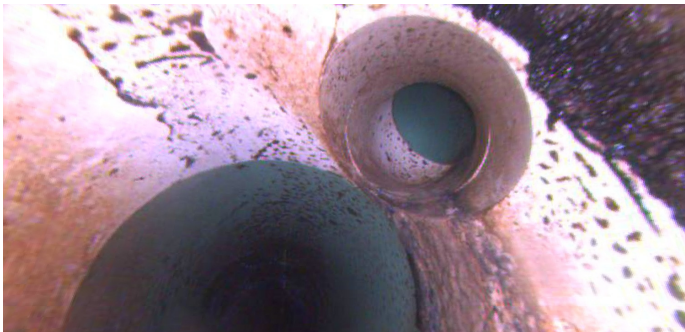
Code:	<b>TF</b>
Description:	<b>Tap Factory</b>

Distance (ft):	<b>52.3</b>
Structural Grade:	<b>0</b>
O&M Grade:	<b>0</b>
Clock Start/From:	<b>10</b>
Clock To:	
1st Value:	<b>4.000</b>
2nd Value:	
Value Percent:	
Continuous Index:	
Within 8" of Joint:	
Remarks:

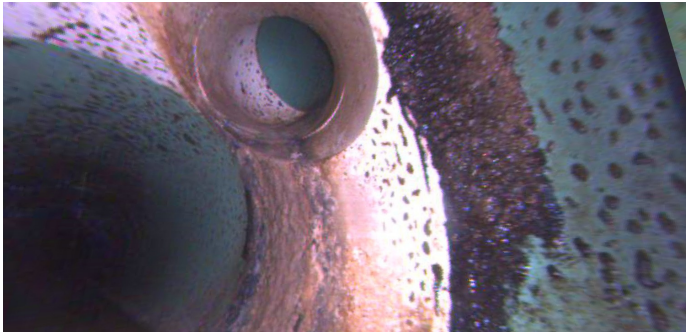
Code: **DAZ**  
Description: **Deposits Attached Other**

Distance (ft): **52.3**  
Structural Grade: **0**  
O&M Grade: **2**  
Clock Start/From: **8**  
Clock To: **10**  
1st Value:  
2nd Value:  
Value Percent: **5.000**  
Continuous Index:  
Within 8" of Joint: **YES**  
Remarks:

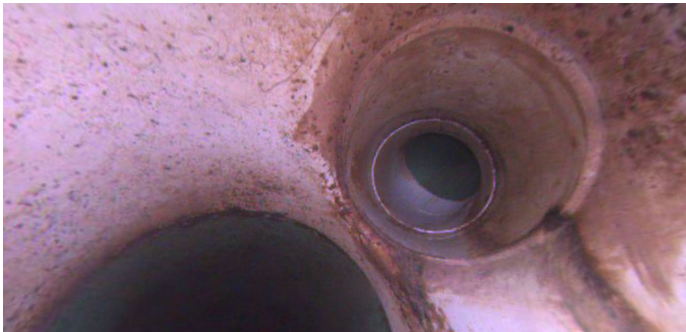
Code: **TF**  
Description: **Tap Factory**

Distance (ft): **105.1**  
Structural Grade: **0**  
O&M Grade: **0**  
Clock Start/From: **10**  
Clock To:  
1st Value: **4.000**  
2nd Value:  
Value Percent:  
Continuous Index:  
Within 8" of Joint:  
Remarks:

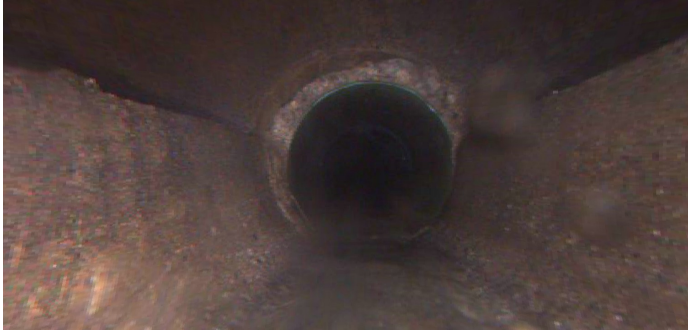
Code:	<b>AMH</b>
Description:	<b>Manhole</b>
Distance (ft):	<b>113.6</b>
Structural Grade:	<b>0</b>
O&M Grade:	<b>0</b>
Clock Start/From:	
Clock To:	
1st Value:	
2nd Value:	
Value Percent:	
Continuous Index:	
Within 8" of Joint:	<b>NO</b>
Remarks:	<b>M-808-012</b>
