Profile/Photo Observation Report

Date:	03/21/2018	Weather:		Coding:	PACP 6.0
Pipe Length (ft):	114.9	Owner:	NA	Pre Clean:	Not Known
P.O.#:		Surveyor:	Selasie Honu	PSR:	P-808-013-012
Customer:		Clean Date:	01/01/1900	Shape:	C

Street:	Oak	Flow Control:	Not Controlled
City:	Hobart, IN	Year Renewed:	
Location:	Light Highway	Tape/Media #:	
Purpose:	Maintenance Related	Dia/Height:	12"
Use:	Sanitary	Material:	PVC
Drain Area:	NA	Lining:	
Category:	NA		
Comment:

Location Details:		Direction of Survey:	Upstream
US MH:	M-808-012	DS MH:	M-808-013
		Total Length Surveyed (ft):	113.6

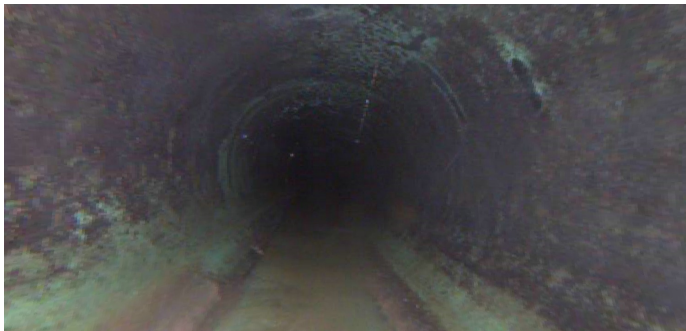
Code: **AMH**
Description: **Manhole**

Distance (ft): **.0**
Structural Grade: **0**
O&M Grade: **0**
Clock Start/From:
Clock To:
1st Value:
2nd Value:
Value Percent:
Continuous Index:
Within 8" of Joint: **NO**
Remarks: **M-808-013**

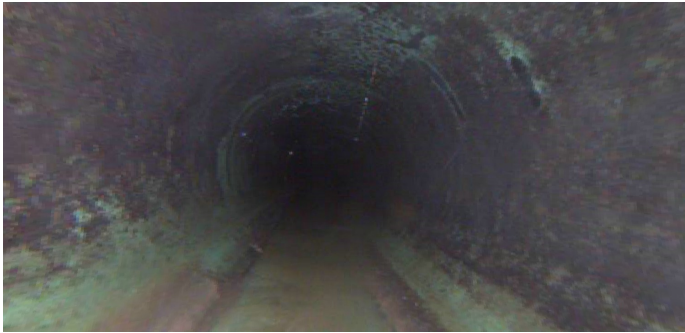
Code:	MWL
Description:	Water Level

Distance (ft):	.0
Structural Grade:	0
O&M Grade:	0
Clock Start/From:	
Clock To:	
1st Value:	
2nd Value:	
Value Percent:	5.000
Continuous Index:	
Within 8" of Joint:	NO
Remarks:

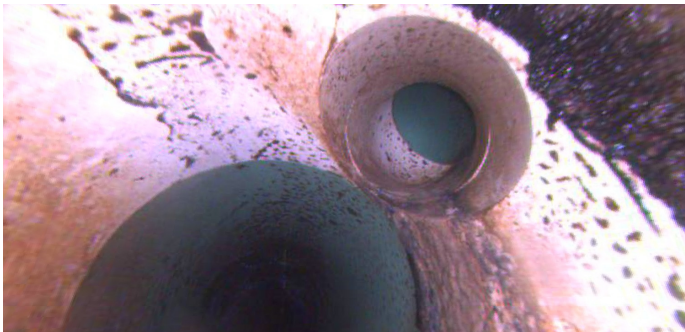
Code:	TF
Description:	Tap Factory

Distance (ft):	52.3
Structural Grade:	0
O&M Grade:	0
Clock Start/From:	10
Clock To:	
1st Value:	4.000
2nd Value:	
Value Percent:	
Continuous Index:	
Within 8" of Joint:	
Remarks:

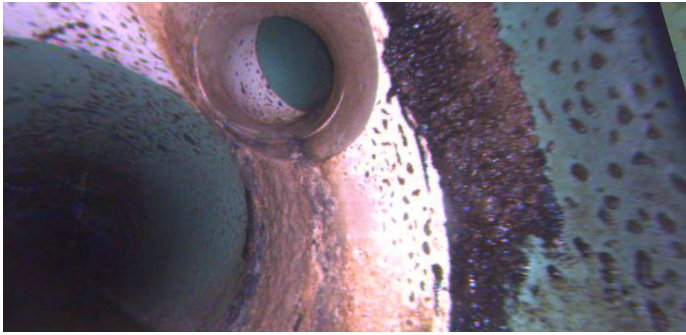
Code: **DAZ**
Description: **Deposits Attached Other**

Distance (ft): **52.3**
Structural Grade: **0**
O&M Grade: **2**
Clock Start/From: **8**
Clock To: **10**
1st Value:
2nd Value:
Value Percent: **5.000**
Continuous Index:
Within 8" of Joint: **YES**
Remarks:

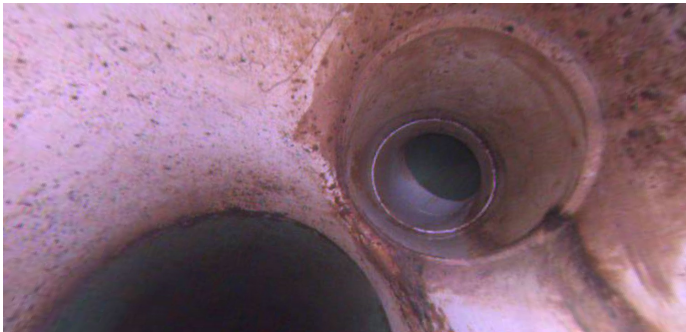
Code: **TF**
Description: **Tap Factory**

Distance (ft): **105.1**
Structural Grade: **0**
O&M Grade: **0**
Clock Start/From: **10**
Clock To:
1st Value: **4.000**
2nd Value:
Value Percent:
Continuous Index:
Within 8" of Joint:
Remarks:

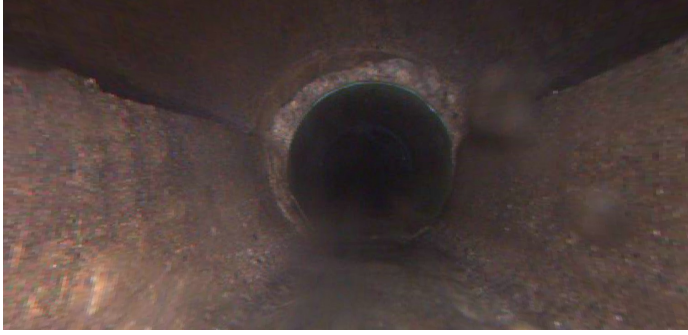
Code:	AMH
Description:	Manhole
Distance (ft):	113.6
Structural Grade:	0
O&M Grade:	0
Clock Start/From:	
Clock To:	
1st Value:	
2nd Value:	
Value Percent:	
Continuous Index:	
Within 8" of Joint:	NO
Remarks:	M-808-012
