Profile/Photo Observation Report

Date:	03/21/2018	Weather:		Coding:	PACP 6.0
Pipe Length (ft):	206.0	Owner:	NA	Pre Clean:	Not Known
P.O.#:		Surveyor:	Selasie Honu	PSR:	P-808-014-013
Customer:		Clean Date:	01/01/1900	Shape:	C

Street:	INDEPENDENCE DR & LIBERTY ST	Flow Control:	Not Controlled
City:	Hobart, IN	Year Renewed:	
Location:	Light Highway	Tape/Media #:	
Purpose:	Maintenance Related	Dia/Height:	12"
Use:	Sanitary	Material:	PVC
Drain Area:	NA	Lining:	
Category:	NA		
Comment:	battery at 190'.

Location Details:		Direction of Survey:	Upstream
US MH:	M-808-013	DS MH:	M-808-014
		Total Length Surveyed (ft):	191.5

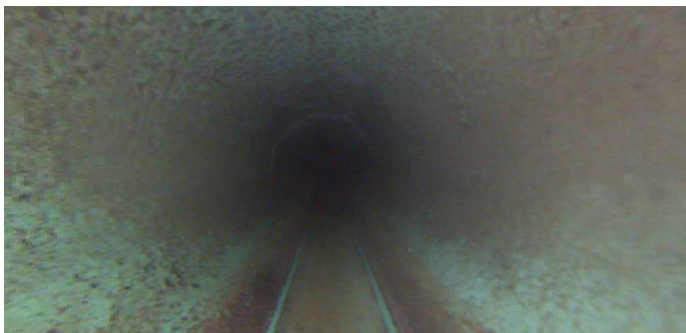
Code: **AMH**
Description: **Manhole**

Distance (ft): **.0**
Structural Grade: **0**
O&M Grade: **0**
Clock Start/From:
Clock To:
1st Value:
2nd Value:
Value Percent:
Continuous Index:
Within 8" of Joint: **NO**
Remarks: **M-808-014**

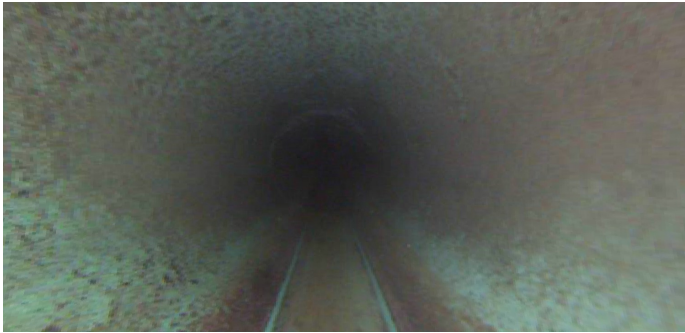
Code:	MWL
Description:	Water Level

Distance (ft):	.0
Structural Grade:	0
O&M Grade:	0
Clock Start/From:	
Clock To:	
1st Value:	
2nd Value:	
Value Percent:	5.000
Continuous Index:	
Within 8" of Joint:	NO
Remarks:

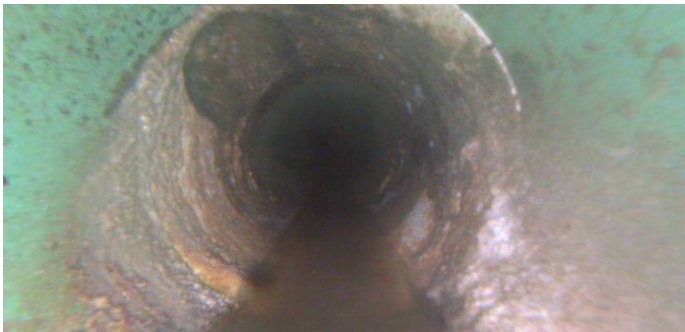
Code:	DAGS
Description:	Deposits Attached Grease

Distance (ft):	46.4
Structural Grade:	0
O&M Grade:	2
Clock Start/From:	8
Clock To:	4
1st Value:	
2nd Value:	
Value Percent:	5.000
Continuous Index:	
Within 8" of Joint:	NO
Remarks:

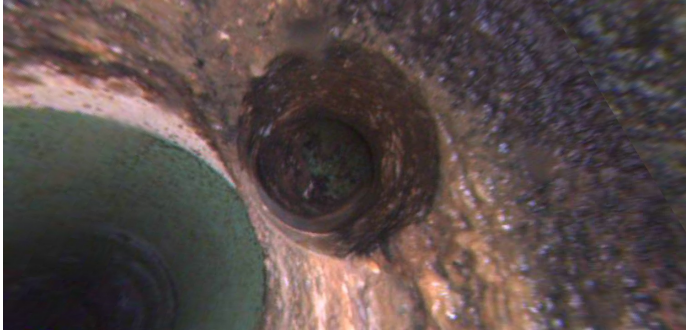
Code: **TF**
Description: **Tap Factory**

Distance (ft): **48.1**
Structural Grade: **0**
O&M Grade: **0**
Clock Start/From: **10**
Clock To:
1st Value: **4.000**
2nd Value:
Value Percent:
Continuous Index:
Within 8" of Joint:
Remarks:

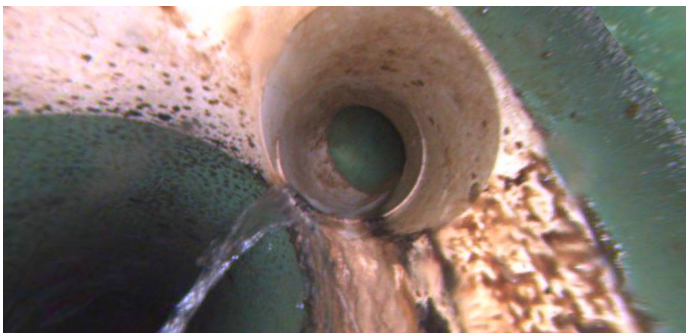
Code: **TFA**
Description: **Tap Factory Active**

Distance (ft): **126.6**
Structural Grade: **0**
O&M Grade: **0**
Clock Start/From: **10**
Clock To:
1st Value: **4.000**
2nd Value:
Value Percent:
Continuous Index:
Within 8" of Joint:
Remarks:

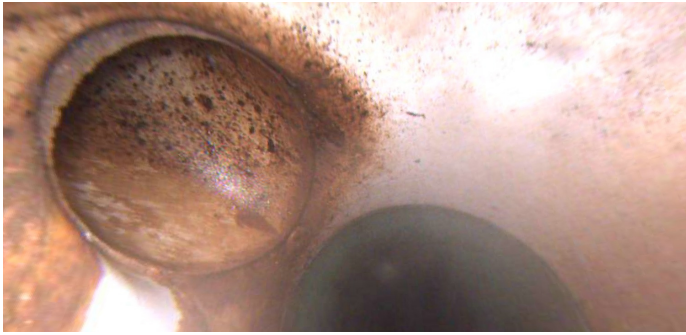
Code: **TF**
Description: **Tap Factory**

Distance (ft): **190.2**
Structural Grade: **0**
O&M Grade: **0**
Clock Start/From: **10**
Clock To:
1st Value: **4.000**
2nd Value:
Value Percent:
Continuous Index:
Within 8" of Joint:
Remarks:

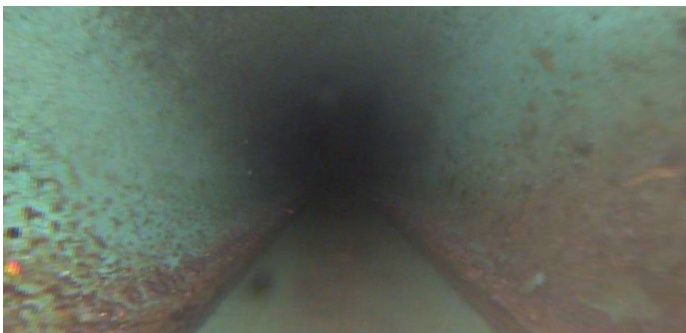
Code: **MSA**
Description: **Abandoned Survey**

Distance (ft): **191.5**
Structural Grade: **0**
O&M Grade: **0**
Clock Start/From:
Clock To:
1st Value:
2nd Value:
Value Percent:
Continuous Index:
Within 8" of Joint: **NO**
Remarks: **UNKNOWN**
