Profile/Photo Observation Report

Street:	INDEPENDENCE DR & LIBERTY ST	Flow Control:	Not Controlled
City:	Hobart, IN	Year Renewed:	
Location:	Light Highway	Tape/Media #:	
Purpose:	Maintenance Related	Dia/Height:	8"
Use:	Sanitary	Material:	PVC
Drain Area:	NA	Lining:	
Category:	NA		
Comment:	incorrect flow direction.

Location Details:		Direction of Survey:	Downstream
US MH:	M-808-014	DS MH:	M-808-015
		Total Length Surveyed (ft):	367.1

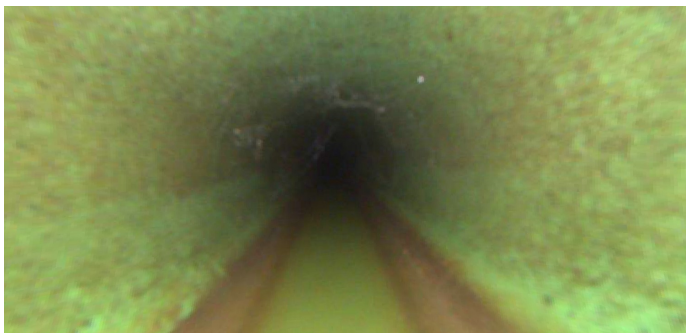
Code: **AMH**
Description: **Manhole**

Distance (ft): **.0**
Structural Grade: **0**
O&M Grade: **0**
Clock Start/From:
Clock To:
1st Value:
2nd Value:
Value Percent:
Continuous Index:
Within 8" of Joint: **NO**
Remarks: **M-808-014**

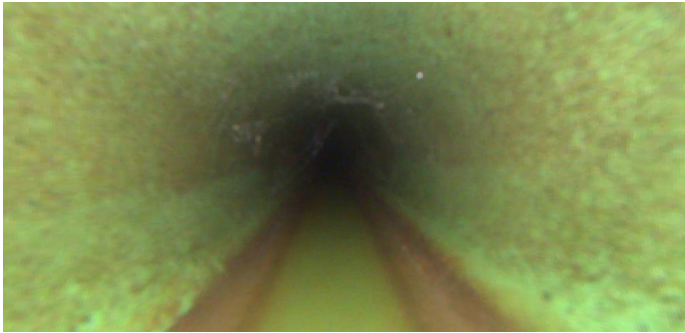
Code:	MWL
Description:	Water Level

Distance (ft):	.0
Structural Grade:	0
O&M Grade:	0
Clock Start/From:	
Clock To:	
1st Value:	
2nd Value:	
Value Percent:	5.000
Continuous Index:	
Within 8" of Joint:	NO
Remarks:

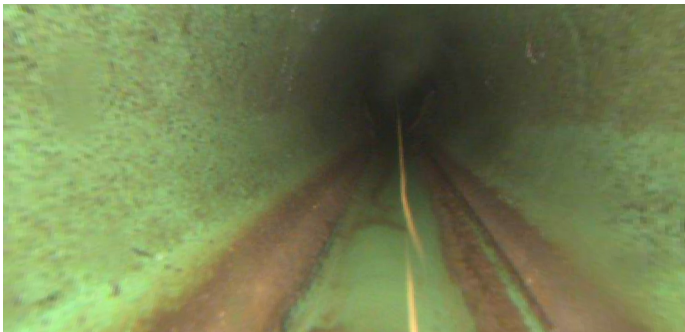
Code:	MGO
Description:	General Observation

Distance (ft):	2.3
Structural Grade:	0
O&M Grade:	0
Clock Start/From:	
Clock To:	
1st Value:	
2nd Value:	
Value Percent:	
Continuous Index:	
Within 8" of Joint:	NO
Remarks:	SWITCHING TO REAR VIEW

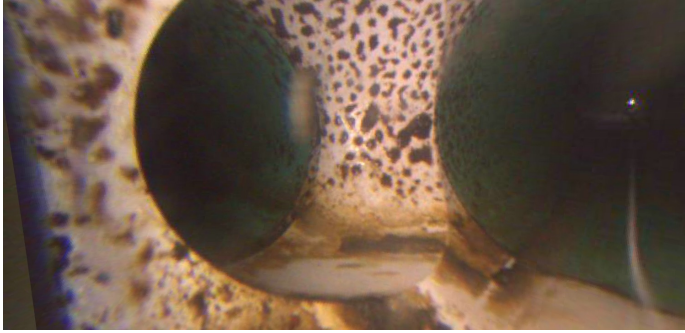
Code: **TFA**
Description: **Tap Factory Active**

Distance (ft): **84.7**
Structural Grade: **0**
O&M Grade: **0**
Clock Start/From: **3**
Clock To:
1st Value: **4.000**
2nd Value:
Value Percent:
Continuous Index:
Within 8" of Joint:
Remarks:

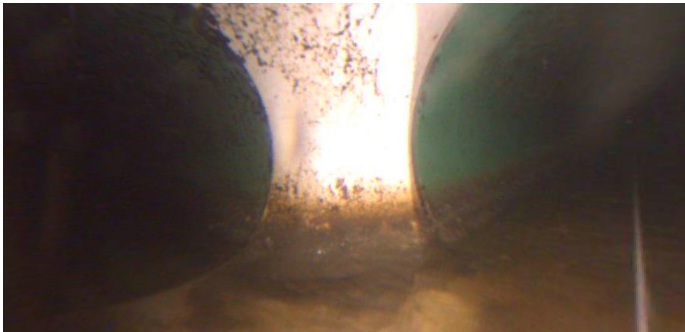
Code: **TFA**
Description: **Tap Factory Active**

Distance (ft): **160.9**
Structural Grade: **0**
O&M Grade: **0**
Clock Start/From: **3**
Clock To:
1st Value: **4.000**
2nd Value:
Value Percent:
Continuous Index:
Within 8" of Joint:
Remarks:

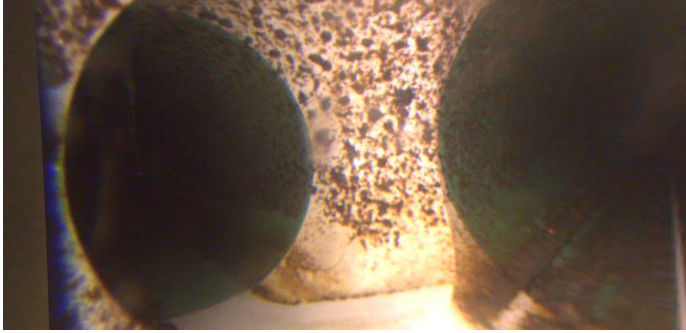
Code: **TFA**
Description: **Tap Factory Active**

Distance (ft): **223.2**
Structural Grade: **0**
O&M Grade: **0**
Clock Start/From: **3**
Clock To:
1st Value: **4.000**
2nd Value:
Value Percent:
Continuous Index:
Within 8" of Joint:
Remarks:

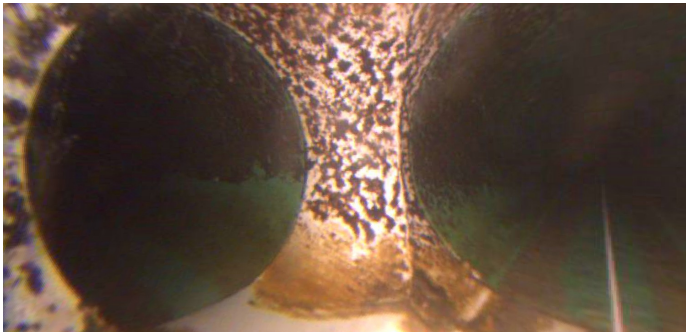
Code: **TF**
Description: **Tap Factory**

Distance (ft): **286.1**
Structural Grade: **0**
O&M Grade: **0**
Clock Start/From: **3**
Clock To:
1st Value: **4.000**
2nd Value:
Value Percent:
Continuous Index:
Within 8" of Joint:
Remarks:

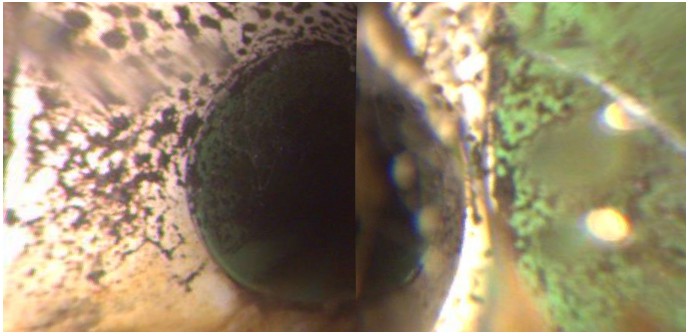
Code: **TF**
Description: **Tap Factory**

Distance (ft): **333.2**
Structural Grade: **0**
O&M Grade: **0**
Clock Start/From: **9**
Clock To:
1st Value: **4.000**
2nd Value:
Value Percent:
Continuous Index:
Within 8" of Joint:
Remarks:

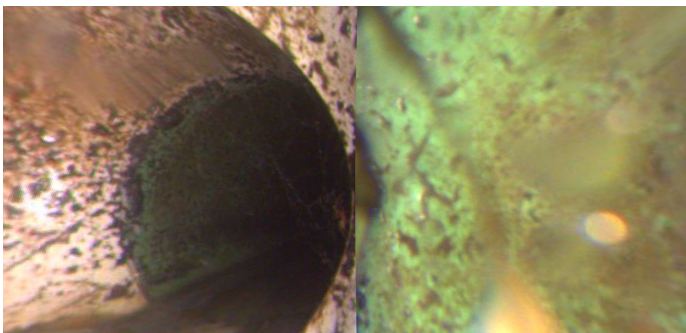
Code: **TFA**
Description: **Tap Factory Active**

Distance (ft): **334.8**
Structural Grade: **0**
O&M Grade: **0**
Clock Start/From: **9**
Clock To:
1st Value: **4.000**
2nd Value:
Value Percent:
Continuous Index:
Within 8" of Joint:
Remarks:

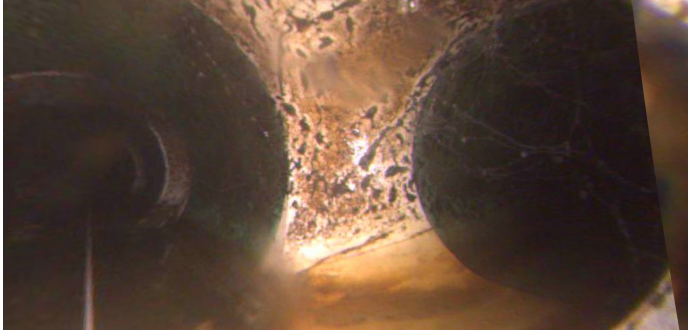
Code: **TFA**
Description: **Tap Factory Active**

Distance (ft): **336.2**
Structural Grade: **0**
O&M Grade: **0**
Clock Start/From: **9**
Clock To:
1st Value: **4.000**
2nd Value:
Value Percent:
Continuous Index:
Within 8" of Joint:
Remarks:

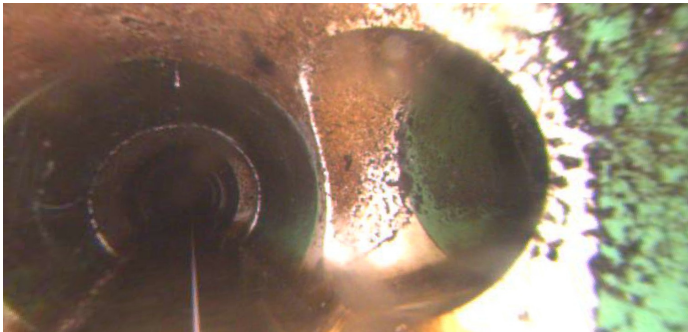
Code: **TFA**
Description: **Tap Factory Active**

Distance (ft): **337.8**
Structural Grade: **0**
O&M Grade: **0**
Clock Start/From: **9**
Clock To:
1st Value: **4.000**
2nd Value:
Value Percent:
Continuous Index:
Within 8" of Joint:
Remarks:

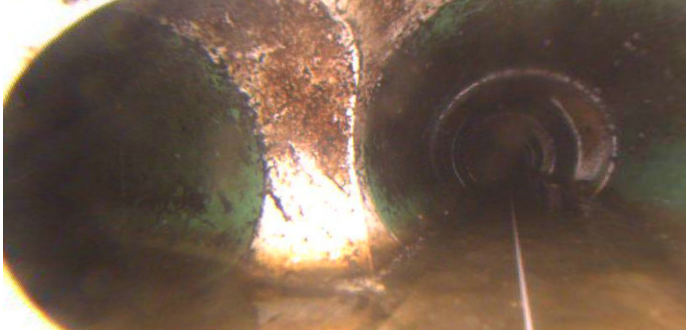
Code: **TFA**
Description: **Tap Factory Active**

Distance (ft): **339.2**
Structural Grade: **0**
O&M Grade: **0**
Clock Start/From: **3**
Clock To:
1st Value: **4.000**
2nd Value:
Value Percent:
Continuous Index:
Within 8" of Joint:
Remarks:

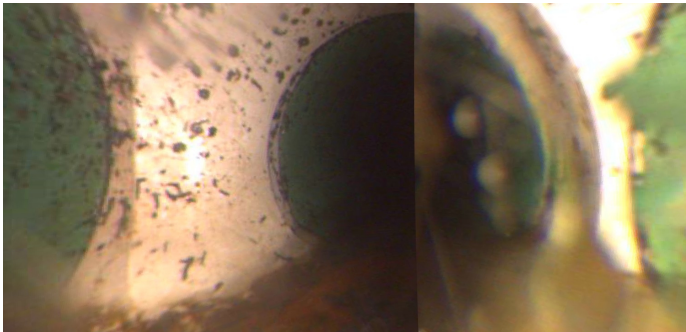
Code: **TFA**
Description: **Tap Factory Active**

Distance (ft): **356.4**
Structural Grade: **0**
O&M Grade: **0**
Clock Start/From: **9**
Clock To:
1st Value: **4.000**
2nd Value:
Value Percent:
Continuous Index:
Within 8" of Joint:
Remarks:

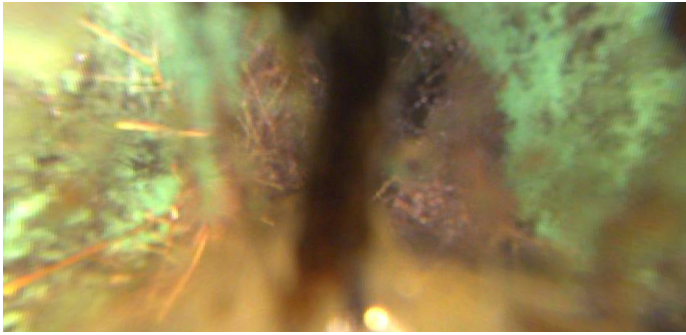
Code: **RBJ**
Description: **Roots Ball Joint**

Distance (ft): **364.2**
Structural Grade: **0**
O&M Grade: **4**
Clock Start/From: **7**
Clock To: **5**
1st Value:
2nd Value:
Value Percent: **55.000**
Continuous Index:
Within 8" of Joint: **YES**
Remarks:

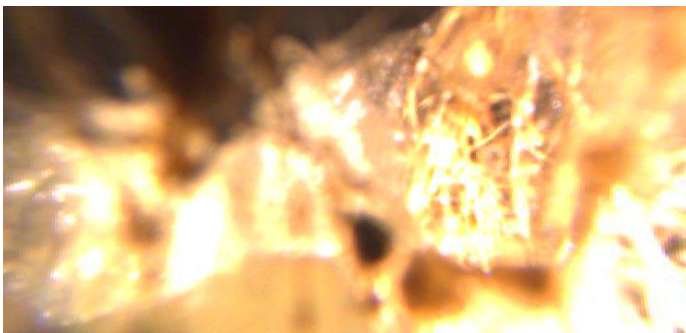
Code: **AMH**
Description: **Manhole**

Distance (ft): **367.1**
Structural Grade: **0**
O&M Grade: **0**
Clock Start/From:
Clock To:
1st Value:
2nd Value:
Value Percent:
Continuous Index:
Within 8" of Joint: **NO**
Remarks: **M-808-015**
