Profile/Photo Observation Report

Street:	Oak	Flow Control:	Not Controlled
City:	Hobart, IN	Year Renewed:	
Location:	Light Highway	Tape/Media #:	
Purpose:	Maintenance Related	Dia/Height:	8"
Use:	Sanitary	Material:	PVC
Drain Area:	NA	Lining:	
Category:	NA		
Comment:	incorrect flow direction.

Location Details:		Direction of Survey:	Downstream
US MH:	M-808-014	DS MH:	M-808-015
		Total Length Surveyed (ft):	367.1

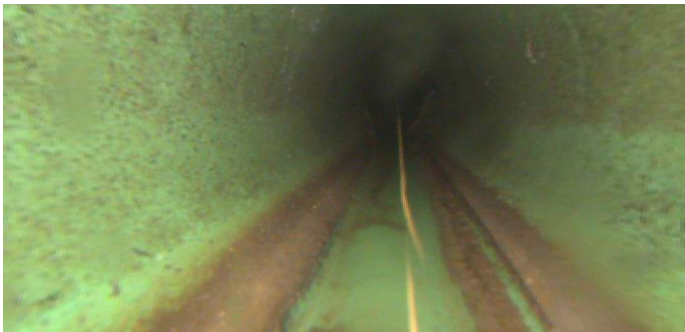
Code:	MGO
Description:	General Observation

Distance (ft):	2.3
Structural Grade:	0
O&M Grade:	0
Clock Start/From:	
Clock To:	
1st Value:	
2nd Value:	
Value Percent:	
Continuous Index:	
Within 8" of Joint:	NO
Remarks:	SWITCHING TO REAR VIEW

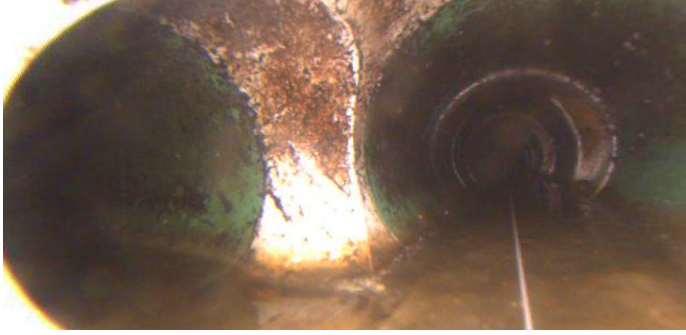
Code: **TFA**
Description: **Tap Factory Active**

Distance (ft): **339.2**
Structural Grade: **0**
O&M Grade: **0**
Clock Start/From: **3**
Clock To:
1st Value: **4.000**
2nd Value:
Value Percent:
Continuous Index:
Within 8" of Joint:
Remarks:

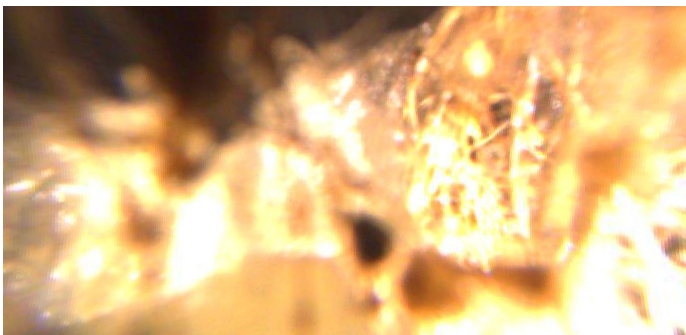
Code: **AMH**
Description: **Manhole**

Distance (ft): **367.1**
Structural Grade: **0**
O&M Grade: **0**
Clock Start/From:
Clock To:
1st Value:
2nd Value:
Value Percent:
Continuous Index:
Within 8" of Joint: **NO**
Remarks: **M-808-015**
