Profile/Photo Observation Report

Street:	Oak	Flow Control:	Not Controlled
City:	Hobart, IN	Year Renewed:	
Location:	Light Highway	Tape/Media #:	
Purpose:	Maintenance Related	Dia/Height:	8"
Use:	Sanitary	Material:	PVC
Drain Area:	NA	Lining:	
Category:	NA		
Comment:

Location Details:		Direction of Survey:	Upstream
US MH:	M-808-014	DS MH:	M-808-016
		Total Length Surveyed (ft):	393.1

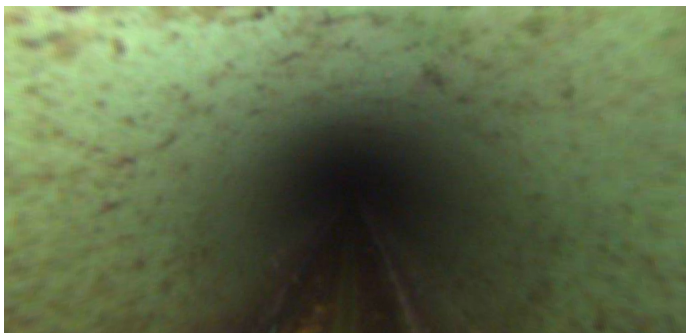
Code: **AMH**
Description: **Manhole**

Distance (ft): **.0**
Structural Grade: **0**
O&M Grade: **0**
Clock Start/From:
Clock To:
1st Value:
2nd Value:
Value Percent:
Continuous Index:
Within 8" of Joint: **NO**
Remarks: **M-808-016**

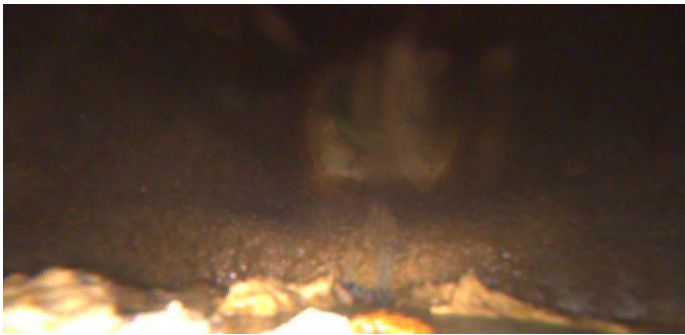
Code:	AMH
Description:	Manhole

Distance (ft):	393.1
Structural Grade:	0
O&M Grade:	0
Clock Start/From:	
Clock To:	
1st Value:	
2nd Value:	
Value Percent:	
Continuous Index:	
Within 8" of Joint:	NO
Remarks:	M-808-014
