Profile/Photo Observation Report

Street:	Oak	Flow Control:	Not Controlled
City:	Hobart, IN	Year Renewed:	
Location:	Sidewalk	Tape/Media #:	
Purpose:	Maintenance Related	Dia/Height:	8"
Use:	Sanitary	Material:	PVC
Drain Area:	NA	Lining:	
Category:	NA		
Comment:

Location Details:		Direction of Survey:	Upstream
US MH:	M-808-018	DS MH:	M-808-019
		Total Length Surveyed (ft):	97.8

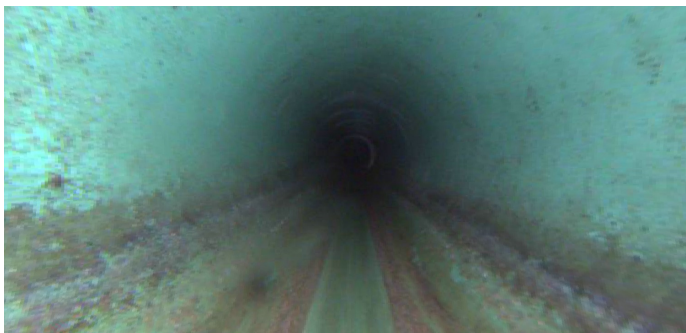
Code: **AMH**
Description: **Manhole**

Distance (ft): **.0**
Structural Grade: **0**
O&M Grade: **0**
Clock Start/From:
Clock To:
1st Value:
2nd Value:
Value Percent:
Continuous Index:
Within 8" of Joint: **NO**
Remarks: **M-808-019**

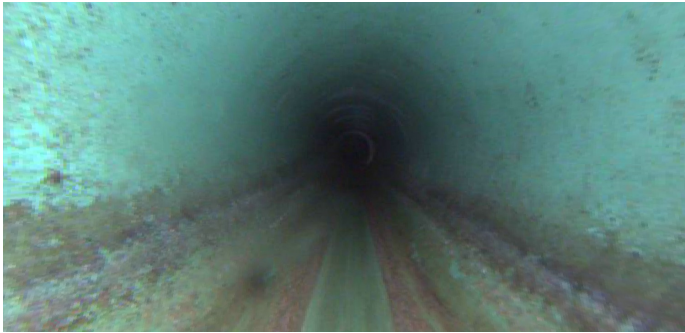
Code:	MWL
Description:	Water Level

Distance (ft):	.0
Structural Grade:	0
O&M Grade:	0
Clock Start/From:	
Clock To:	
1st Value:	
2nd Value:	
Value Percent:	5.000
Continuous Index:	
Within 8" of Joint:	NO
Remarks:

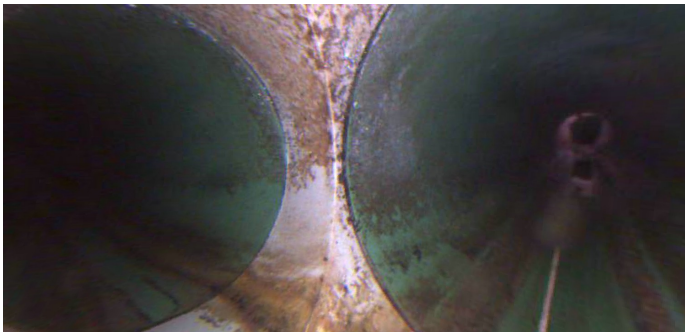
Code:	TF
Description:	Tap Factory

Distance (ft):	5.7
Structural Grade:	0
O&M Grade:	0
Clock Start/From:	3
Clock To:	
1st Value:	4.000
2nd Value:	
Value Percent:	
Continuous Index:	
Within 8" of Joint:	
Remarks:

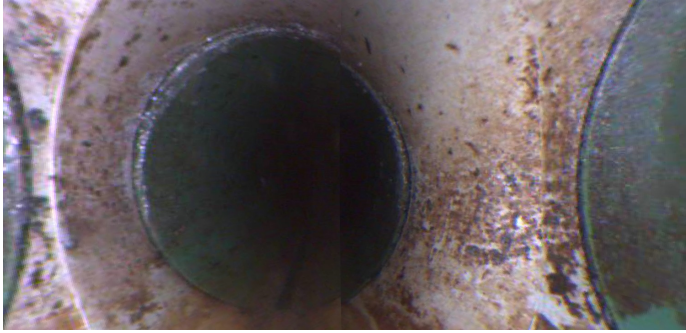
Code: **TF**
Description: **Tap Factory**

Distance (ft): **43.1**
Structural Grade: **0**
O&M Grade: **0**
Clock Start/From: **9**
Clock To:
1st Value: **4.000**
2nd Value:
Value Percent:
Continuous Index:
Within 8" of Joint:
Remarks:

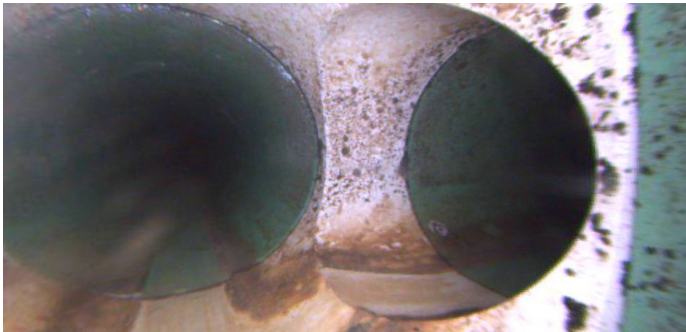
Code: **TF**
Description: **Tap Factory**

Distance (ft): **67.9**
Structural Grade: **0**
O&M Grade: **0**
Clock Start/From: **3**
Clock To:
1st Value: **4.000**
2nd Value:
Value Percent:
Continuous Index:
Within 8" of Joint:
Remarks:

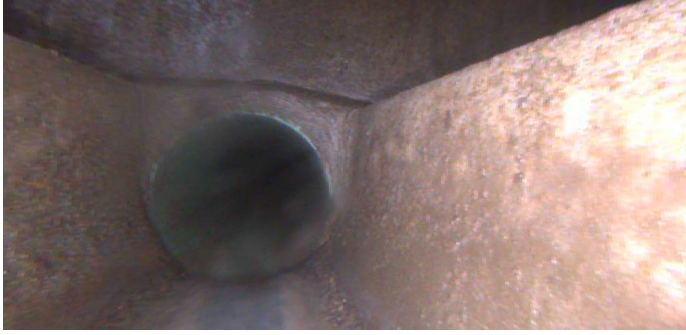
Code:	AMH
Description:	Manhole
Distance (ft):	97.8
Structural Grade:	0
O&M Grade:	0
Clock Start/From:	
Clock To:	
1st Value:	
2nd Value:	
Value Percent:	
Continuous Index:	
Within 8" of Joint:	NO
Remarks:	M-808-018
