Profile/Photo Observation Report

Date:	03/22/2018	Weather:		Coding:	PACP 6.0
Pipe Length (ft):	96.4	Owner:	NA	Pre Clean:	Not Known
P.O.#:		Surveyor:	Selasie Honu	PSR:	P-808-020-019
Customer:		Clean Date:	01/01/1900	Shape:	C

Street:	Oak	Flow Control:	Not Controlled
City:	Hobart, IN	Year Renewed:	
Location:	Sidewalk	Tape/Media #:	
Purpose:	Maintenance Related	Dia/Height:	8"
Use:	Sanitary	Material:	PVC
Drain Area:	NA	Lining:	
Category:	NA		
Comment:	flow incorrect.

Location Details:		Direction of Survey:	Downstream
US MH:	M-808-019	DS MH:	M-808-020
		Total Length Surveyed (ft):	98.5

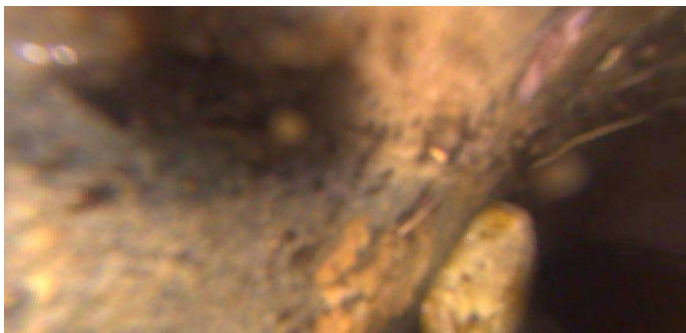
Code: **AMH**
Description: **Manhole**

Distance (ft): **.0**
Structural Grade: **0**
O&M Grade: **0**
Clock Start/From:
Clock To:
1st Value:
2nd Value:
Value Percent:
Continuous Index:
Within 8" of Joint: **NO**
Remarks: **M-808-019**

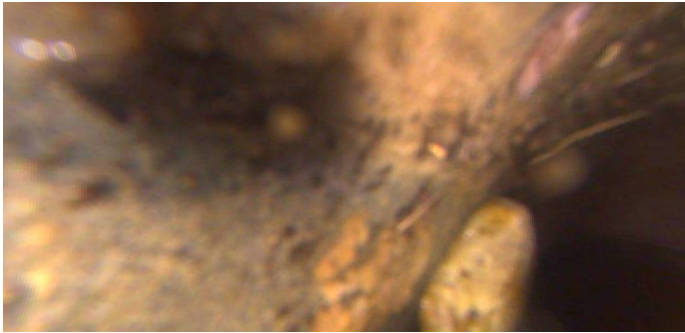
Code:	MWL
Description:	Water Level

Distance (ft):	.0
Structural Grade:	0
O&M Grade:	0
Clock Start/From:	
Clock To:	
1st Value:	
2nd Value:	
Value Percent:	5.000
Continuous Index:	
Within 8" of Joint:	NO
Remarks:

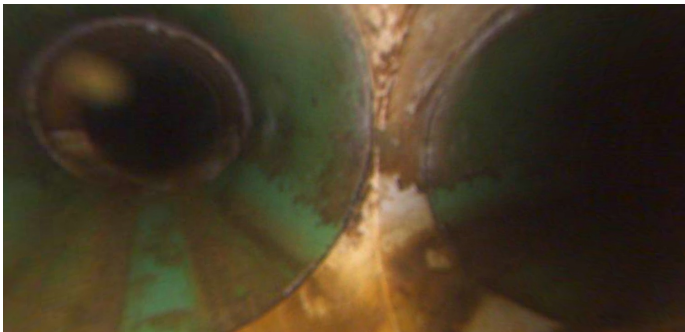
Code:	TFA
Description:	Tap Factory Active

Distance (ft):	54.2
Structural Grade:	0
O&M Grade:	0
Clock Start/From:	3
Clock To:	
1st Value:	4.000
2nd Value:	
Value Percent:	
Continuous Index:	
Within 8" of Joint:	
Remarks:

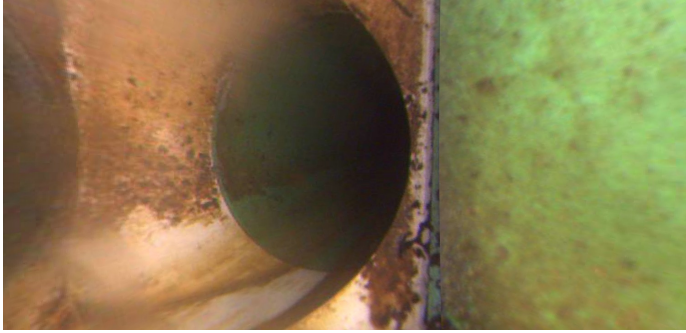
Code: **TFA**
Description: **Tap Factory Active**

Distance (ft): **56.2**
Structural Grade: **0**
O&M Grade: **0**
Clock Start/From: **9**
Clock To:
1st Value: **4.000**
2nd Value:
Value Percent:
Continuous Index:
Within 8" of Joint:
Remarks:

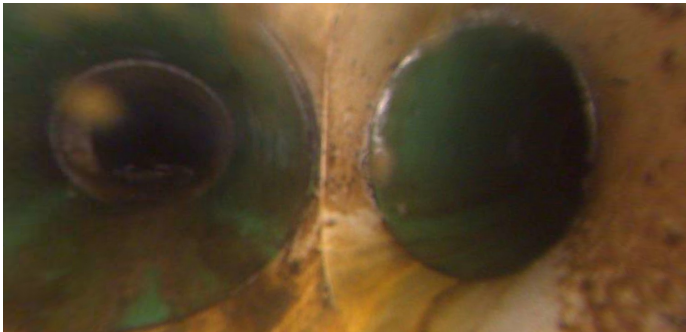
Code: **TF**
Description: **Tap Factory**

Distance (ft): **89.6**
Structural Grade: **0**
O&M Grade: **0**
Clock Start/From: **3**
Clock To:
1st Value: **4.000**
2nd Value:
Value Percent:
Continuous Index:
Within 8" of Joint:
Remarks:

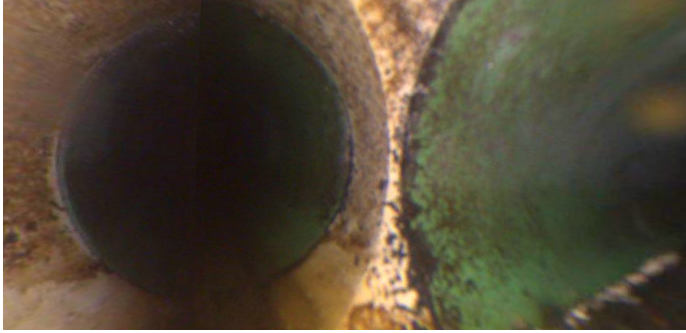
Code: **TF**
Description: **Tap Factory**

Distance (ft): **91.5**
Structural Grade: **0**
O&M Grade: **0**
Clock Start/From: **9**
Clock To:
1st Value: **4.000**
2nd Value:
Value Percent:
Continuous Index:
Within 8" of Joint:
Remarks:

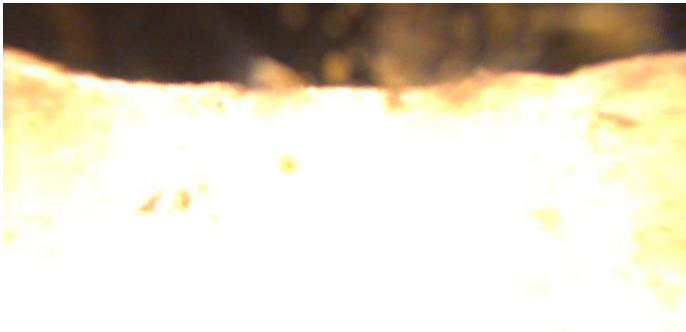
Code: **AMH**
Description: **Manhole**

Distance (ft): **98.5**
Structural Grade: **0**
O&M Grade: **0**
Clock Start/From:
Clock To:
1st Value:
2nd Value:
Value Percent:
Continuous Index:
Within 8" of Joint: **NO**
Remarks: **M-808-020**
