Profile/Photo Observation Report

Street:	Union Court	Flow Control:	
City:	Hobart, IN	Year Renewed:	
Location:	Light Highway	Tape/Media #:	959
Purpose:	Routine Assessment	Dia/Height:	8"
Use:	Sanitary	Material:	PVC
Drain Area:		Lining:	
Category:	NA		
Comment:

Location Details:		Direction of Survey:	Upstream
US MH:	M-808-22	DS MH:	M-808-23
		Total Length Surveyed (ft):	96.1

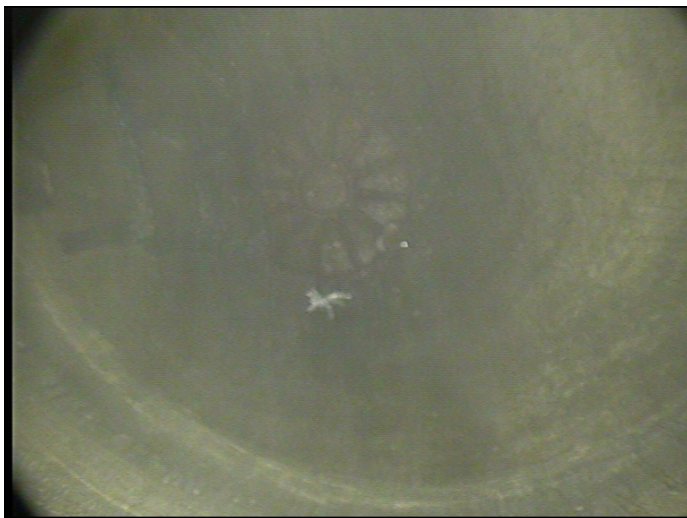
Code:	AMH
Description:	Manhole
Distance (ft):	.0
Structural Grade:	0
O&M Grade:	0
Clock Start/From:	
Clock To:	
1st Value:	
2nd Value:	
Value Percent:	
Continuous Index:	
Within 8" of Joint:	NO
Remarks:	M-808-23

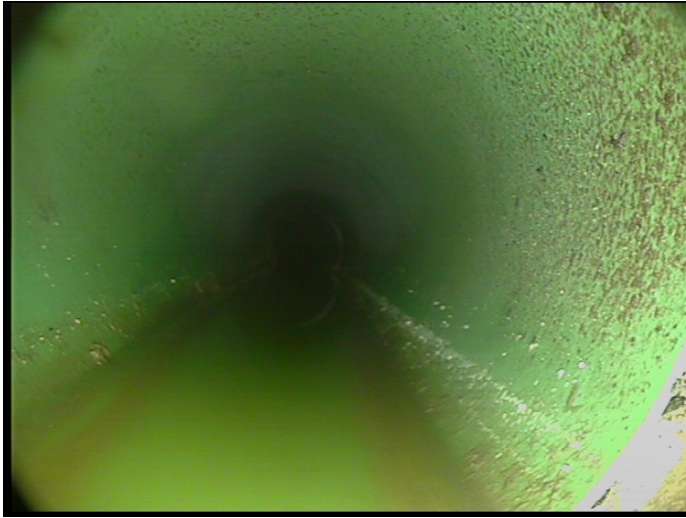
Code:	MWL
Description:	Water Level
Distance (ft):	.0
Structural Grade:	0
O&M Grade:	0
Clock Start/From:	
Clock To:	
1st Value:	
2nd Value:	
Value Percent:	5.000
Continuous Index:	
Within 8" of Joint:	NO
Remarks:

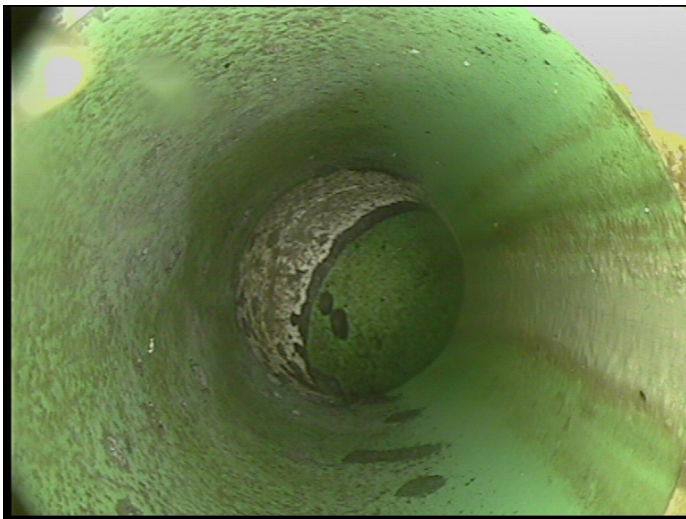
Code:	TF
Description:	Tap Factory
Distance (ft):	7.1
Structural Grade:	0
O&M Grade:	0
Clock Start/From:	2
Clock To:	
1st Value:	4.000
2nd Value:	
Value Percent:	
Continuous Index:	
Within 8" of Joint:	NO
Remarks:

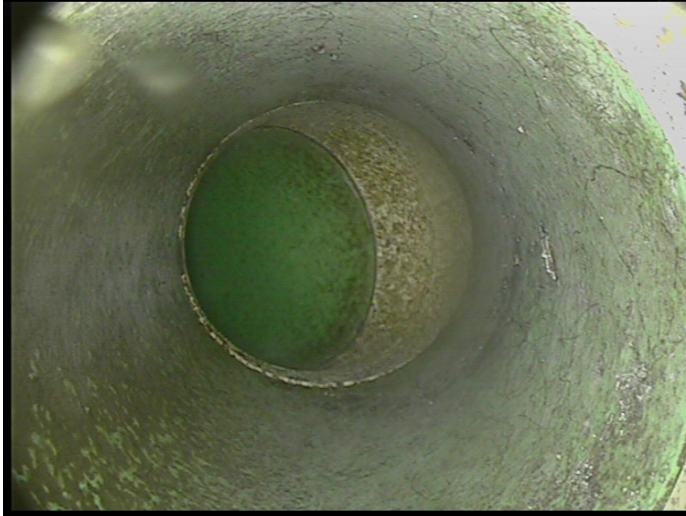
Code: **TF**
Description: **Tap Factory**

Distance (ft): **33.6**
Structural Grade: **0**
O&M Grade: **0**
Clock Start/From: **10**
Clock To:
1st Value: **4.000**
2nd Value:
Value Percent:
Continuous Index:
Within 8" of Joint: **NO**
Remarks:

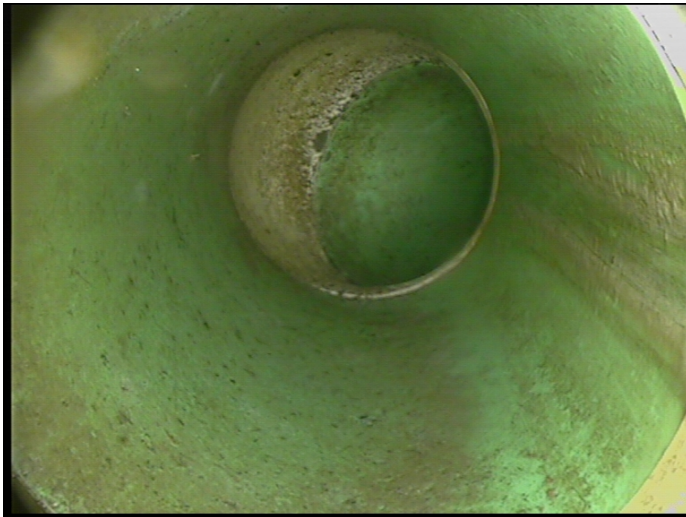
Code: **TF**
Description: **Tap Factory**

Distance (ft): **85.0**
Structural Grade: **0**
O&M Grade: **0**
Clock Start/From: **2**
Clock To:
1st Value: **4.000**
2nd Value:
Value Percent:
Continuous Index:
Within 8" of Joint: **NO**
Remarks:

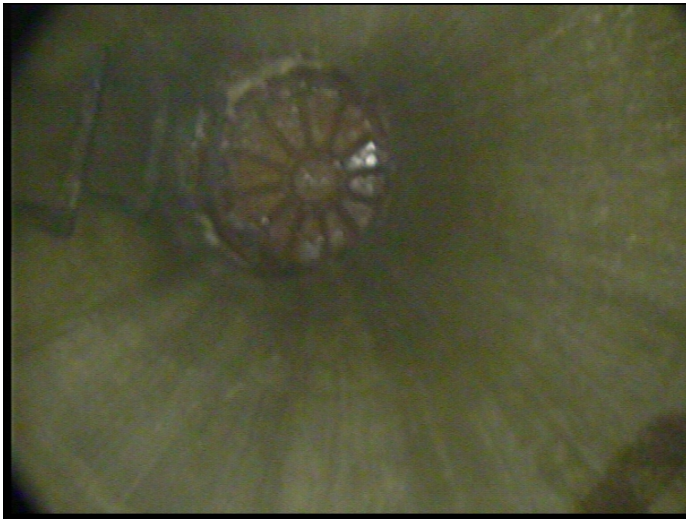
Code:	AMH
Description:	Manhole
Distance (ft):	96.1
Structural Grade:	0
O&M Grade:	0
Clock Start/From:	
Clock To:	
1st Value:	
2nd Value:	
Value Percent:	
Continuous Index:	
Within 8" of Joint:	NO
Remarks:	M-808-22
