Profile/Photo Observation Report

Date:	03/31/2018	Weather:		Coding:	PACP 6.0
Pipe Length (ft):	330.0	Owner:	NA	Pre Clean:	Not Known
P.O.#:		Surveyor:	Jen Costello	PSR:	P-808-024-023
Customer:		Clean Date:	01/01/1900	Shape:	C

Street:	UNION CT	Flow Control:	Not Controlled
City:	Hobart, IN	Year Renewed:	
Location:	Light Highway	Tape/Media #:	
Purpose:	Maintenance Related	Dia/Height:	8"
Use:	Sanitary	Material:	PVC
Drain Area:	NA	Lining:	Cured in Place
Category:	NA		
Comment:	Flow direction wrong.

Location Details:		Direction of Survey:	Upstream
US MH:	M-808-023	DS MH:	M-808-024
		Total Length Surveyed (ft):	206.3

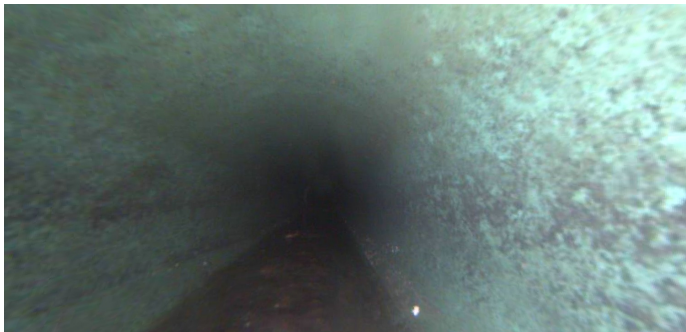
Code: **AMH**
Description: **Manhole**

Distance (ft): **.0**
Structural Grade: **0**
O&M Grade: **0**
Clock Start/From:
Clock To:
1st Value:
2nd Value:
Value Percent:
Continuous Index:
Within 8" of Joint: **NO**
Remarks: **M-808-024**

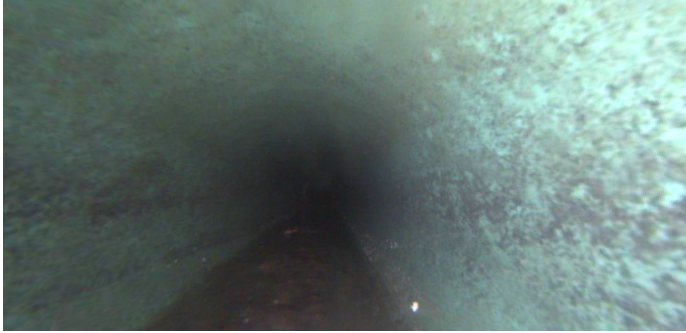
Code:	MWL
Description:	Water Level

Distance (ft):	.0
Structural Grade:	0
O&M Grade:	0
Clock Start/From:	
Clock To:	
1st Value:	
2nd Value:	
Value Percent:	5.000
Continuous Index:	
Within 8" of Joint:	NO
Remarks:

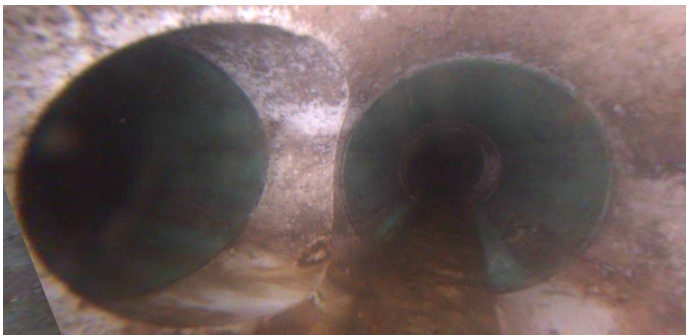
Code:	TF
Description:	Tap Factory

Distance (ft):	6.4
Structural Grade:	0
O&M Grade:	0
Clock Start/From:	9
Clock To:	
1st Value:	4.000
2nd Value:	
Value Percent:	
Continuous Index:	
Within 8" of Joint:	
Remarks:

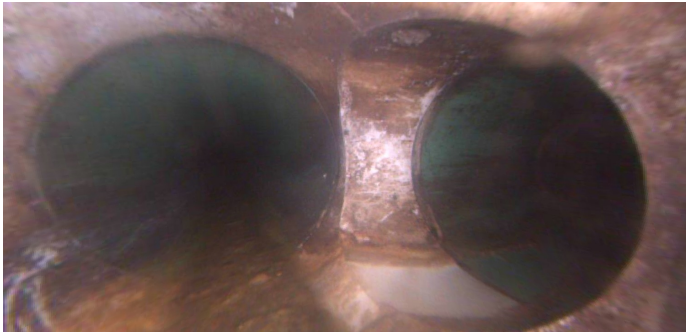
Code: **TF**
Description: **Tap Factory**

Distance (ft): **9.8**
Structural Grade: **0**
O&M Grade: **0**
Clock Start/From: **3**
Clock To:
1st Value: **4.000**
2nd Value:
Value Percent:
Continuous Index:
Within 8" of Joint:
Remarks:

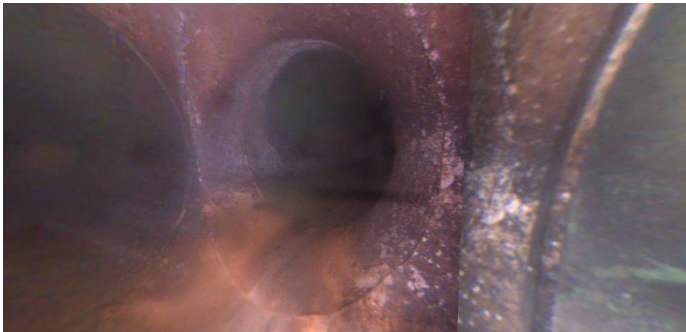
Code: **TF**
Description: **Tap Factory**

Distance (ft): **11.7**
Structural Grade: **0**
O&M Grade: **0**
Clock Start/From: **9**
Clock To:
1st Value: **4.000**
2nd Value:
Value Percent:
Continuous Index:
Within 8" of Joint:
Remarks:

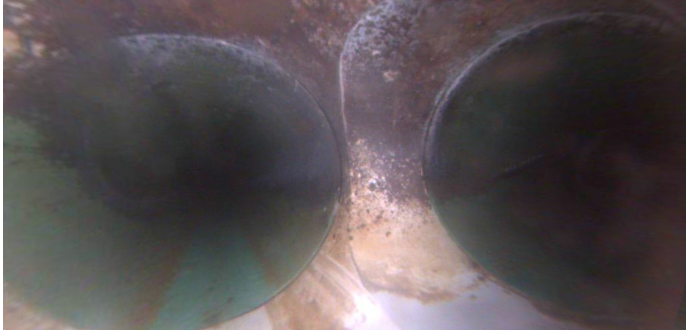
Code: **TF**
Description: **Tap Factory**

Distance (ft): **23.9**
Structural Grade: **0**
O&M Grade: **0**
Clock Start/From: **3**
Clock To:
1st Value: **4.000**
2nd Value:
Value Percent:
Continuous Index:
Within 8" of Joint:
Remarks:

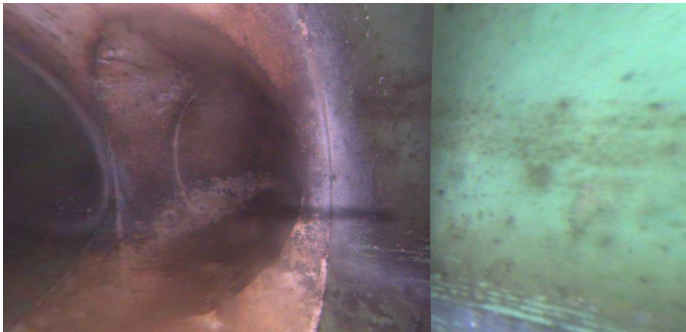
Code: **TF**
Description: **Tap Factory**

Distance (ft): **28.8**
Structural Grade: **0**
O&M Grade: **0**
Clock Start/From: **9**
Clock To:
1st Value: **4.000**
2nd Value:
Value Percent:
Continuous Index:
Within 8" of Joint:
Remarks:

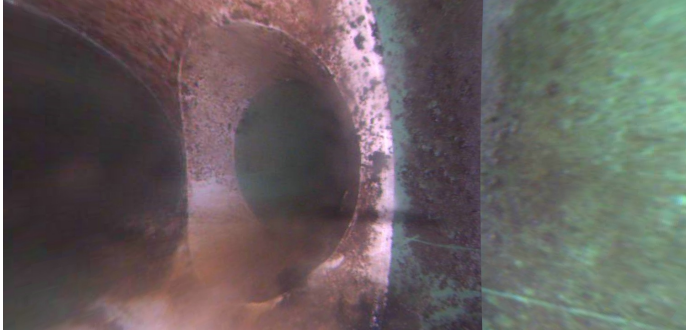
Code: **TF**
Description: **Tap Factory**

Distance (ft): **68.1**
Structural Grade: **0**
O&M Grade: **0**
Clock Start/From: **9**
Clock To:
1st Value: **4.000**
2nd Value:
Value Percent:
Continuous Index:
Within 8" of Joint:
Remarks:

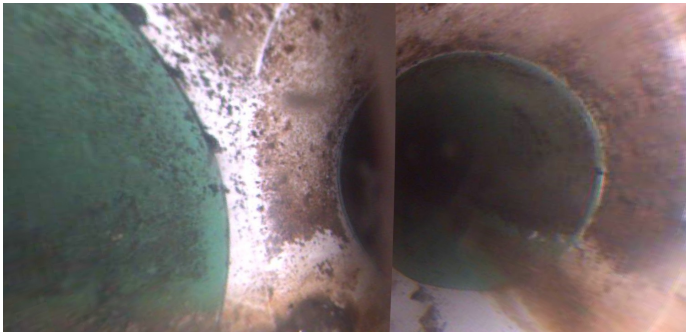
Code: **TF**
Description: **Tap Factory**

Distance (ft): **71.6**
Structural Grade: **0**
O&M Grade: **0**
Clock Start/From: **3**
Clock To:
1st Value: **4.000**
2nd Value:
Value Percent:
Continuous Index:
Within 8" of Joint:
Remarks:

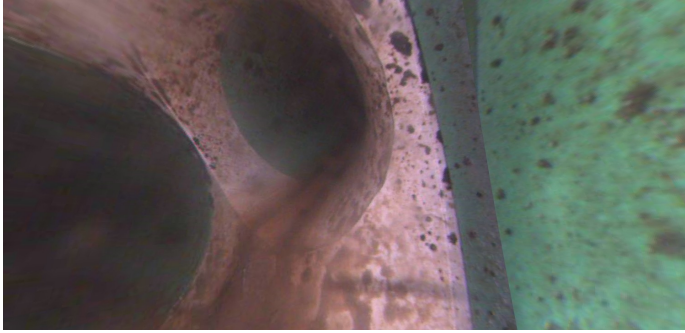
Code: **TF**
Description: **Tap Factory**

Distance (ft): **129.9**
Structural Grade: **0**
O&M Grade: **0**
Clock Start/From: **10**
Clock To:
1st Value: **4.000**
2nd Value:
Value Percent:
Continuous Index:
Within 8" of Joint:
Remarks:

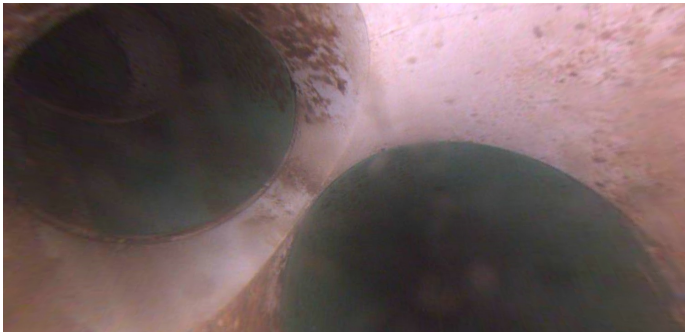
Code: **TF**
Description: **Tap Factory**

Distance (ft): **134.1**
Structural Grade: **0**
O&M Grade: **0**
Clock Start/From: **2**
Clock To:
1st Value: **4.000**
2nd Value:
Value Percent:
Continuous Index:
Within 8" of Joint:
Remarks:

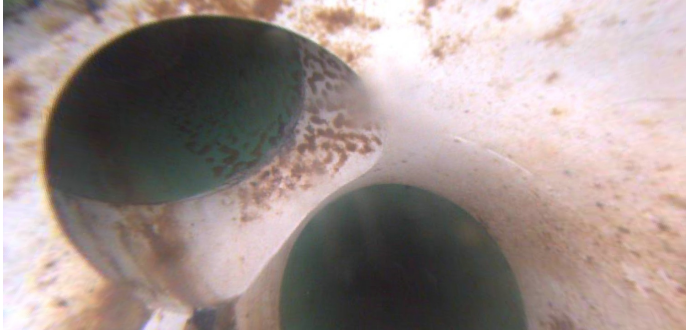
Code: **TF**
Description: **Tap Factory**

Distance (ft): **204.6**
Structural Grade: **0**
O&M Grade: **0**
Clock Start/From: **10**
Clock To:
1st Value: **4.000**
2nd Value:
Value Percent:
Continuous Index:
Within 8" of Joint:
Remarks:

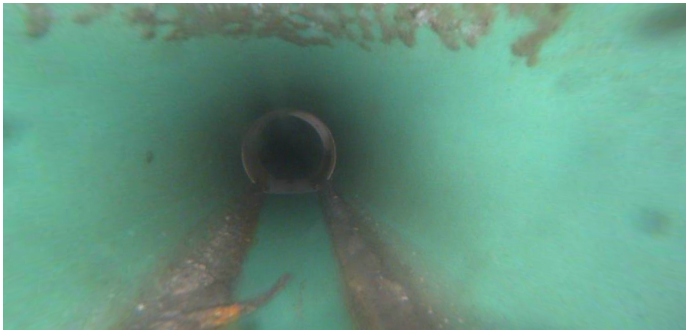
Code: **MSA**
Description: **Abandoned Survey**

Distance (ft): **206.3**
Structural Grade: **0**
O&M Grade: **0**
Clock Start/From:
Clock To:
1st Value:
2nd Value:
Value Percent:
Continuous Index:
Within 8" of Joint: **NO**
Remarks: **unknown**
