Profile/Photo Observation Report

Street:	Union	Flow Control:	Not Controlled
City:	Hobart, IN	Year Renewed:	
Location:	Light Highway	Tape/Media #:	
Purpose:	Maintenance Related	Dia/Height:	8"
Use:	Sanitary	Material:	PVC
Drain Area:	NA	Lining:	Cured in Place
Category:	NA		
Comment:	Flow direction wrong.

Location Details:		Direction of Survey:	Upstream
US MH:	M-808-023	DS MH:	M-808-024
		Total Length Surveyed (ft):	206.3

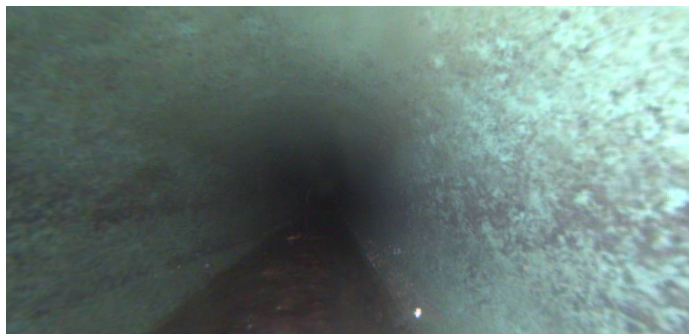
Code: **AMH**
 Description: **Manhole**
 Distance (ft): **.0**
 Structural Grade: **0**
 O&M Grade: **0**
 Clock Start/From:
 Clock To:
 1st Value:
 2nd Value:
 Value Percent:
 Continuous Index:
 Within 8" of Joint: **NO**
 Remarks: **M-808-024**

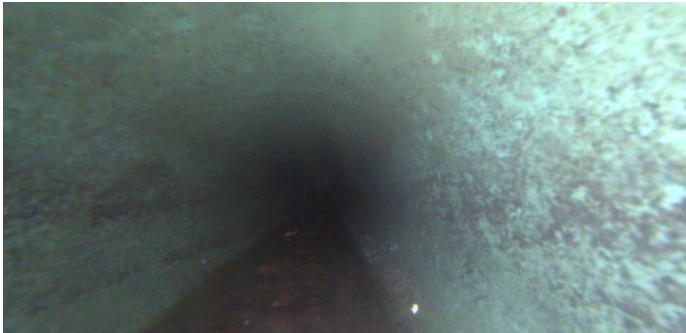
Code:	MWL
Description:	Water Level

Distance (ft):	.0
Structural Grade:	0
O&M Grade:	0
Clock Start/From:	
Clock To:	
1st Value:	
2nd Value:	
Value Percent:	5.000
Continuous Index:	
Within 8" of Joint:	NO
Remarks:

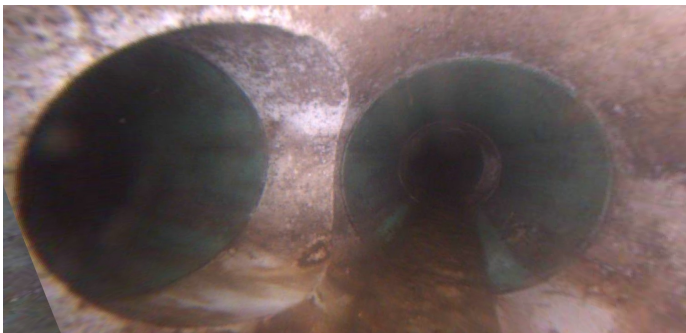
Code:	TF
Description:	Tap Factory

Distance (ft):	6.4
Structural Grade:	0
O&M Grade:	0
Clock Start/From:	9
Clock To:	
1st Value:	4.000
2nd Value:	
Value Percent:	
Continuous Index:	
Within 8" of Joint:	
Remarks:

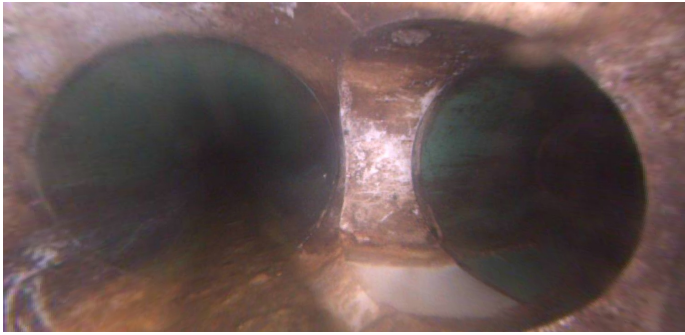
Code: **TF**
Description: **Tap Factory**

Distance (ft): **9.8**
Structural Grade: **0**
O&M Grade: **0**
Clock Start/From: **3**
Clock To:
1st Value: **4.000**
2nd Value:
Value Percent:
Continuous Index:
Within 8" of Joint:
Remarks:

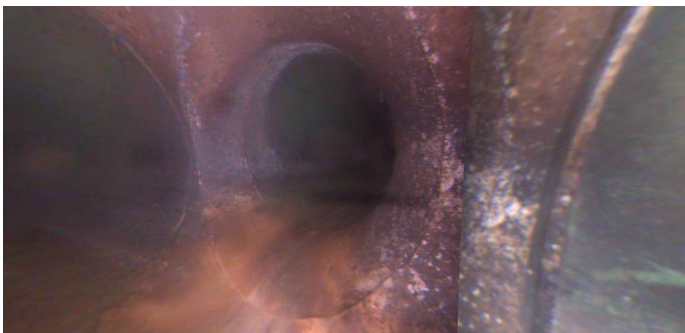
Code: **TF**
Description: **Tap Factory**

Distance (ft): **11.7**
Structural Grade: **0**
O&M Grade: **0**
Clock Start/From: **9**
Clock To:
1st Value: **4.000**
2nd Value:
Value Percent:
Continuous Index:
Within 8" of Joint:
Remarks:

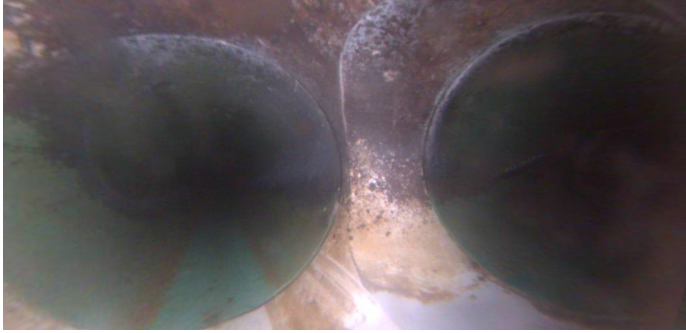
Code: **TF**
Description: **Tap Factory**

Distance (ft): **23.9**
Structural Grade: **0**
O&M Grade: **0**
Clock Start/From: **3**
Clock To:
1st Value: **4.000**
2nd Value:
Value Percent:
Continuous Index:
Within 8" of Joint:
Remarks:

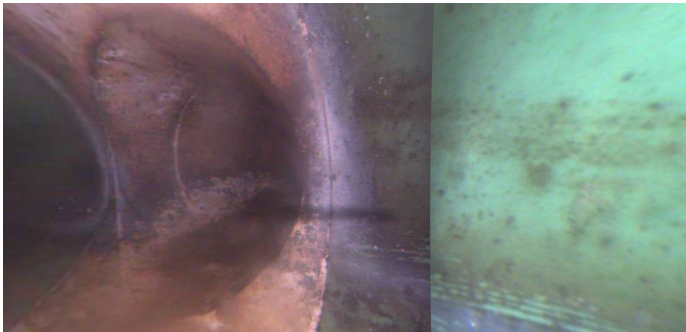
Code: **TF**
Description: **Tap Factory**

Distance (ft): **28.8**
Structural Grade: **0**
O&M Grade: **0**
Clock Start/From: **9**
Clock To:
1st Value: **4.000**
2nd Value:
Value Percent:
Continuous Index:
Within 8" of Joint:
Remarks:

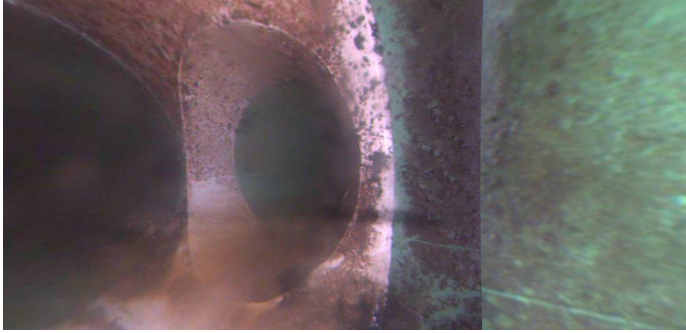
Code: **TF**
Description: **Tap Factory**

Distance (ft): **68.1**
Structural Grade: **0**
O&M Grade: **0**
Clock Start/From: **9**
Clock To:
1st Value: **4.000**
2nd Value:
Value Percent:
Continuous Index:
Within 8" of Joint:
Remarks:

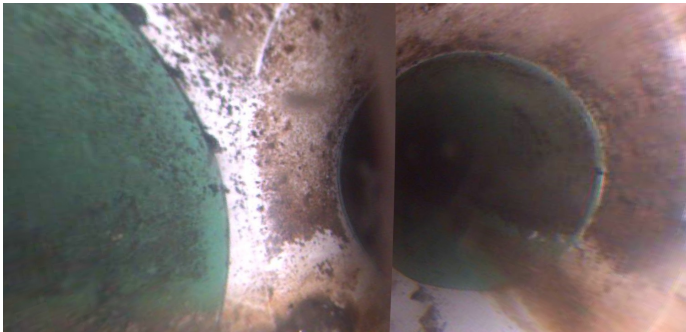
Code: **TF**
Description: **Tap Factory**

Distance (ft): **71.6**
Structural Grade: **0**
O&M Grade: **0**
Clock Start/From: **3**
Clock To:
1st Value: **4.000**
2nd Value:
Value Percent:
Continuous Index:
Within 8" of Joint:
Remarks:

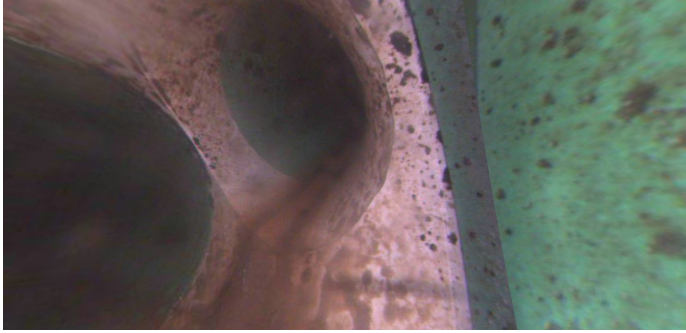
Code: **TF**
Description: **Tap Factory**

Distance (ft): **129.9**
Structural Grade: **0**
O&M Grade: **0**
Clock Start/From: **10**
Clock To:
1st Value: **4.000**
2nd Value:
Value Percent:
Continuous Index:
Within 8" of Joint:
Remarks:

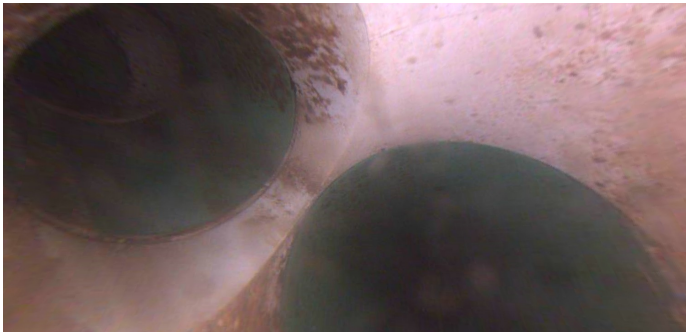
Code: **TF**
Description: **Tap Factory**

Distance (ft): **134.1**
Structural Grade: **0**
O&M Grade: **0**
Clock Start/From: **2**
Clock To:
1st Value: **4.000**
2nd Value:
Value Percent:
Continuous Index:
Within 8" of Joint:
Remarks:

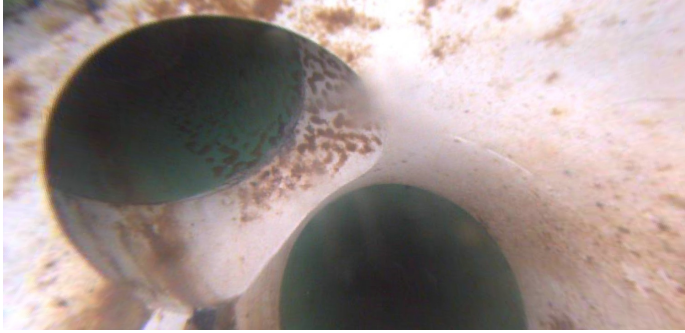
Code: **TF**
Description: **Tap Factory**

Distance (ft): **204.6**
Structural Grade: **0**
O&M Grade: **0**
Clock Start/From: **10**
Clock To:
1st Value: **4.000**
2nd Value:
Value Percent:
Continuous Index:
Within 8" of Joint:
Remarks:

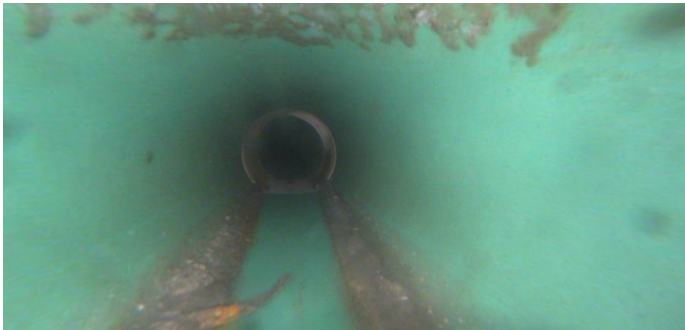
Code: **MSA**
Description: **Abandoned Survey**

Distance (ft): **206.3**
Structural Grade: **0**
O&M Grade: **0**
Clock Start/From:
Clock To:
1st Value:
2nd Value:
Value Percent:
Continuous Index:
Within 8" of Joint: **NO**
Remarks: **unknown**
