## Profile/Photo Observation Report

Date:	<b>01/15/2025</b>	Weather:		Coding:	<b>PACP 7.0</b>
Pipe Length (ft):	<b>364.6</b>	Owner:	<b>City of Hobart</b>	Pre Clean:	<b>Heavy Cleaning</b>
P.O.#:	<b>YES502259</b>	Surveyor:	<b>S. Bucklin</b>	PSR:	<b>P-808-025-026</b>
Customer:	<b>City of Hobart</b>	Clean Date:	<b>01/11/2025</b>	Shape:	<b>C</b>

Street:	<b>South Hobart Road</b>	Flow Control:	<b>Not Controlled</b>
City:	<b>Hobart, IN</b>	Year Renewed:	
Location:	<b>Ditch</b>	Tape/Media #:	
Purpose:	<b>Sewer System Evaluation Survey (SS</b>	Dia/Height:	<b>12"</b>
Use:	<b>Sanitary Sewage Pipe</b>	Material:	<b>PVC</b>
Drain Area:		Lining:	<b>None</b>
Category:	<b>NA</b>		
Comment:			
Location Details:		Direction of Survey:	<b>Downstream</b>
US MH:	<b>M-808-025</b>	DS MH:	<b>M-808-026</b>
		Total Length Surveyed (ft):	<b>393.3</b>

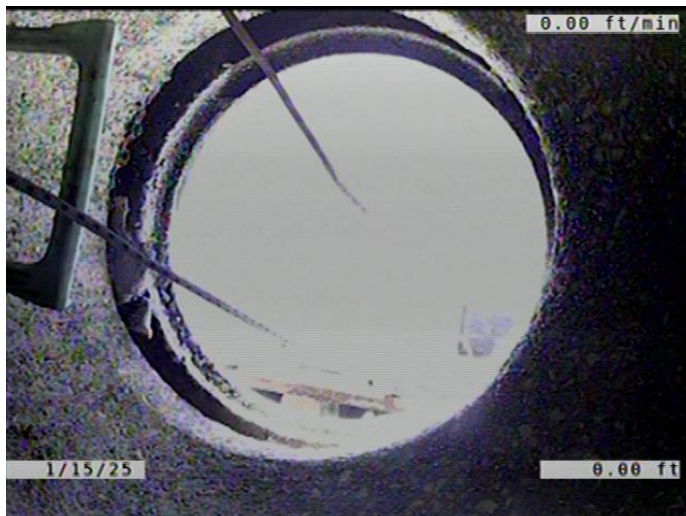
Code: **AMH**  
Description: **Manhole**

Distance (ft): **.0**  
Structural Grade: **0**  
O&M Grade: **0**  
Clock Start/From:  
Clock To:  
1st Value:  
2nd Value:  
Value Percent:  
Continuous Index:  
Within 8" of Joint: **NO**  
Remarks: **M-808-025**

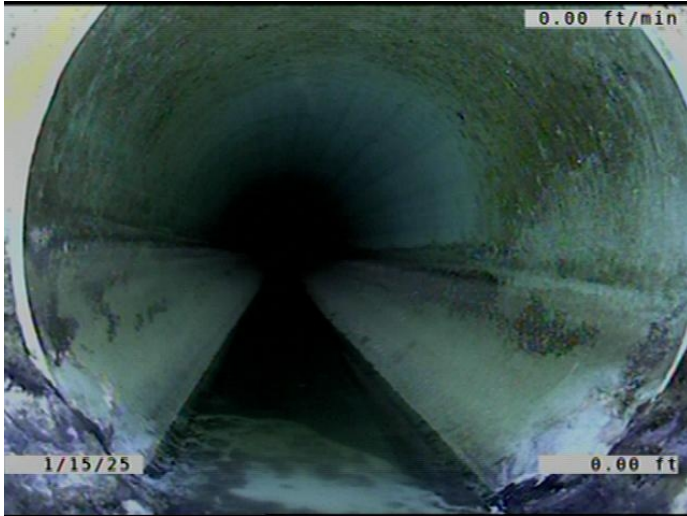
Code: **MWL**  
Description: **Miscellaneous Water Level**

Distance (ft): **.0**  
Structural Grade: **0**  
O&M Grade: **0**  
Clock Start/From:  
Clock To:  
1st Value:  
2nd Value:  
Value Percent: **5.000**  
Continuous Index:  
Within 8" of Joint: **NO**  
Remarks:

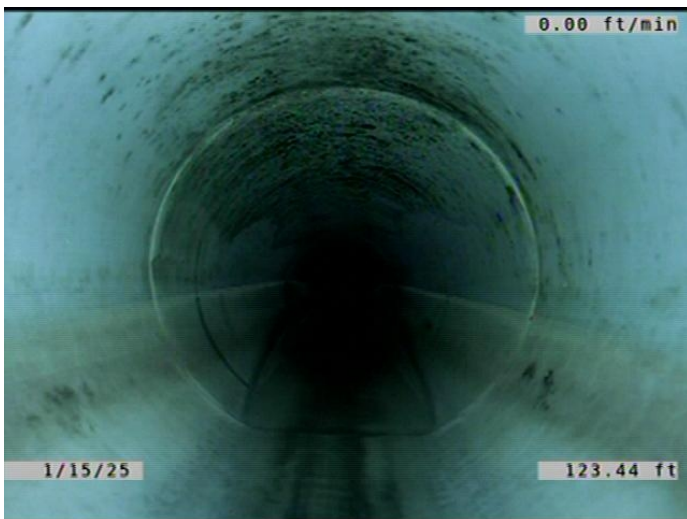
Code: **MWLS**  
Description: **Miscellaneous Water Level Sag**

Distance (ft): **123.4**  
Structural Grade: **2**  
O&M Grade: **0**  
Clock Start/From:  
Clock To:  
1st Value:  
2nd Value:  
Value Percent: **15.000**  
Continuous Index: **S01**  
Within 8" of Joint: **NO**  
Remarks:

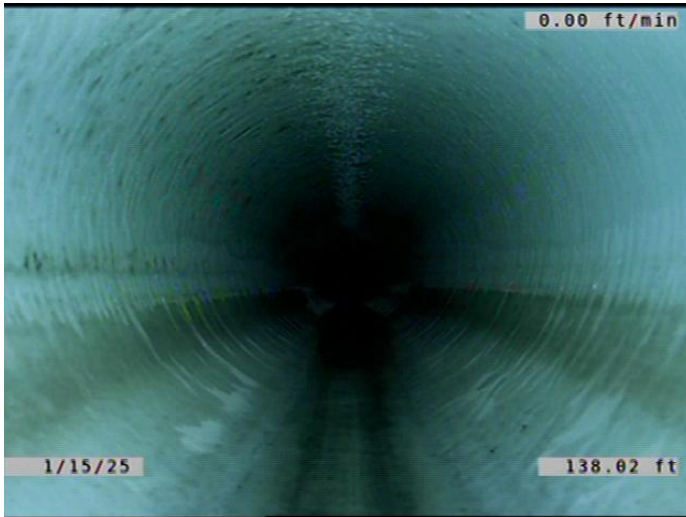
Code: **MWLS**  
Description: **Miscellaneous Water Level Sag**

Distance (ft): **138.0**  
Structural Grade: **2**  
O&M Grade: **0**  
Clock Start/From:  
Clock To:  
1st Value:  
2nd Value:  
Value Percent: **15.000**  
Continuous Index: **F01**  
Within 8" of Joint: **NO**  
Remarks:

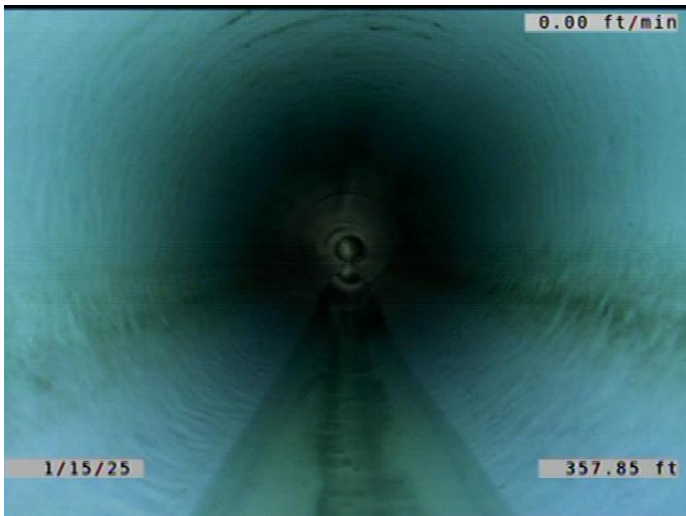
Code: **MWLS**  
Description: **Miscellaneous Water Level Sag**

Distance (ft): **357.8**  
Structural Grade: **2**  
O&M Grade: **0**  
Clock Start/From:  
Clock To:  
1st Value:  
2nd Value:  
Value Percent: **5.000**  
Continuous Index: **S02**  
Within 8" of Joint: **NO**  
Remarks:

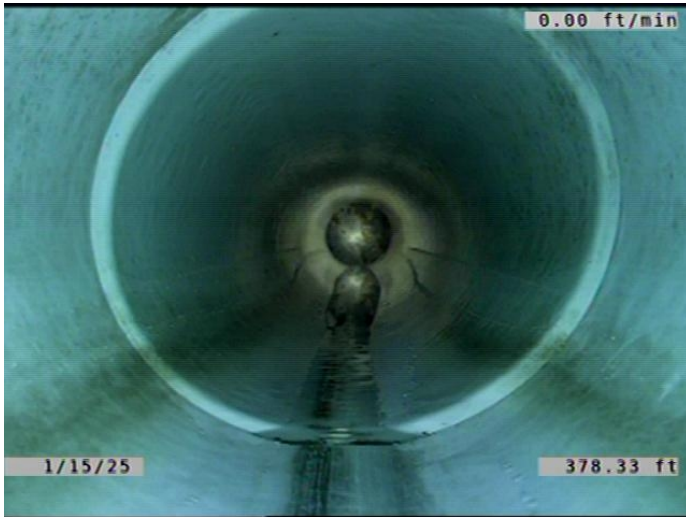
Code: **MWLS**  
 Description: **Miscellaneous Water Level Sag**

Distance (ft): **378.3**  
 Structural Grade: **2**  
 O&M Grade: **0**  
 Clock Start/From:  
 Clock To:  
 1st Value:  
 2nd Value:  
 Value Percent: **5.000**  
 Continuous Index: **F02**  
 Within 8" of Joint: **NO**  
 Remarks:

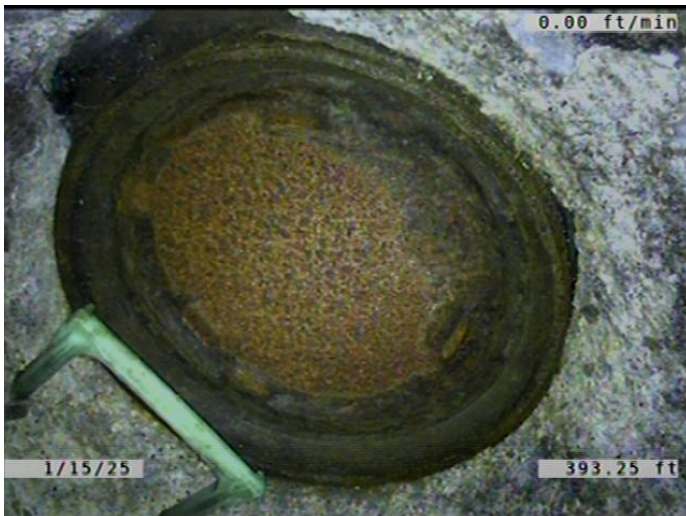
Code: **AMH**  
 Description: **Manhole**

Distance (ft): **393.2**  
 Structural Grade: **0**  
 O&M Grade: **0**  
 Clock Start/From:  
 Clock To:  
 1st Value:  
 2nd Value:  
 Value Percent:  
 Continuous Index:  
 Within 8" of Joint: **NO**  
 Remarks: **M-808-026**
