Profile/Photo Observation Report

Date:	03/22/2018	Weather:		Coding:	PACP 6.0
Pipe Length (ft):	395.4	Owner:	NA	Pre Clean:	Not Known
P.O.#:		Surveyor:	Selasie Honu	PSR:	P-808-026-027
Customer:		Clean Date:	01/01/1900	Shape:	C

Street:	Oak	Flow Control:	Not Controlled
City:	Hobart, IN	Year Renewed:	
Location:	Ditch	Tape/Media #:	
Purpose:	Maintenance Related	Dia/Height:	12"
Use:	Sanitary	Material:	PVC
Drain Area:	NA	Lining:	
Category:	NA		
Comment:	Reverse setup. possible sludge at 313'.		
Location Details:		Direction of Survey:	Downstream
US MH:	M-808-026	DS MH:	M-808-027
		Total Length Surveyed (ft):	315.1

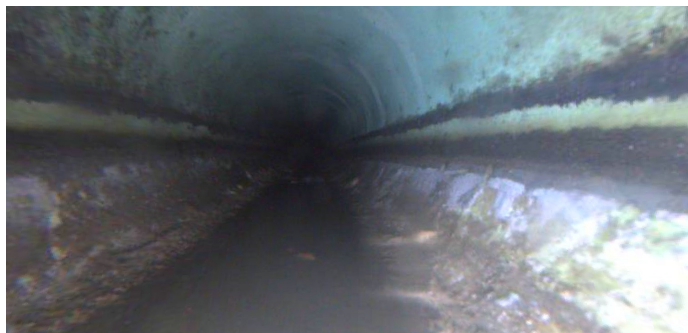
Code: **DAGS**
Description: **Deposits Attached Grease**

Distance (ft): **.0**
Structural Grade: **0**
O&M Grade: **2**
Clock Start/From: **8**
Clock To: **4**
1st Value:
2nd Value:
Value Percent: **5.000**
Continuous Index: **S01**
Within 8" of Joint: **NO**
Remarks:

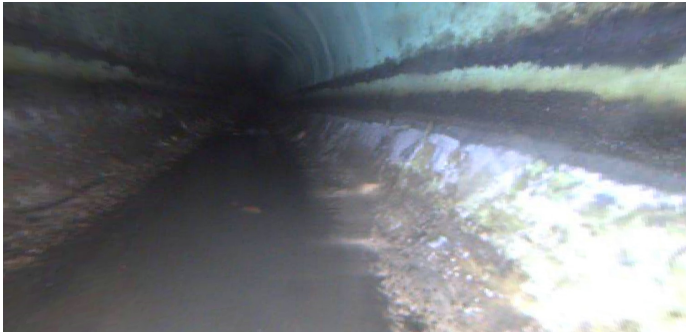
Code:	AMH
Description:	Manhole

Distance (ft):	.0
Structural Grade:	0
O&M Grade:	0
Clock Start/From:	
Clock To:	
1st Value:	
2nd Value:	
Value Percent:	
Continuous Index:	
Within 8" of Joint:	NO
Remarks:	M-808-026

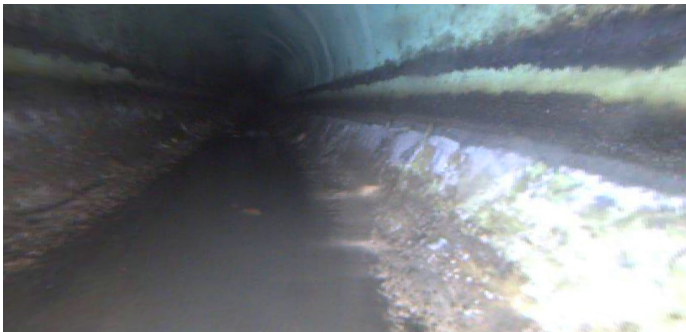
Code:	MWL
Description:	Water Level

Distance (ft):	.0
Structural Grade:	0
O&M Grade:	0
Clock Start/From:	
Clock To:	
1st Value:	
2nd Value:	
Value Percent:	5.000
Continuous Index:	
Within 8" of Joint:	NO
Remarks:

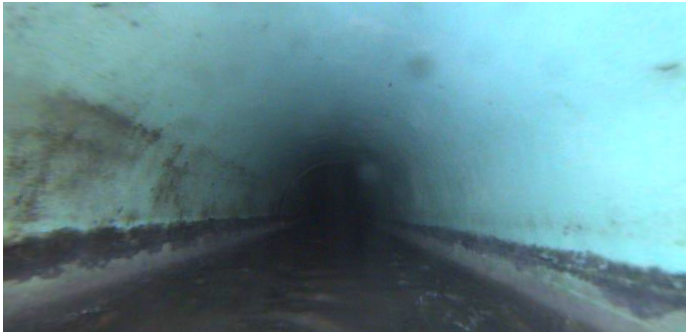
Code: **DAGS**
Description: **Deposits Attached Grease**

Distance (ft): **46.7**
Structural Grade: **0**
O&M Grade: **2**
Clock Start/From: **8**
Clock To: **4**
1st Value:
2nd Value:
Value Percent: **5.000**
Continuous Index: **F01**
Within 8" of Joint: **NO**
Remarks:

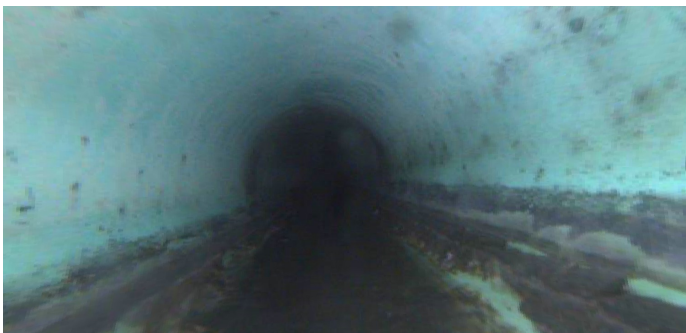
Code: **MSA**
Description: **Abandoned Survey**

Distance (ft): **315.1**
Structural Grade: **0**
O&M Grade: **0**
Clock Start/From:
Clock To:
1st Value:
2nd Value:
Value Percent:
Continuous Index:
Within 8" of Joint: **NO**
Remarks: **CAMERA STOPPED**
