Profile/Photo Observation Report

Street:	S HOBART RD	Flow Control:	Not Controlled
City:	Hobart, IN	Year Renewed:	
Location:	Ditch	Tape/Media #:	
Purpose:	Maintenance Related	Dia/Height:	12"
Use:	Sanitary	Material:	PVC
Drain Area:	NA	Lining:	
Category:	NA		
Comment:

Location Details:		Direction of Survey:	Downstream
US MH:	M-808-027	DS MH:	M-808-028
		Total Length Surveyed (ft):	312.1

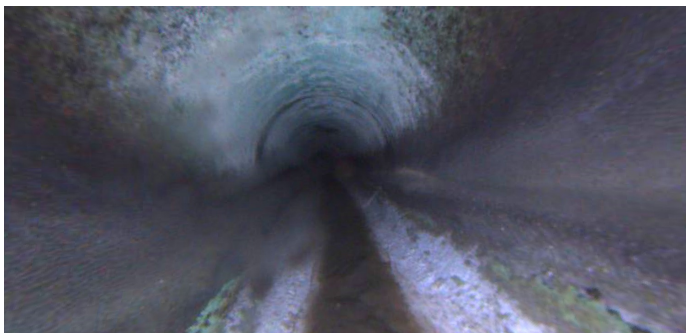
Code: **DAGS**
Description: **Deposits Attached Grease**

Distance (ft): **.0**
Structural Grade: **0**
O&M Grade: **2**
Clock Start/From: **7**
Clock To: **5**
1st Value:
2nd Value:
Value Percent: **5.000**
Continuous Index: **S01**
Within 8" of Joint: **NO**
Remarks:

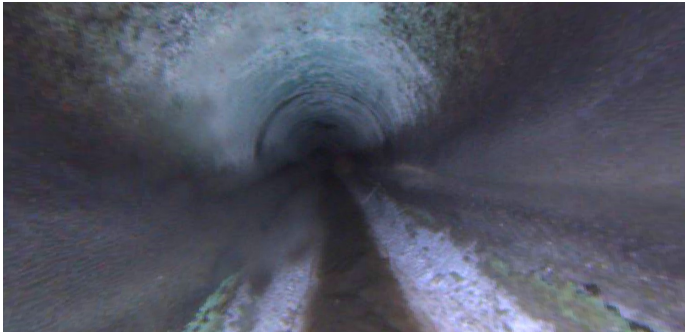
Code:	AMH
Description:	Manhole

Distance (ft):	.0
Structural Grade:	0
O&M Grade:	0
Clock Start/From:	
Clock To:	
1st Value:	
2nd Value:	
Value Percent:	
Continuous Index:	
Within 8" of Joint:	NO
Remarks:	M-808-027

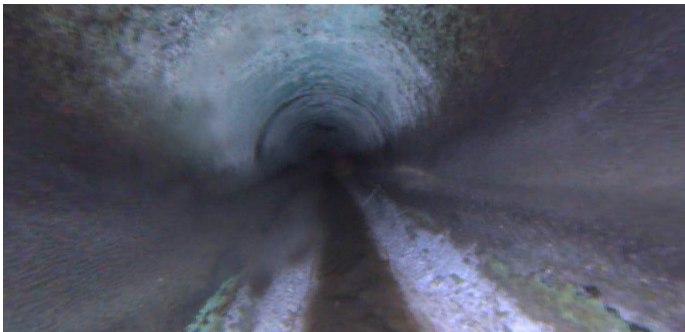
Code:	MWL
Description:	Water Level

Distance (ft):	.0
Structural Grade:	0
O&M Grade:	0
Clock Start/From:	
Clock To:	
1st Value:	
2nd Value:	
Value Percent:	5.000
Continuous Index:	
Within 8" of Joint:	NO
Remarks:

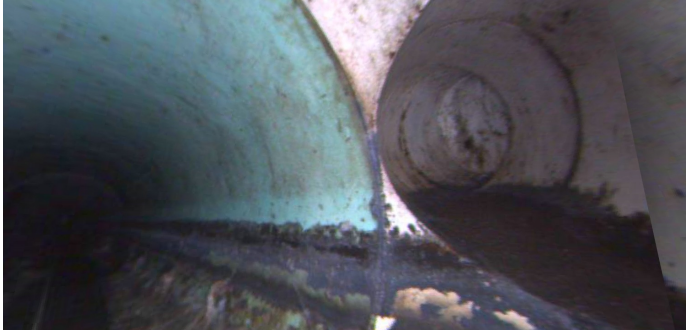
Code: **TF**
Description: **Tap Factory**

Distance (ft): **120.6**
Structural Grade: **0**
O&M Grade: **0**
Clock Start/From: **9**
Clock To:
1st Value: **4.000**
2nd Value:
Value Percent:
Continuous Index:
Within 8" of Joint:
Remarks:

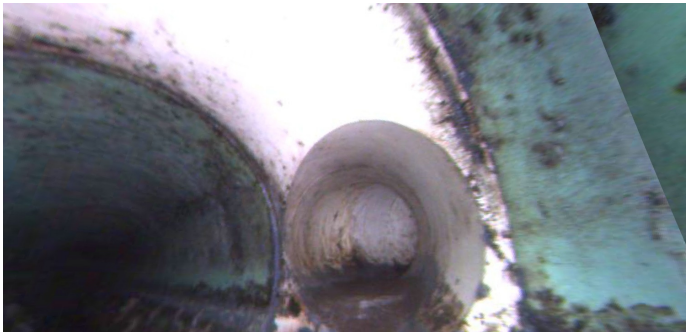
Code: **TFC**
Description: **Tap Factory Capped**

Distance (ft): **252.1**
Structural Grade: **0**
O&M Grade: **0**
Clock Start/From: **9**
Clock To:
1st Value: **4.000**
2nd Value:
Value Percent:
Continuous Index:
Within 8" of Joint:
Remarks:

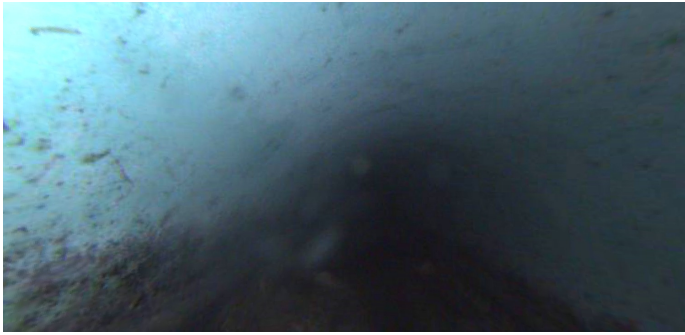
Code: **DAGS**
Description: **Deposits Attached Grease**

Distance (ft): **312.1**
Structural Grade: **0**
O&M Grade: **2**
Clock Start/From: **7**
Clock To: **5**
1st Value:
2nd Value:
Value Percent: **5.000**
Continuous Index: **F01**
Within 8" of Joint: **NO**
Remarks:

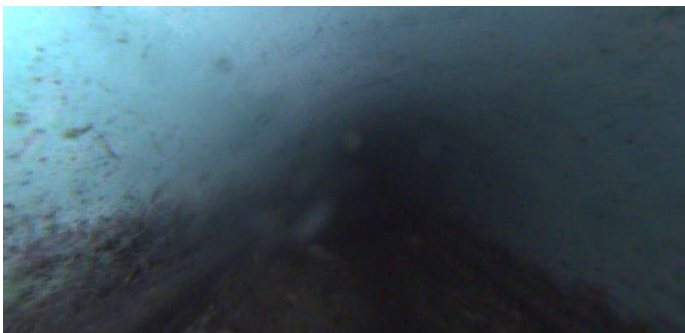
Code: **MSA**
Description: **Abandoned Survey**

Distance (ft): **312.1**
Structural Grade: **0**
O&M Grade: **0**
Clock Start/From:
Clock To:
1st Value:
2nd Value:
Value Percent:
Continuous Index:
Within 8" of Joint: **NO**
Remarks: **deposits**
