Profile/Photo Observation Report

Street:	Oak	Flow Control:	Not Controlled
City:	Hobart, IN	Year Renewed:	
Location:	Ditch	Tape/Media #:	
Purpose:	Maintenance Related	Dia/Height:	12"
Use:	Sanitary	Material:	PVC
Drain Area:	NA	Lining:	
Category:	NA		
Comment:

Location Details:		Direction of Survey:	Downstream
US MH:	M-808-027	DS MH:	M-808-028
		Total Length Surveyed (ft):	312.1

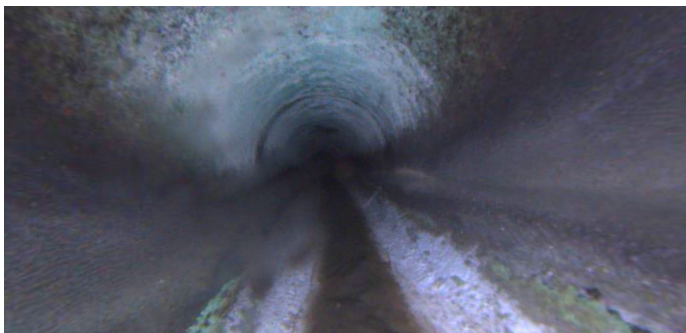
Code: **DAGS**
Description: **Deposits Attached Grease**

Distance (ft): **.0**
Structural Grade: **0**
O&M Grade: **2**
Clock Start/From: **7**
Clock To: **5**
1st Value:
2nd Value:
Value Percent: **5.000**
Continuous Index: **S01**
Within 8" of Joint: **NO**
Remarks:

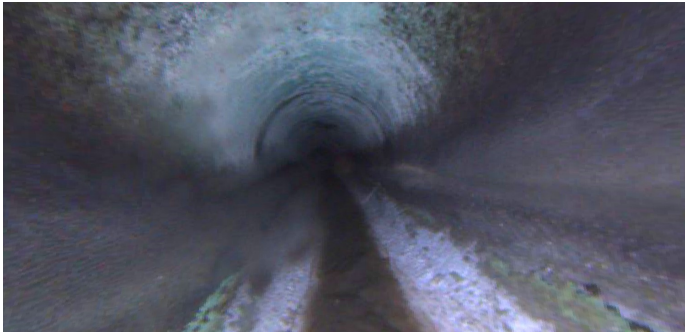
Code:	AMH
Description:	Manhole

Distance (ft):	.0
Structural Grade:	0
O&M Grade:	0
Clock Start/From:	
Clock To:	
1st Value:	
2nd Value:	
Value Percent:	
Continuous Index:	
Within 8" of Joint:	NO
Remarks:	M-808-027

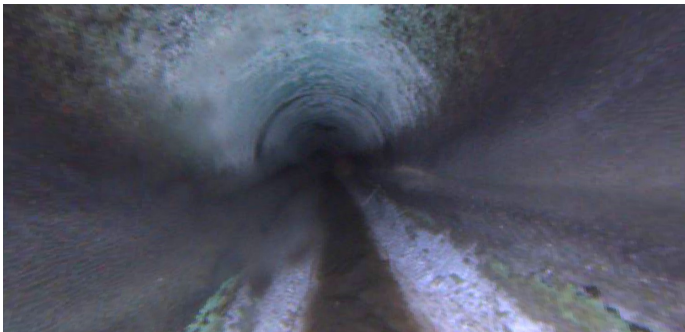
Code:	MWL
Description:	Water Level

Distance (ft):	.0
Structural Grade:	0
O&M Grade:	0
Clock Start/From:	
Clock To:	
1st Value:	
2nd Value:	
Value Percent:	5.000
Continuous Index:	
Within 8" of Joint:	NO
Remarks:

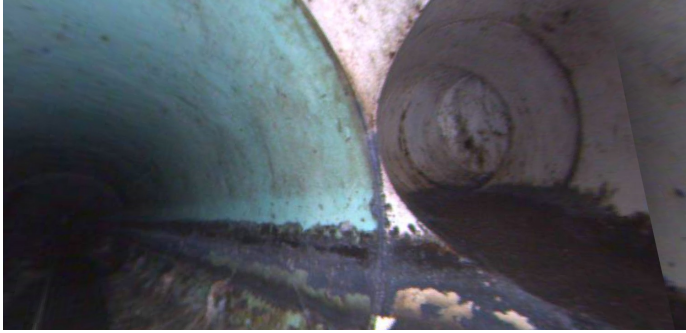
Code: **TF**
Description: **Tap Factory**

Distance (ft): **120.6**
Structural Grade: **0**
O&M Grade: **0**
Clock Start/From: **9**
Clock To:
1st Value: **4.000**
2nd Value:
Value Percent:
Continuous Index:
Within 8" of Joint:
Remarks:

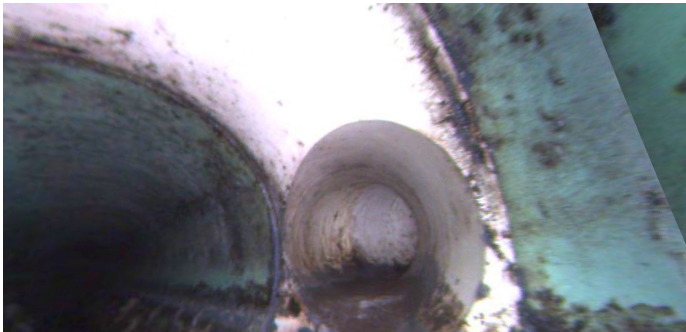
Code: **TFC**
Description: **Tap Factory Capped**

Distance (ft): **252.1**
Structural Grade: **0**
O&M Grade: **0**
Clock Start/From: **9**
Clock To:
1st Value: **4.000**
2nd Value:
Value Percent:
Continuous Index:
Within 8" of Joint:
Remarks:

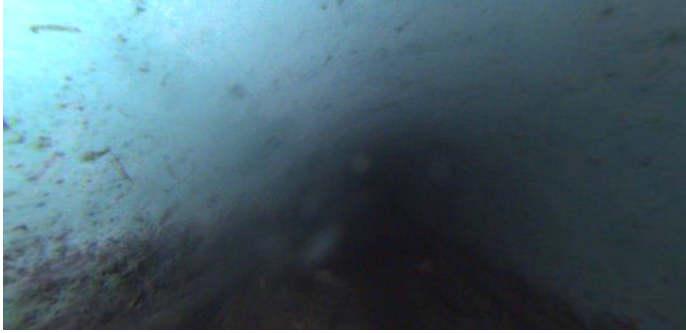
Code: **DAGS**
Description: **Deposits Attached Grease**

Distance (ft): **312.1**
Structural Grade: **0**
O&M Grade: **2**
Clock Start/From: **7**
Clock To: **5**
1st Value:
2nd Value:
Value Percent: **5.000**
Continuous Index: **F01**
Within 8" of Joint: **NO**
Remarks:

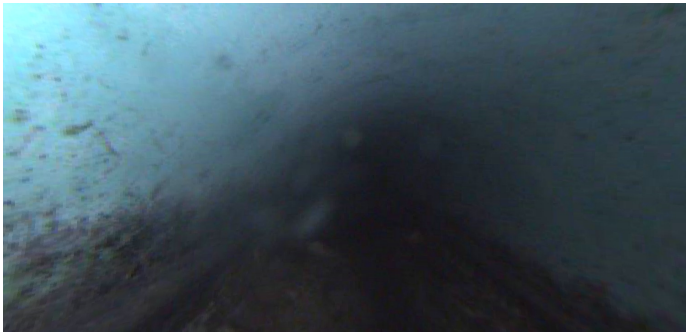
Code: **MSA**
Description: **Abandoned Survey**

Distance (ft): **312.1**
Structural Grade: **0**
O&M Grade: **0**
Clock Start/From:
Clock To:
1st Value:
2nd Value:
Value Percent:
Continuous Index:
Within 8" of Joint: **NO**
Remarks: **deposits**
