Profile/Photo Observation Report

Street:	S HOBART RD	Flow Control:	Not Controlled
City:	Hobart, IN	Year Renewed:	
Location:	Ditch	Tape/Media #:	
Purpose:	Maintenance Related	Dia/Height:	12"
Use:	Sanitary	Material:	PVC
Drain Area:	NA	Lining:	Cured in Place
Category:	NA		
Comment:

Location Details:		Direction of Survey:	Upstream
US MH:	M-808-028	DS MH:	M-808-029
		Total Length Surveyed (ft):	401.9

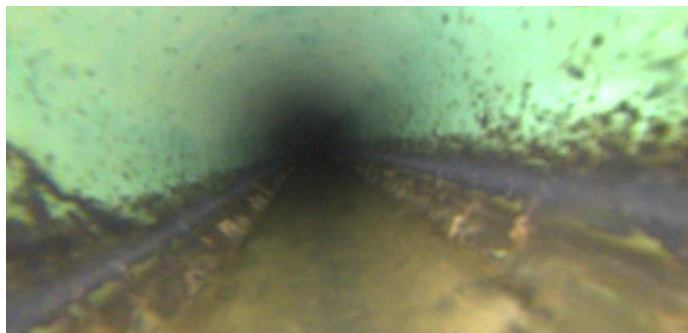
Code: **AMH**
 Description: **Manhole**
 Distance (ft): **.0**
 Structural Grade: **0**
 O&M Grade: **0**
 Clock Start/From:
 Clock To:
 1st Value:
 2nd Value:
 Value Percent:
 Continuous Index:
 Within 8" of Joint: **NO**
 Remarks: **M-808-029**

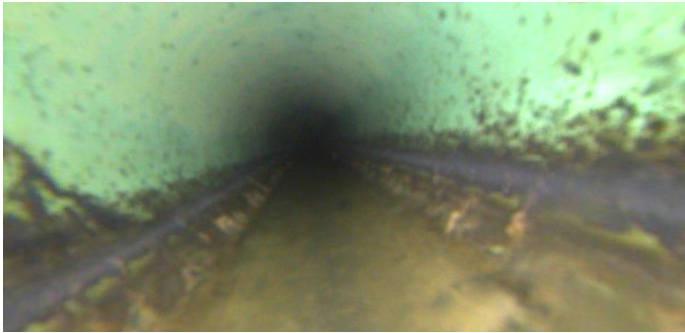
Code:	MWL
Description:	Water Level

Distance (ft):	.0
Structural Grade:	0
O&M Grade:	0
Clock Start/From:	
Clock To:	
1st Value:	
2nd Value:	
Value Percent:	10.000
Continuous Index:	
Within 8" of Joint:	NO
Remarks:

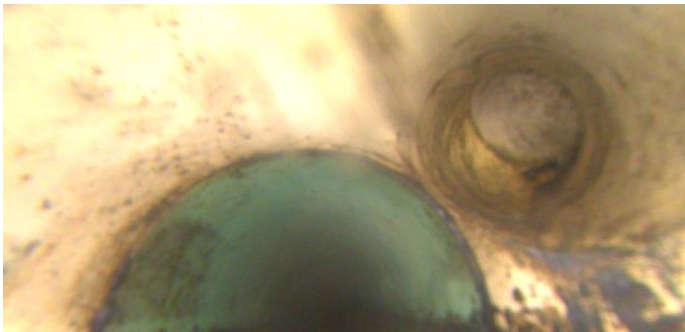
Code:	TF
Description:	Tap Factory

Distance (ft):	302.2
Structural Grade:	0
O&M Grade:	0
Clock Start/From:	2
Clock To:	
1st Value:	4.000
2nd Value:	
Value Percent:	
Continuous Index:	
Within 8" of Joint:	
Remarks:

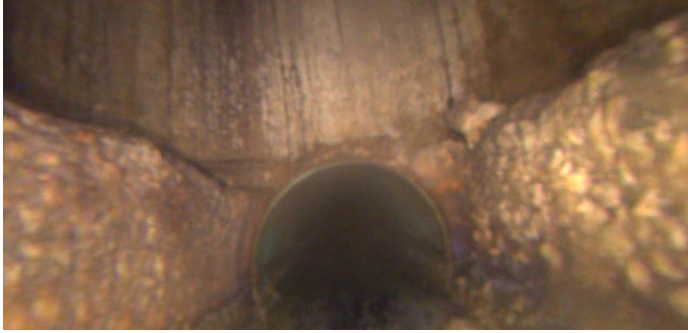
Code:	AMH
Description:	Manhole
Distance (ft):	401.9
Structural Grade:	0
O&M Grade:	0
Clock Start/From:	
Clock To:	
1st Value:	
2nd Value:	
Value Percent:	
Continuous Index:	
Within 8" of Joint:	NO
Remarks:	M-808-028
