Profile/Photo Observation Report

Street:	S HOBART RD	Flow Control:	Not Controlled
City:	Hobart, IN	Year Renewed:	
Location:	Light Highway	Tape/Media #:	
Purpose:	Routine Assessment	Dia/Height:	12"
Use:	Sanitary	Material:	PVC
Drain Area:	NA	Lining:	
Category:	NA		
Comment:

Location Details:		Direction of Survey:	Downstream
US MH:	M-808-030	DS MH:	M-808-029
		Total Length Surveyed (ft):	334.4

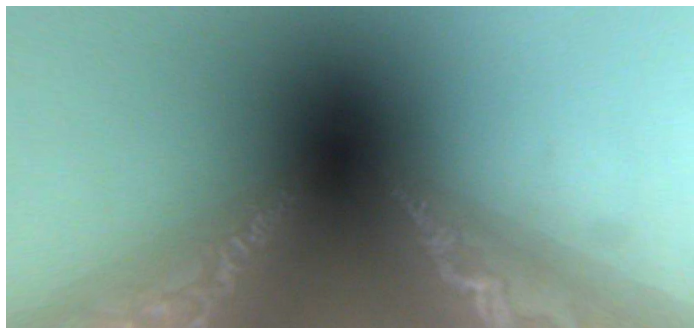
Code: **AMH**
Description: **Manhole**

Distance (ft): **.0**
Structural Grade: **0**
O&M Grade: **0**
Clock Start/From:
Clock To:
1st Value:
2nd Value:
Value Percent:
Continuous Index:
Within 8" of Joint: **NO**
Remarks: **M-808-030**

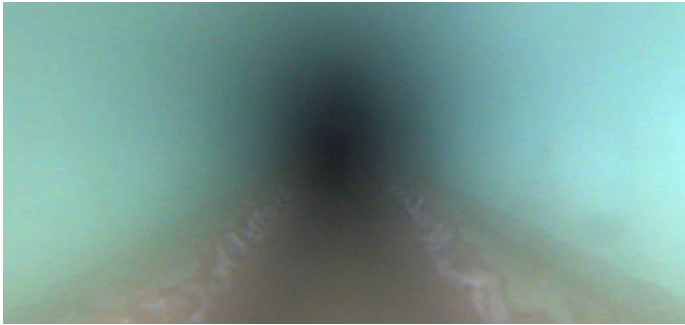
Code:	MWL
Description:	Water Level

Distance (ft):	.0
Structural Grade:	0
O&M Grade:	0
Clock Start/From:	
Clock To:	
1st Value:	
2nd Value:	
Value Percent:	5.000
Continuous Index:	
Within 8" of Joint:	NO
Remarks:

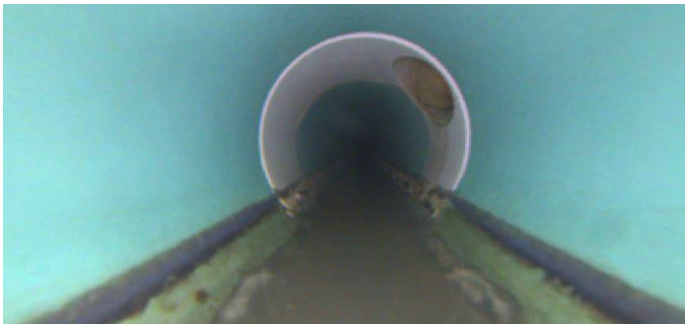
Code:	TF
Description:	Tap Factory

Distance (ft):	227.7
Structural Grade:	0
O&M Grade:	0
Clock Start/From:	2
Clock To:	
1st Value:	4.000
2nd Value:	
Value Percent:	
Continuous Index:	
Within 8" of Joint:	
Remarks:

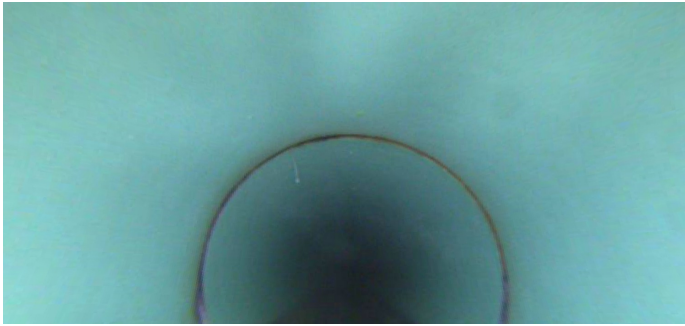
Code: **RFJ**
Description: **Roots Fine Joint**

Distance (ft): **241.6**
Structural Grade: **0**
O&M Grade: **1**
Clock Start/From: **11**
Clock To:
1st Value:
2nd Value:
Value Percent:
Continuous Index:
Within 8" of Joint: **YES**
Remarks:

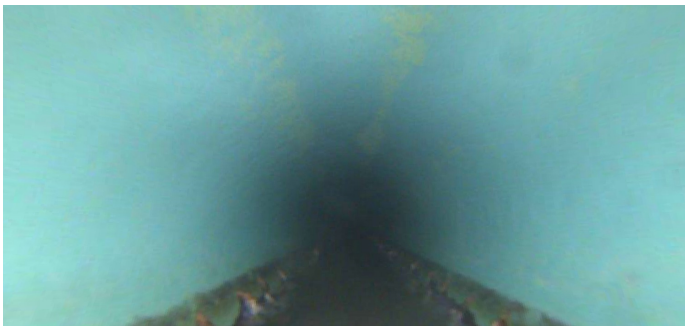
Code: **MSA**
Description: **Abandoned Survey**

Distance (ft): **334.4**
Structural Grade: **0**
O&M Grade: **0**
Clock Start/From:
Clock To:
1st Value:
2nd Value:
Value Percent:
Continuous Index:
Within 8" of Joint: **NO**
Remarks: **camera stopped**
