Profile/Photo Observation Report

Date:	04/05/2018	Weather:		Coding:	PACP 6.0
Pipe Length (ft):	394.2	Owner:	NA	Pre Clean:	Not Known
P.O.#:		Surveyor:	Jen Costello	PSR:	P-808-030-031
Customer:		Clean Date:	01/01/1900	Shape:	C

Street:	Hobart	Flow Control:	Not Controlled
City:	Hobart, IN	Year Renewed:	
Location:	Light Highway	Tape/Media #:	
Purpose:	Maintenance Related	Dia/Height:	12"
Use:	Sanitary	Material:	PVC
Drain Area:	NA	Lining:	Cured in Place
Category:	NA		
Comment:	Flow direction wrong. Reverse setup. Debris at 54'.		
Location Details:		Direction of Survey:	Downstream
US MH:	M-808-031	DS MH:	M-808-030
		Total Length Surveyed (ft):	56.3

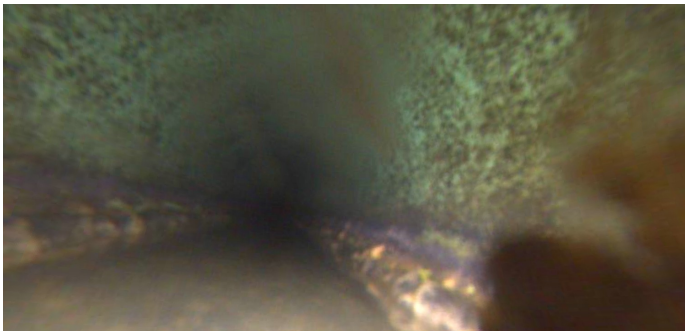
Code: **AMH**
Description: **Manhole**

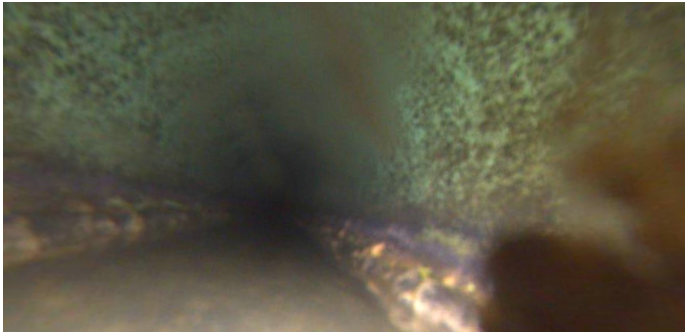
Code:	MWL
Description:	Water Level

Distance (ft):	.0
Structural Grade:	0
O&M Grade:	0
Clock Start/From:	
Clock To:	
1st Value:	
2nd Value:	
Value Percent:	10.000
Continuous Index:	
Within 8" of Joint:	NO
Remarks:

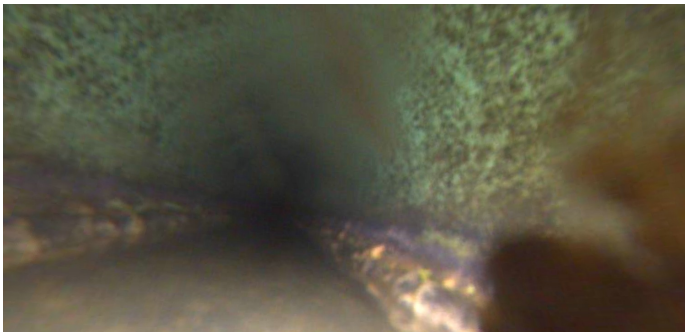
Code:	DAGS
Description:	Deposits Attached Grease

Distance (ft):	.0
Structural Grade:	0
O&M Grade:	2
Clock Start/From:	8
Clock To:	4
1st Value:	
2nd Value:	
Value Percent:	5.000
Continuous Index:	
Within 8" of Joint:	NO
Remarks:

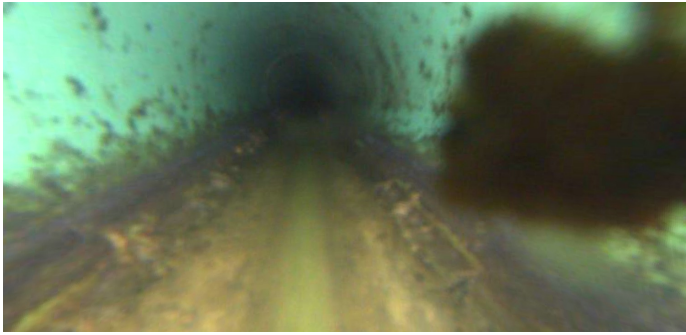
Code: **DAGS**
Description: **Deposits Attached Grease**

Distance (ft): **21.4**
Structural Grade: **0**
O&M Grade: **2**
Clock Start/From: **5**
Clock To: **4**
1st Value:
2nd Value:
Value Percent: **5.000**
Continuous Index: **S01**
Within 8" of Joint: **NO**
Remarks:

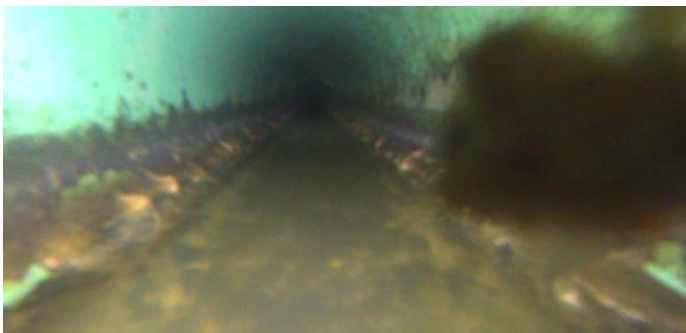
Code: **MSA**
Description: **Abandoned Survey**

Distance (ft): **56.3**
Structural Grade: **0**
O&M Grade: **0**
Clock Start/From:
Clock To:
1st Value:
2nd Value:
Value Percent:
Continuous Index:
Within 8" of Joint: **NO**
Remarks: **DAGS**

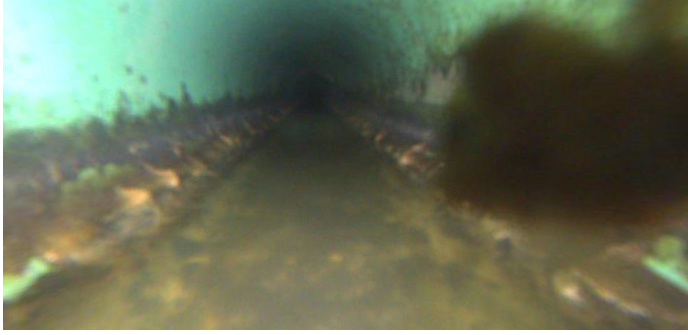
Code:	DAGS
Description:	Deposits Attached Grease
Distance (ft):	56.3
Structural Grade:	0
O&M Grade:	2
Clock Start/From:	5
Clock To:	4
1st Value:	
2nd Value:	
Value Percent:	5.000
Continuous Index:	F01
Within 8" of Joint:	NO
Remarks:
