## Profile/Photo Observation Report

Street:	<b>S HOBART RD</b>	Flow Control:	<b>Not Controlled</b>
City:	<b>Hobart, IN</b>	Year Renewed:	
Location:	<b>Light Highway</b>	Tape/Media #:	
Purpose:	<b>Routine Assessment</b>	Dia/Height:	<b>12"</b>
Use:	<b>Sanitary</b>	Material:	<b>PVC</b>
Drain Area:	<b>NA</b>	Lining:	
Category:	<b>NA</b>		
Comment:

Location Details:		Direction of Survey:	<b>Downstream</b>
US MH:	<b>M-808-031</b>	DS MH:	<b>M-808-030</b>
		Total Length Surveyed (ft):	<b>182.1</b>

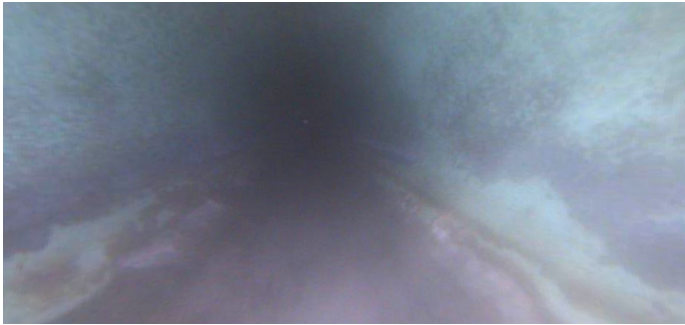
Code:	<b>MWL</b>
Description:	<b>Water Level</b>

Distance (ft):	<b>.0</b>
Structural Grade:	<b>0</b>
O&M Grade:	<b>0</b>
Clock Start/From:	
Clock To:	
1st Value:	
2nd Value:	
Value Percent:	<b>5.000</b>
Continuous Index:	
Within 8" of Joint:	<b>NO</b>
Remarks:

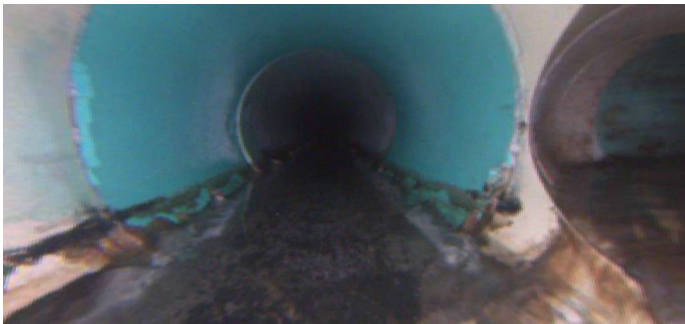
Code:	<b>TF</b>
Description:	<b>Tap Factory</b>

Distance (ft):	<b>121.0</b>
Structural Grade:	<b>0</b>
O&M Grade:	<b>0</b>
Clock Start/From:	<b>3</b>
Clock To:	
1st Value:	<b>4.000</b>
2nd Value:	
Value Percent:	
Continuous Index:	
Within 8" of Joint:	
Remarks:

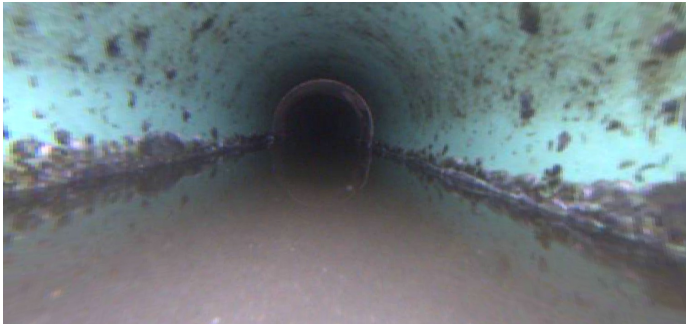
Code:	<b>MSA</b>
Description:	<b>Abandoned Survey</b>
Distance (ft):	<b>182.1</b>
Structural Grade:	<b>0</b>
O&M Grade:	<b>0</b>
Clock Start/From:	
Clock To:	
1st Value:	
2nd Value:	
Value Percent:	
Continuous Index:	
Within 8" of Joint:	<b>NO</b>
Remarks:	<b>camera stopped</b>
