Profile/Photo Observation Report

Date:	03/26/2018	Weather:		Coding:	PACP 6.0
Pipe Length (ft):	272.5	Owner:	NA	Pre Clean:	Not Known
P.O.#:		Surveyor:	Justin Gonzales	PSR:	P-809-001-002
Customer:		Clean Date:	01/01/1900	Shape:	C

Street:	GROSBEAK CT	Flow Control:	Not Controlled
City:	Hobart, IN	Year Renewed:	
Location:	Sidewalk	Tape/Media #:	
Purpose:	Maintenance Related	Dia/Height:	8"
Use:	Sanitary	Material:	PVC
Drain Area:	NA	Lining:	
Category:	NA		
Comment:

Location Details:		Direction of Survey:	Downstream
US MH:	M-809-001	DS MH:	M-809-002
		Total Length Surveyed (ft):	270.1

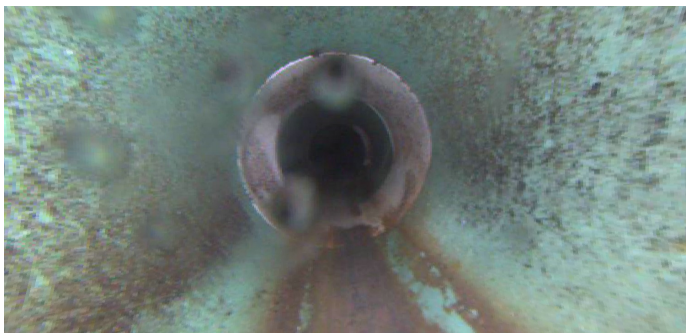
Code: **AMH**
Description: **Manhole**

Distance (ft): **.0**
Structural Grade: **0**
O&M Grade: **0**
Clock Start/From:
Clock To:
1st Value:
2nd Value:
Value Percent:
Continuous Index:
Within 8" of Joint: **NO**
Remarks: **M-809-001**

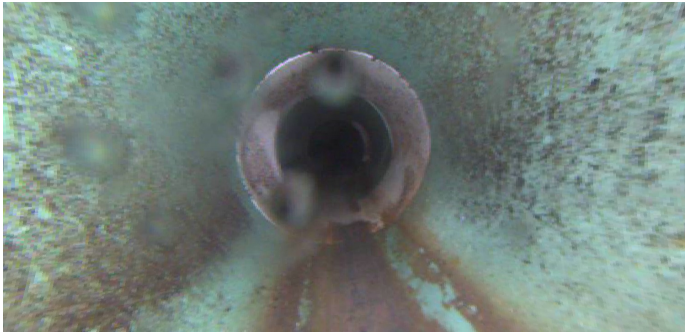
Code: **MWL**
Description: **Water Level**

Distance (ft): **.0**
Structural Grade: **0**
O&M Grade: **0**
Clock Start/From:
Clock To:
1st Value:
2nd Value:
Value Percent: **5.000**
Continuous Index:
Within 8" of Joint: **NO**
Remarks:

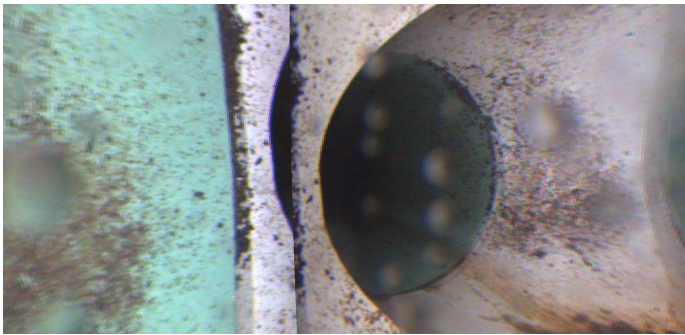
Code: **TF**
Description: **Tap Factory**

Distance (ft): **1.7**
Structural Grade: **0**
O&M Grade: **0**
Clock Start/From: **9**
Clock To:
1st Value: **4.000**
2nd Value:
Value Percent:
Continuous Index:
Within 8" of Joint:
Remarks:

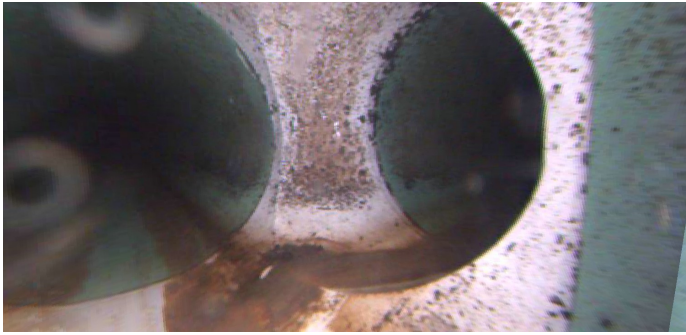
Code: **TF**
Description: **Tap Factory**

Distance (ft): **3.3**
Structural Grade: **0**
O&M Grade: **0**
Clock Start/From: **3**
Clock To:
1st Value: **4.000**
2nd Value:
Value Percent:
Continuous Index:
Within 8" of Joint:
Remarks:

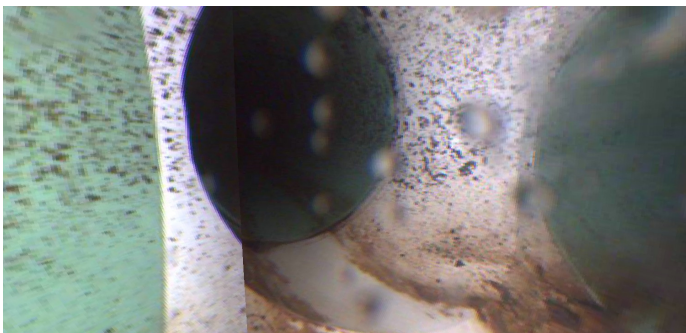
Code: **TF**
Description: **Tap Factory**

Distance (ft): **27.1**
Structural Grade: **0**
O&M Grade: **0**
Clock Start/From: **9**
Clock To:
1st Value: **4.000**
2nd Value:
Value Percent:
Continuous Index:
Within 8" of Joint:
Remarks:

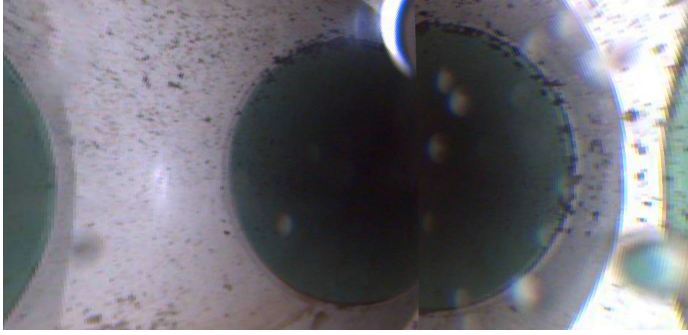
Code: **TF**
Description: **Tap Factory**

Distance (ft): **28.8**
Structural Grade: **0**
O&M Grade: **0**
Clock Start/From: **3**
Clock To:
1st Value: **4.000**
2nd Value:
Value Percent:
Continuous Index:
Within 8" of Joint:
Remarks:

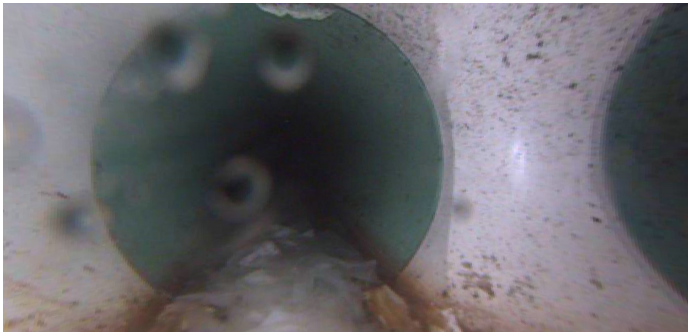
Code: **MGO**
Description: **General Observation**

Distance (ft): **28.8**
Structural Grade: **0**
O&M Grade: **0**
Clock Start/From:
Clock To:
1st Value:
2nd Value:
Value Percent:
Continuous Index:
Within 8" of Joint: **NO**
Remarks: **TOILET TISSUE**

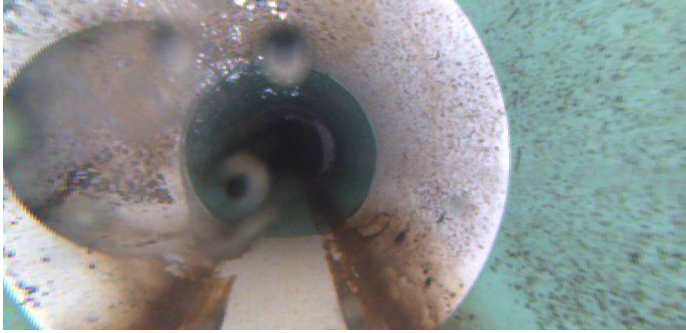
Code: **TF**
Description: **Tap Factory**

Distance (ft): **66.6**
Structural Grade: **0**
O&M Grade: **0**
Clock Start/From: **9**
Clock To:
1st Value: **4.000**
2nd Value:
Value Percent:
Continuous Index:
Within 8" of Joint:
Remarks:

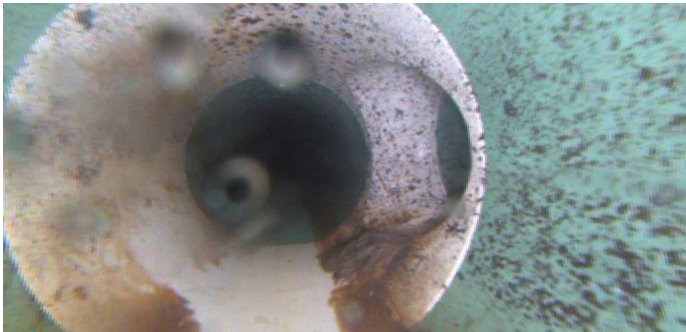
Code: **TF**
Description: **Tap Factory**

Distance (ft): **68.3**
Structural Grade: **0**
O&M Grade: **0**
Clock Start/From: **3**
Clock To:
1st Value: **4.000**
2nd Value:
Value Percent:
Continuous Index:
Within 8" of Joint:
Remarks:

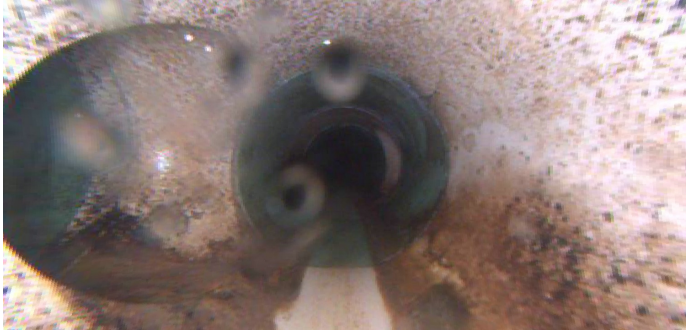
Code: **TF**
Description: **Tap Factory**

Distance (ft): **119.5**
Structural Grade: **0**
O&M Grade: **0**
Clock Start/From: **9**
Clock To:
1st Value: **4.000**
2nd Value:
Value Percent:
Continuous Index:
Within 8" of Joint:
Remarks:

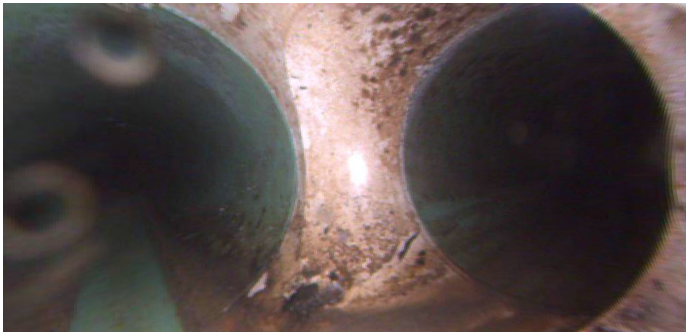
Code: **TF**
Description: **Tap Factory**

Distance (ft): **121.1**
Structural Grade: **0**
O&M Grade: **0**
Clock Start/From: **3**
Clock To:
1st Value: **4.000**
2nd Value:
Value Percent:
Continuous Index:
Within 8" of Joint:
Remarks:

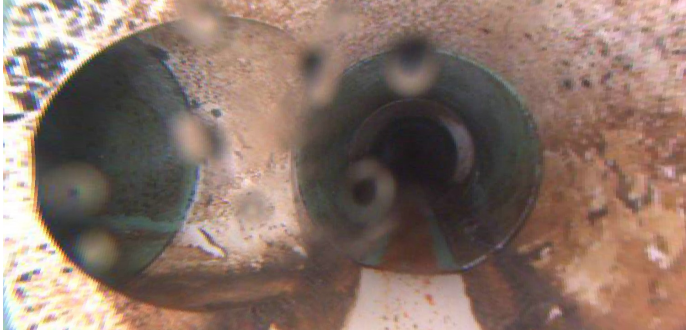
Code: **TF**
Description: **Tap Factory**

Distance (ft): **169.0**
Structural Grade: **0**
O&M Grade: **0**
Clock Start/From: **9**
Clock To:
1st Value: **4.000**
2nd Value:
Value Percent:
Continuous Index:
Within 8" of Joint:
Remarks:

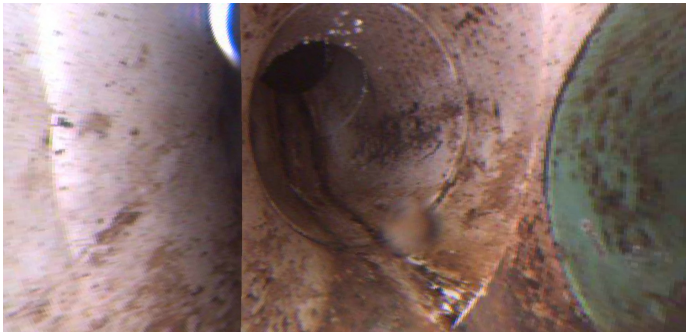
Code: **TF**
Description: **Tap Factory**

Distance (ft): **171.0**
Structural Grade: **0**
O&M Grade: **0**
Clock Start/From: **3**
Clock To:
1st Value: **4.000**
2nd Value:
Value Percent:
Continuous Index:
Within 8" of Joint:
Remarks:

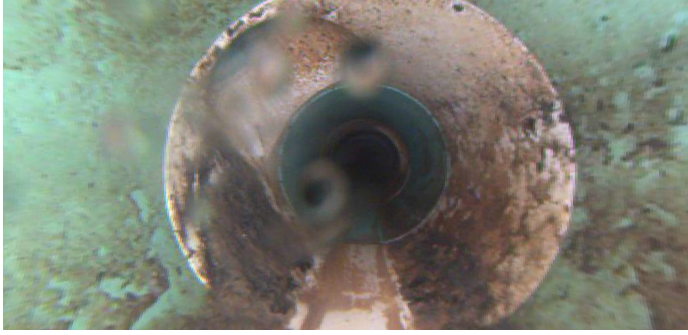
Code: **TF**
Description: **Tap Factory**

Distance (ft): **221.1**
Structural Grade: **0**
O&M Grade: **0**
Clock Start/From: **10**
Clock To:
1st Value: **4.000**
2nd Value:
Value Percent:
Continuous Index:
Within 8" of Joint:
Remarks:

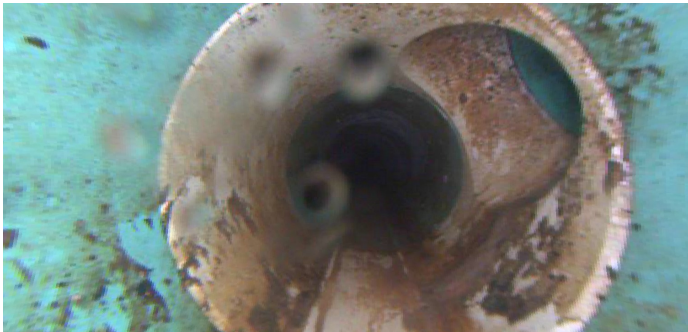
Code: **TF**
Description: **Tap Factory**

Distance (ft): **222.8**
Structural Grade: **0**
O&M Grade: **0**
Clock Start/From: **10**
Clock To:
1st Value: **4.000**
2nd Value:
Value Percent:
Continuous Index:
Within 8" of Joint:
Remarks:

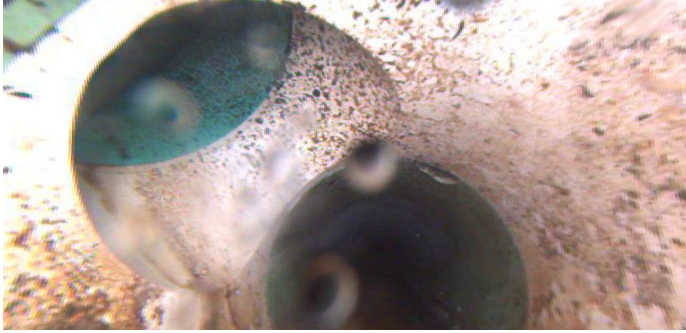
Code: **TF**
Description: **Tap Factory**

Distance (ft): **261.3**
Structural Grade: **0**
O&M Grade: **0**
Clock Start/From: **10**
Clock To:
1st Value: **4.000**
2nd Value:
Value Percent:
Continuous Index:
Within 8" of Joint:
Remarks:

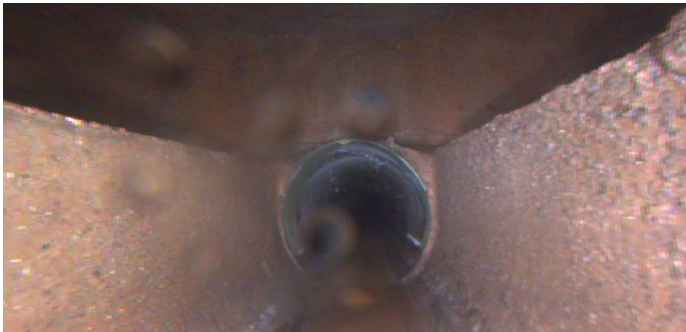
Code: **AMH**
Description: **Manhole**

Distance (ft): **270.1**
Structural Grade: **0**
O&M Grade: **0**
Clock Start/From:
Clock To:
1st Value:
2nd Value:
Value Percent:
Continuous Index:
Within 8" of Joint: **NO**
Remarks: **M-809-002**
