## Profile/Photo Observation Report

Street:	<b>Grosbeak</b>	Flow Control:	<b>Not Controlled</b>
City:	<b>Hobart, IN</b>	Year Renewed:	
Location:	<b>Sidewalk</b>	Tape/Media #:	
Purpose:	<b>Maintenance Related</b>	Dia/Height:	<b>8"</b>
Use:	<b>Sanitary</b>	Material:	<b>PVC</b>
Drain Area:	<b>NA</b>	Lining:	
Category:	<b>NA</b>		
Comment:

Location Details:		Direction of Survey:	<b>Downstream</b>
US MH:	<b>M-809-001</b>	DS MH:	<b>M-809-002</b>
		Total Length Surveyed (ft):	<b>270.1</b>

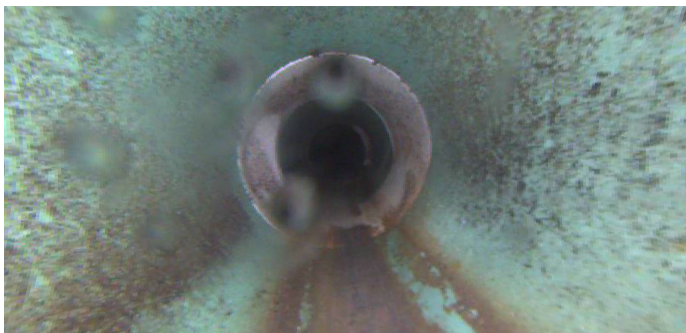
Code: **AMH**  
Description: **Manhole**

Distance (ft): **.0**  
Structural Grade: **0**  
O&M Grade: **0**  
Clock Start/From:  
Clock To:  
1st Value:  
2nd Value:  
Value Percent:  
Continuous Index:  
Within 8" of Joint: **NO**  
Remarks: **M-809-001**

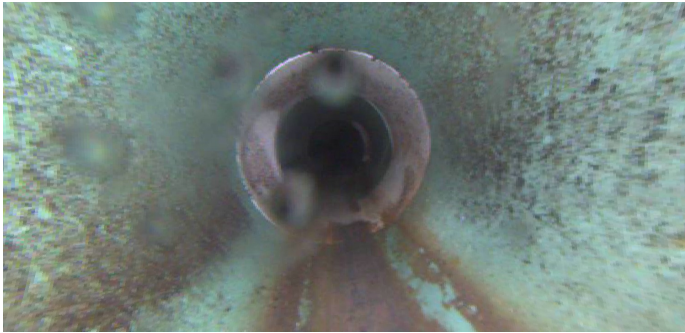
Code: **MWL**  
Description: **Water Level**

Distance (ft): **.0**  
Structural Grade: **0**  
O&M Grade: **0**  
Clock Start/From:  
Clock To:  
1st Value:  
2nd Value:  
Value Percent: **5.000**  
Continuous Index:  
Within 8" of Joint: **NO**  
Remarks:

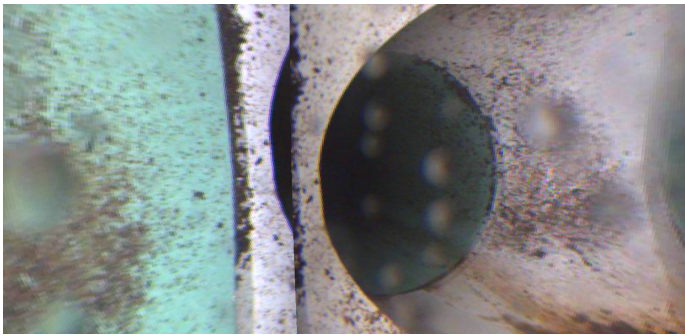
Code: **TF**  
Description: **Tap Factory**

Distance (ft): **1.7**  
Structural Grade: **0**  
O&M Grade: **0**  
Clock Start/From: **9**  
Clock To:  
1st Value: **4.000**  
2nd Value:  
Value Percent:  
Continuous Index:  
Within 8" of Joint:  
Remarks:

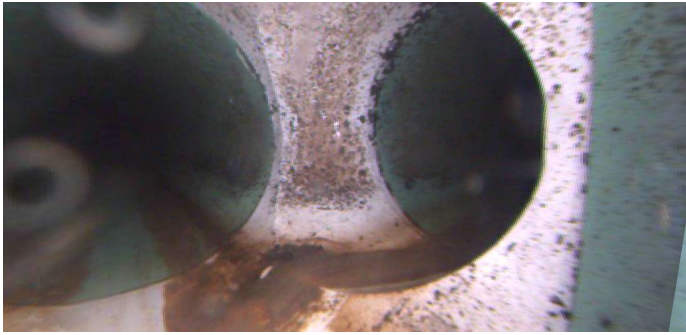
Code: **TF**  
Description: **Tap Factory**

Distance (ft): **3.3**  
Structural Grade: **0**  
O&M Grade: **0**  
Clock Start/From: **3**  
Clock To:  
1st Value: **4.000**  
2nd Value:  
Value Percent:  
Continuous Index:  
Within 8" of Joint:  
Remarks:

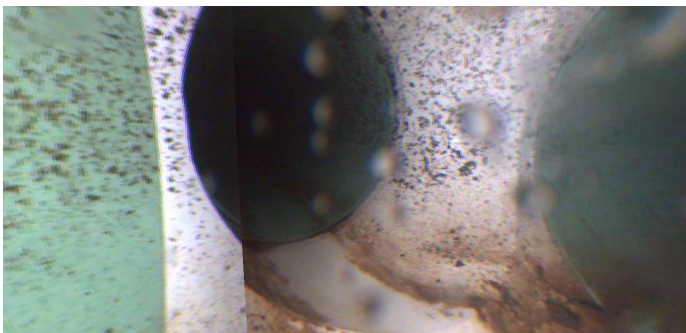
Code: **TF**  
Description: **Tap Factory**

Distance (ft): **27.1**  
Structural Grade: **0**  
O&M Grade: **0**  
Clock Start/From: **9**  
Clock To:  
1st Value: **4.000**  
2nd Value:  
Value Percent:  
Continuous Index:  
Within 8" of Joint:  
Remarks:

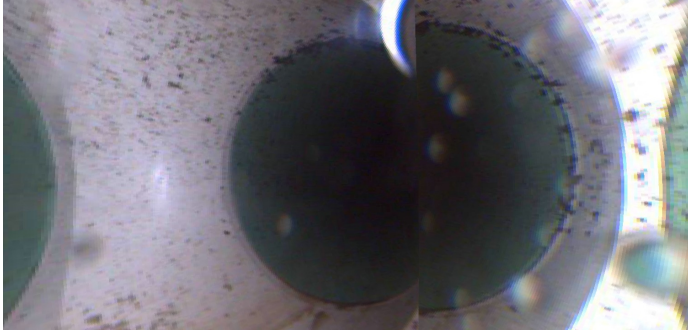
Code: **TF**  
Description: **Tap Factory**

Distance (ft): **28.8**  
Structural Grade: **0**  
O&M Grade: **0**  
Clock Start/From: **3**  
Clock To:  
1st Value: **4.000**  
2nd Value:  
Value Percent:  
Continuous Index:  
Within 8" of Joint:  
Remarks:

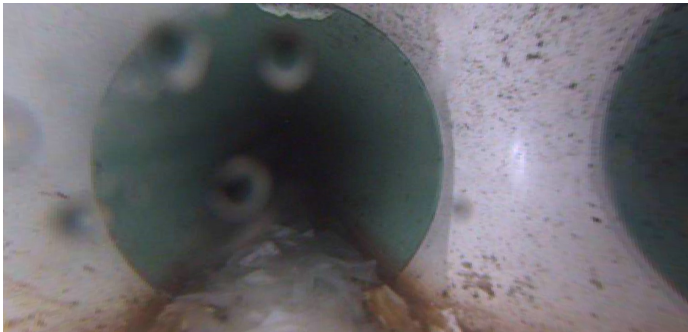
Code: **MGO**  
Description: **General Observation**

Distance (ft): **28.8**  
Structural Grade: **0**  
O&M Grade: **0**  
Clock Start/From:  
Clock To:  
1st Value:  
2nd Value:  
Value Percent:  
Continuous Index:  
Within 8" of Joint: **NO**  
Remarks: **TOILET TISSUE**

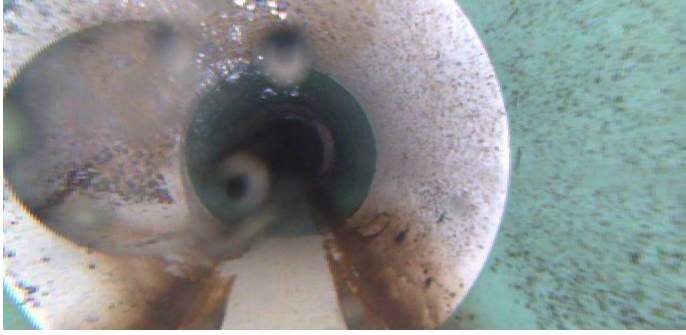
Code: **TF**  
Description: **Tap Factory**

Distance (ft): **66.6**  
Structural Grade: **0**  
O&M Grade: **0**  
Clock Start/From: **9**  
Clock To:  
1st Value: **4.000**  
2nd Value:  
Value Percent:  
Continuous Index:  
Within 8" of Joint:  
Remarks:

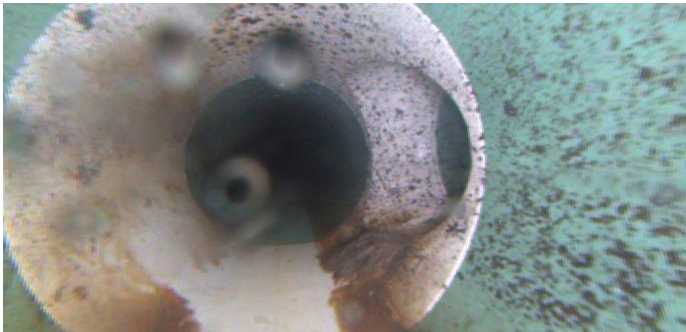
Code: **TF**  
Description: **Tap Factory**

Distance (ft): **68.3**  
Structural Grade: **0**  
O&M Grade: **0**  
Clock Start/From: **3**  
Clock To:  
1st Value: **4.000**  
2nd Value:  
Value Percent:  
Continuous Index:  
Within 8" of Joint:  
Remarks:

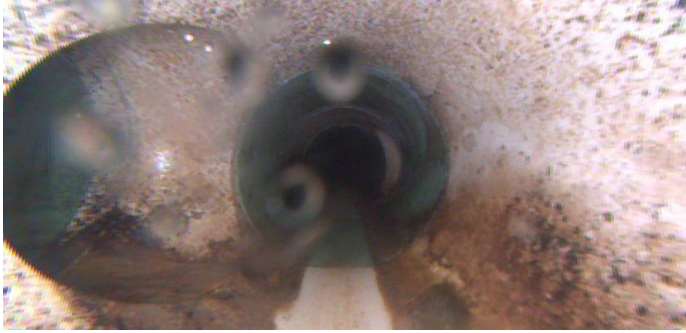
Code: **TF**  
Description: **Tap Factory**

Distance (ft): **119.5**  
Structural Grade: **0**  
O&M Grade: **0**  
Clock Start/From: **9**  
Clock To:  
1st Value: **4.000**  
2nd Value:  
Value Percent:  
Continuous Index:  
Within 8" of Joint:  
Remarks:

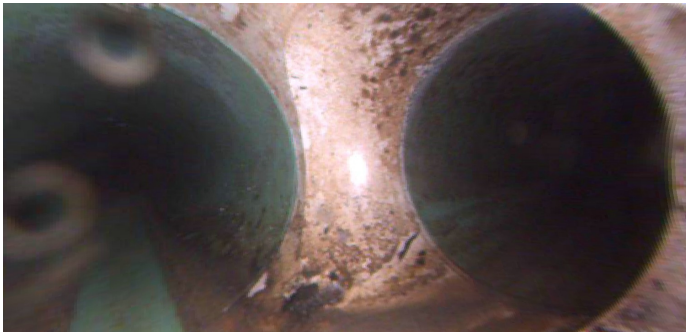
Code: **TF**  
Description: **Tap Factory**

Distance (ft): **121.1**  
Structural Grade: **0**  
O&M Grade: **0**  
Clock Start/From: **3**  
Clock To:  
1st Value: **4.000**  
2nd Value:  
Value Percent:  
Continuous Index:  
Within 8" of Joint:  
Remarks:

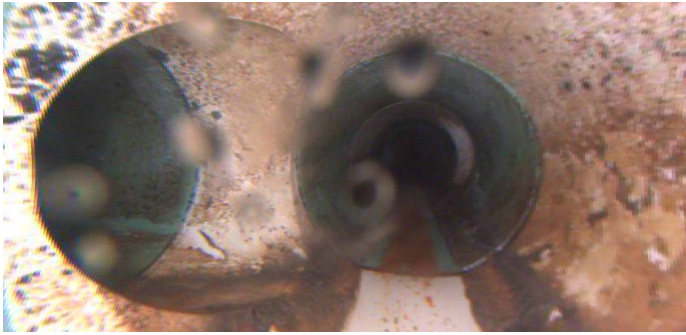
Code: **TF**  
Description: **Tap Factory**

Distance (ft): **169.0**  
Structural Grade: **0**  
O&M Grade: **0**  
Clock Start/From: **9**  
Clock To:  
1st Value: **4.000**  
2nd Value:  
Value Percent:  
Continuous Index:  
Within 8" of Joint:  
Remarks:

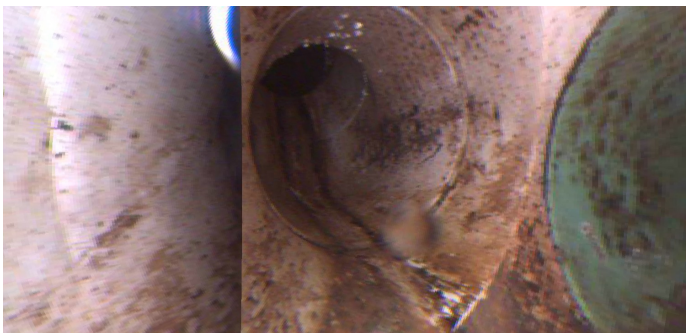
Code: **TF**  
Description: **Tap Factory**

Distance (ft): **171.0**  
Structural Grade: **0**  
O&M Grade: **0**  
Clock Start/From: **3**  
Clock To:  
1st Value: **4.000**  
2nd Value:  
Value Percent:  
Continuous Index:  
Within 8" of Joint:  
Remarks:

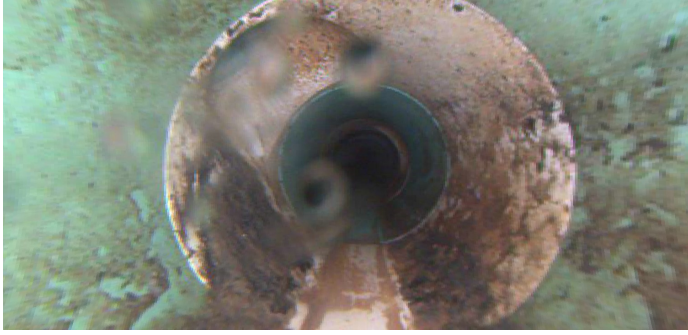
Code: **TF**  
Description: **Tap Factory**

Distance (ft): **221.1**  
Structural Grade: **0**  
O&M Grade: **0**  
Clock Start/From: **10**  
Clock To:  
1st Value: **4.000**  
2nd Value:  
Value Percent:  
Continuous Index:  
Within 8" of Joint:  
Remarks:

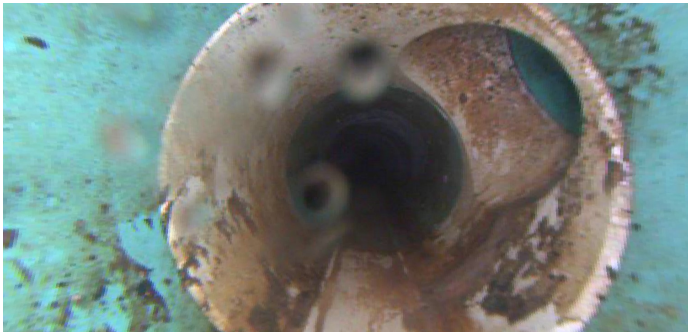
Code: **TF**  
Description: **Tap Factory**

Distance (ft): **222.8**  
Structural Grade: **0**  
O&M Grade: **0**  
Clock Start/From: **10**  
Clock To:  
1st Value: **4.000**  
2nd Value:  
Value Percent:  
Continuous Index:  
Within 8" of Joint:  
Remarks:

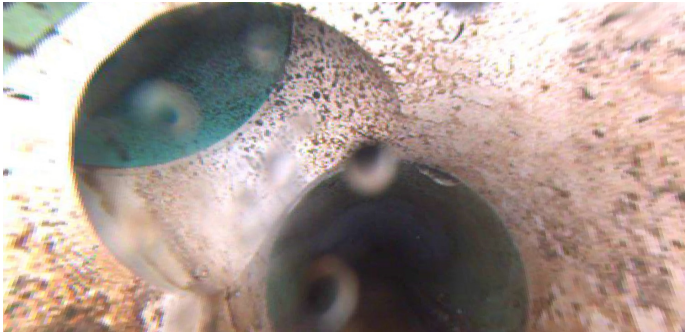
Code: **TF**  
Description: **Tap Factory**

Distance (ft): **261.3**  
Structural Grade: **0**  
O&M Grade: **0**  
Clock Start/From: **10**  
Clock To:  
1st Value: **4.000**  
2nd Value:  
Value Percent:  
Continuous Index:  
Within 8" of Joint:  
Remarks:

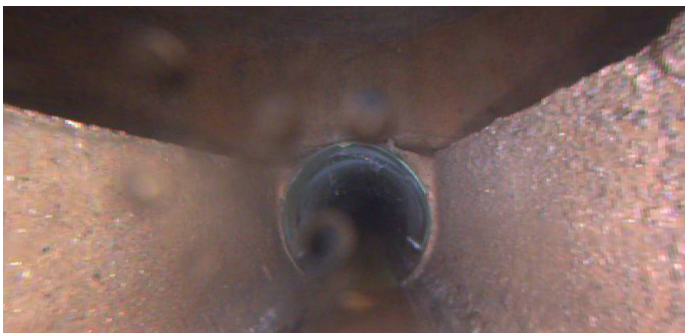
Code: **AMH**  
Description: **Manhole**

Distance (ft): **270.1**  
Structural Grade: **0**  
O&M Grade: **0**  
Clock Start/From:  
Clock To:  
1st Value:  
2nd Value:  
Value Percent:  
Continuous Index:  
Within 8" of Joint: **NO**  
Remarks: **M-809-002**
