Profile/Photo Observation Report

Street:	Grosbeak	Flow Control:	Not Controlled
City:	Hobart, IN	Year Renewed:	
Location:	Sidewalk	Tape/Media #:	
Purpose:	Maintenance Related	Dia/Height:	8"
Use:	Sanitary	Material:	PVC
Drain Area:	NA	Lining:	
Category:	NA		
Comment:

Location Details:		Direction of Survey:	Upstream
US MH:	M-809-002	DS MH:	M-809-003
		Total Length Surveyed (ft):	72.4

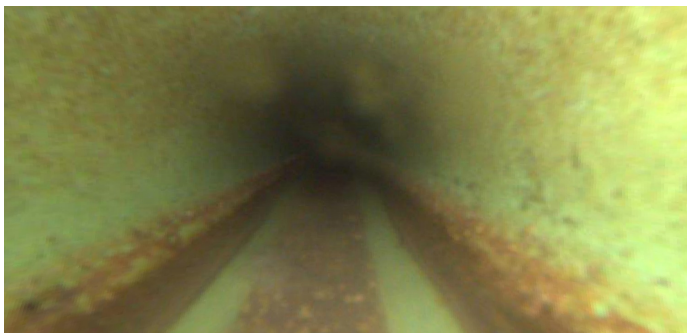
Code: **AMH**
Description: **Manhole**

Distance (ft): **.0**
Structural Grade: **0**
O&M Grade: **0**
Clock Start/From:
Clock To:
1st Value:
2nd Value:
Value Percent:
Continuous Index:
Within 8" of Joint: **NO**
Remarks: **M-809-003**

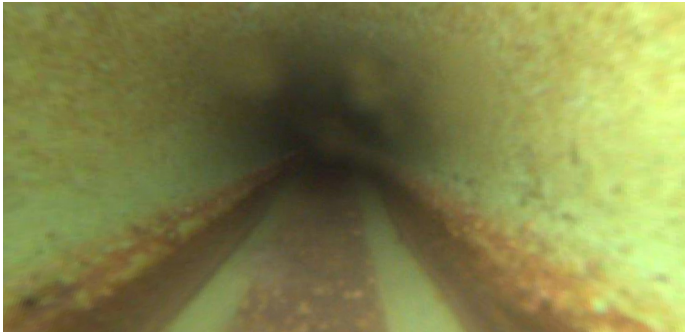
Code:	MWL
Description:	Water Level

Distance (ft):	.0
Structural Grade:	0
O&M Grade:	0
Clock Start/From:	
Clock To:	
1st Value:	
2nd Value:	
Value Percent:	5.000
Continuous Index:	
Within 8" of Joint:	NO
Remarks:

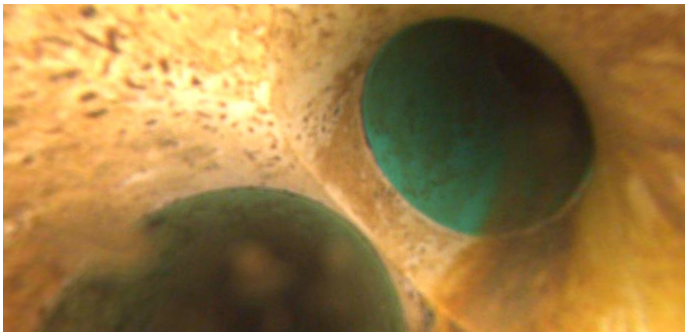
Code:	TF
Description:	Tap Factory

Distance (ft):	10.4
Structural Grade:	0
O&M Grade:	0
Clock Start/From:	2
Clock To:	
1st Value:	4.000
2nd Value:	
Value Percent:	
Continuous Index:	
Within 8" of Joint:	
Remarks:

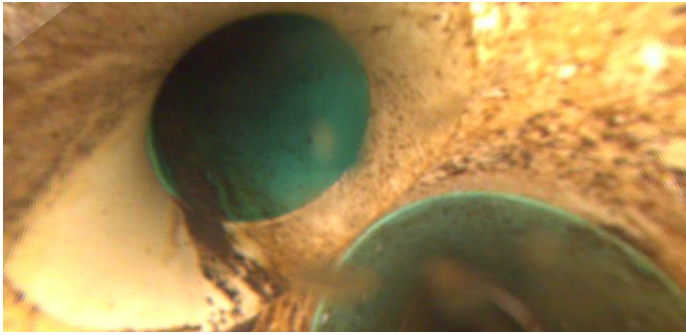
Code: **TF**
Description: **Tap Factory**

Distance (ft): **51.1**
Structural Grade: **0**
O&M Grade: **0**
Clock Start/From: **11**
Clock To:
1st Value: **4.000**
2nd Value:
Value Percent:
Continuous Index:
Within 8" of Joint: **YES**
Remarks:

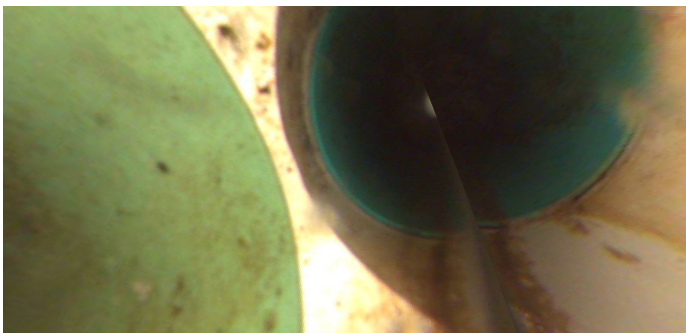
Code: **TF**
Description: **Tap Factory**

Distance (ft): **53.3**
Structural Grade: **0**
O&M Grade: **0**
Clock Start/From: **1**
Clock To:
1st Value: **4.000**
2nd Value:
Value Percent:
Continuous Index:
Within 8" of Joint: **YES**
Remarks:

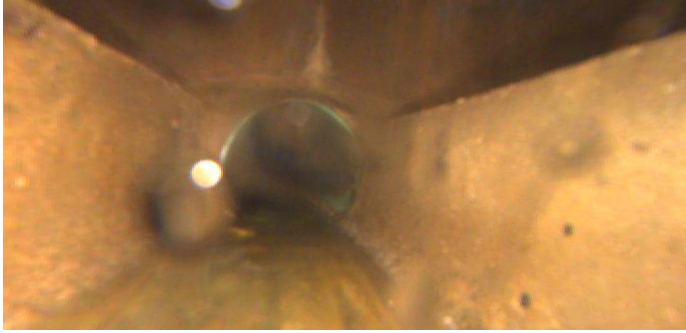
Code:	AMH
Description:	Manhole
Distance (ft):	72.4
Structural Grade:	0
O&M Grade:	0
Clock Start/From:	
Clock To:	
1st Value:	
2nd Value:	
Value Percent:	
Continuous Index:	
Within 8" of Joint:	NO
Remarks:	M-809-002
