Profile/Photo Observation Report

Street:	GROSBEAK CT	Flow Control:	Not Controlled
City:	Hobart, IN	Year Renewed:	
Location:	Sidewalk	Tape/Media #:	
Purpose:	Maintenance Related	Dia/Height:	8"
Use:	Sanitary	Material:	PVC
Drain Area:	NA	Lining:	
Category:	NA		
Comment:

Location Details:		Direction of Survey:	Downstream
US MH:	M-809-003	DS MH:	M-809-004
		Total Length Surveyed (ft):	81.0

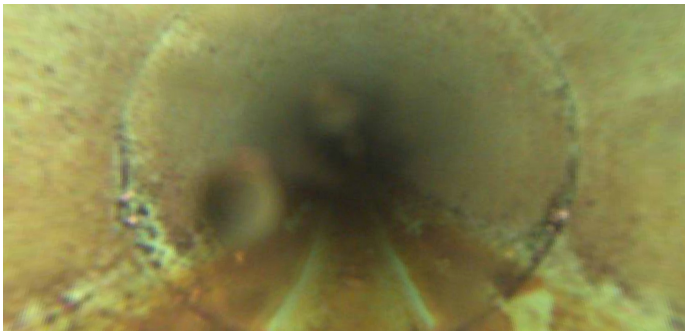
Code: **AMH**
Description: **Manhole**

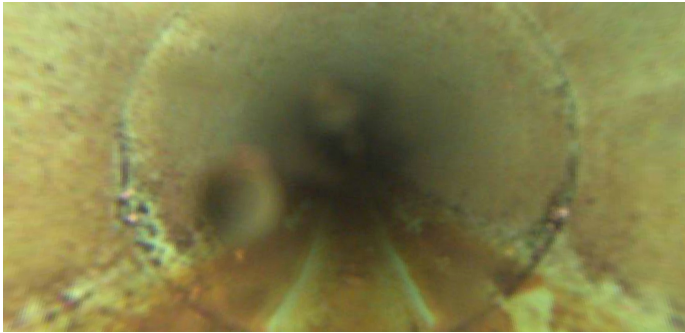
Code:	MWL
Description:	Water Level

Distance (ft):	.0
Structural Grade:	0
O&M Grade:	0
Clock Start/From:	
Clock To:	
1st Value:	
2nd Value:	
Value Percent:	5.000
Continuous Index:	
Within 8" of Joint:	NO
Remarks:

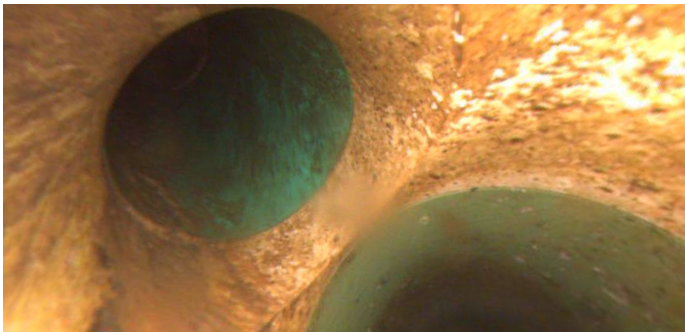
Code:	TF
Description:	Tap Factory

Distance (ft):	14.8
Structural Grade:	0
O&M Grade:	0
Clock Start/From:	1
Clock To:	
1st Value:	4.000
2nd Value:	
Value Percent:	
Continuous Index:	
Within 8" of Joint:	
Remarks:

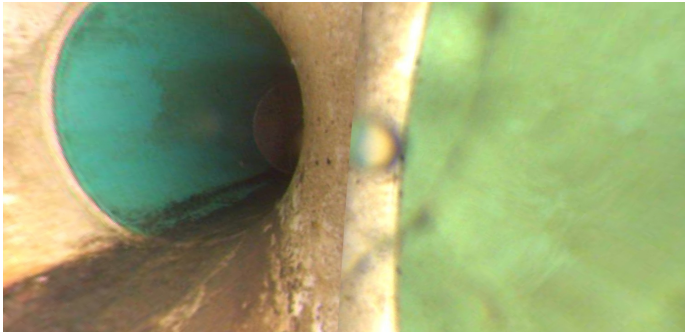
Code: **TF**
Description: **Tap Factory**

Distance (ft): **27.9**
Structural Grade: **0**
O&M Grade: **0**
Clock Start/From: **10**
Clock To:
1st Value: **4.000**
2nd Value:
Value Percent:
Continuous Index:
Within 8" of Joint:
Remarks:

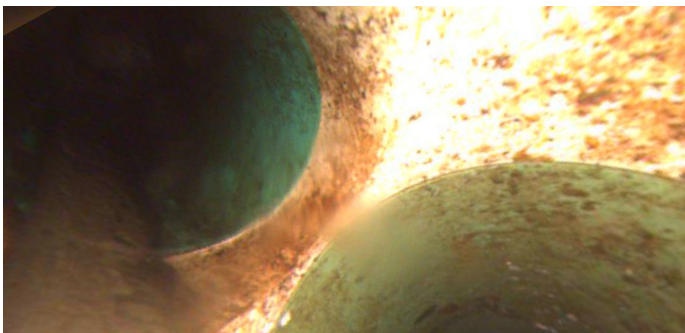
Code: **TF**
Description: **Tap Factory**

Distance (ft): **66.3**
Structural Grade: **0**
O&M Grade: **0**
Clock Start/From: **1**
Clock To:
1st Value: **4.000**
2nd Value:
Value Percent:
Continuous Index:
Within 8" of Joint:
Remarks:

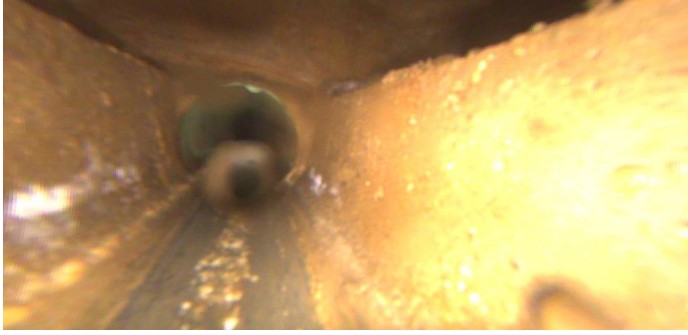
Code:	AMH
Description:	Manhole
Distance (ft):	81.0
Structural Grade:	0
O&M Grade:	0
Clock Start/From:	
Clock To:	
1st Value:	
2nd Value:	
Value Percent:	
Continuous Index:	
Within 8" of Joint:	NO
Remarks:	M-809-004
