Profile/Photo Observation Report

Date:	03/26/2018	Weather:		Coding:	PACP 6.0
Pipe Length (ft):	83.5	Owner:	NA	Pre Clean:	Not Known
P.O.#:		Surveyor:	Byrd Fitzgerald	PSR:	P-809-003-004
Customer:		Clean Date:	01/01/1900	Shape:	C

Street:	Grosbeak	Flow Control:	Not Controlled
City:	Hobart, IN	Year Renewed:	
Location:	Sidewalk	Tape/Media #:	
Purpose:	Maintenance Related	Dia/Height:	8"
Use:	Sanitary	Material:	PVC
Drain Area:	NA	Lining:	
Category:	NA		
Comment:			
Location Details:		Direction of Survey:	Downstream
US MH:	M-809-003	DS MH:	M-809-004
		Total Length Surveyed (ft):	81.0

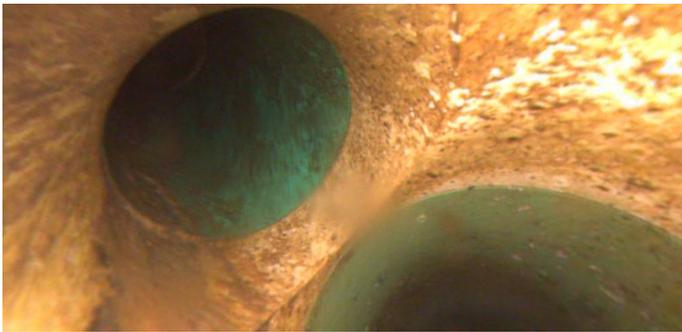
Code: **TF**
Description: **Tap Factory**

Distance (ft): **14.8**
Structural Grade: **0**
O&M Grade: **0**
Clock Start/From: **1**
Clock To:
1st Value: **4.000**
2nd Value:
Value Percent:
Continuous Index:
Within 8" of Joint:
Remarks:

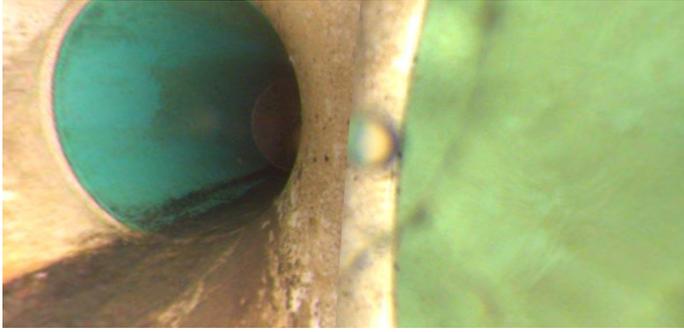
Code: **TF**
Description: **Tap Factory**

Distance (ft): **27.9**
Structural Grade: **0**
O&M Grade: **0**
Clock Start/From: **10**
Clock To:
1st Value: **4.000**
2nd Value:
Value Percent:
Continuous Index:
Within 8" of Joint:
Remarks:

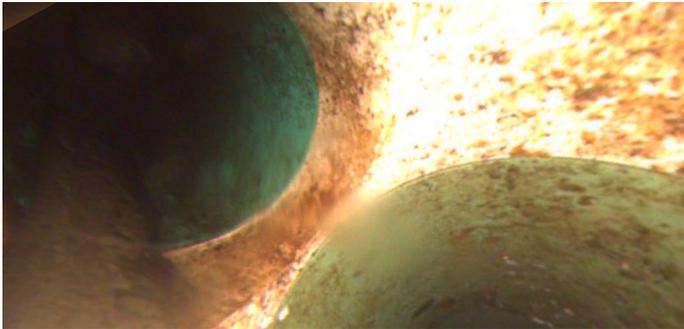
Code: **TF**
Description: **Tap Factory**

Distance (ft): **66.3**
Structural Grade: **0**
O&M Grade: **0**
Clock Start/From: **1**
Clock To:
1st Value: **4.000**
2nd Value:
Value Percent:
Continuous Index:
Within 8" of Joint:
Remarks:

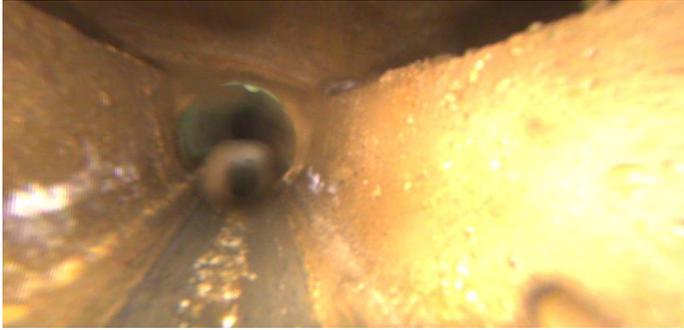
Code: **AMH**
Description: **Manhole**

Distance (ft): **81.0**
Structural Grade: **0**
O&M Grade: **0**
Clock Start/From:
Clock To:
1st Value:
2nd Value:
Value Percent:
Continuous Index:
Within 8" of Joint: **NO**
Remarks: **M-809-004**
