## Profile/Photo Observation Report

Street:	<b>GROSBEAK CT</b>	Flow Control:	<b>Not Controlled</b>
City:	<b>Hobart, IN</b>	Year Renewed:	
Location:	<b>Sidewalk</b>	Tape/Media #:	
Purpose:	<b>Maintenance Related</b>	Dia/Height:	<b>8"</b>
Use:	<b>Sanitary</b>	Material:	<b>PVC</b>
Drain Area:	<b>NA</b>	Lining:	
Category:	<b>NA</b>		
Comment:

Location Details:		Direction of Survey:	<b>Upstream</b>
US MH:	<b>M-809-004</b>	DS MH:	<b>M-809-005</b>
		Total Length Surveyed (ft):	<b>99.9</b>

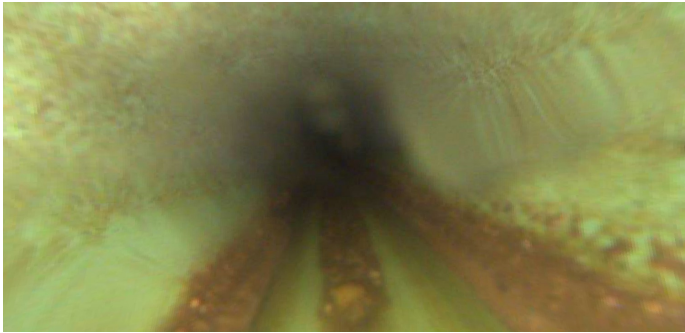
Code:	<b>MWL</b>
Description:	<b>Water Level</b>

Distance (ft):	<b>.0</b>
Structural Grade:	<b>0</b>
O&M Grade:	<b>0</b>
Clock Start/From:	
Clock To:	
1st Value:	
2nd Value:	
Value Percent:	<b>5.000</b>
Continuous Index:	
Within 8" of Joint:	<b>NO</b>
Remarks:

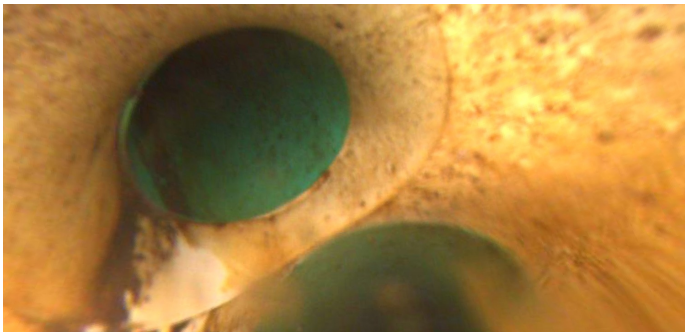
Code:	<b>TF</b>
Description:	<b>Tap Factory</b>

Distance (ft):	<b>25.9</b>
Structural Grade:	<b>0</b>
O&M Grade:	<b>0</b>
Clock Start/From:	<b>11</b>
Clock To:	
1st Value:	<b>4.000</b>
2nd Value:	
Value Percent:	
Continuous Index:	
Within 8" of Joint:	
Remarks:

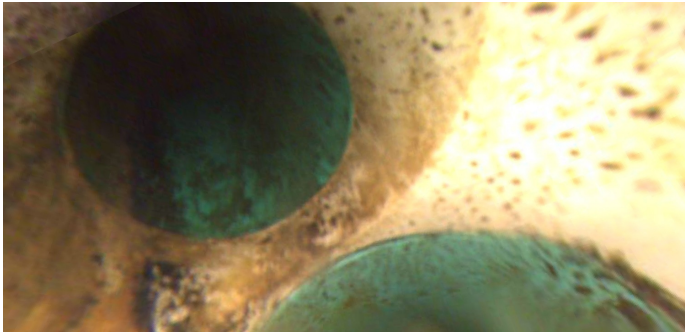
Code: **TF**  
Description: **Tap Factory**

Distance (ft): **64.6**  
Structural Grade: **0**  
O&M Grade: **0**  
Clock Start/From: **11**  
Clock To:  
1st Value: **4.000**  
2nd Value:  
Value Percent:  
Continuous Index:  
Within 8" of Joint:  
Remarks:

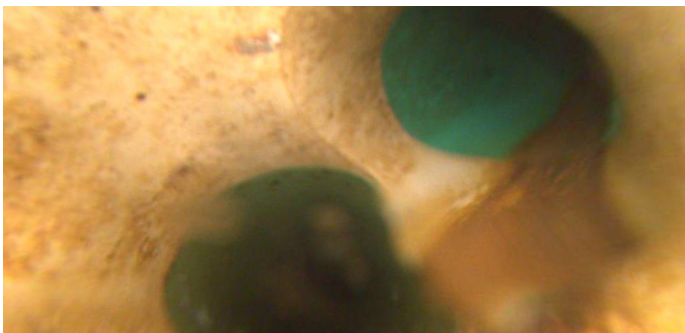
Code: **TF**  
Description: **Tap Factory**

Distance (ft): **65.9**  
Structural Grade: **0**  
O&M Grade: **0**  
Clock Start/From: **1**  
Clock To:  
1st Value: **4.000**  
2nd Value:  
Value Percent:  
Continuous Index:  
Within 8" of Joint:  
Remarks:

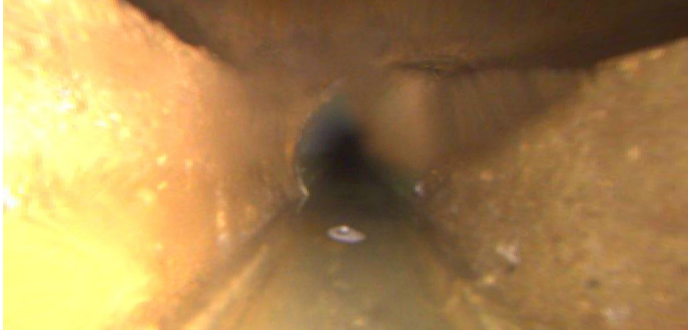
Code:	AMH
Description:	Manhole
Distance (ft):	99.0
Structural Grade:	0
O&M Grade:	0
Clock Start/From:	
Clock To:	
1st Value:	
2nd Value:	
Value Percent:	
Continuous Index:	
Within 8" of Joint:	NO
Remarks:	M-809-004
