Profile/Photo Observation Report

Street:	Grosbeak	Flow Control:	Not Controlled
City:	Hobart, IN	Year Renewed:	
Location:	Sidewalk	Tape/Media #:	
Purpose:	Maintenance Related	Dia/Height:	8"
Use:	Sanitary	Material:	PVC
Drain Area:	NA	Lining:	
Category:	NA		
Comment:

Location Details:		Direction of Survey:	Upstream
US MH:	M-809-004	DS MH:	M-809-005
		Total Length Surveyed (ft):	99.9

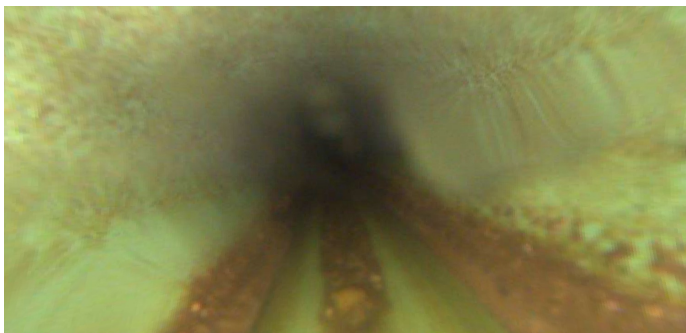
Code: **AMH**
Description: **Manhole**

Distance (ft): **.0**
Structural Grade: **0**
O&M Grade: **0**
Clock Start/From:
Clock To:
1st Value:
2nd Value:
Value Percent:
Continuous Index:
Within 8" of Joint: **NO**
Remarks: **M-809-005**

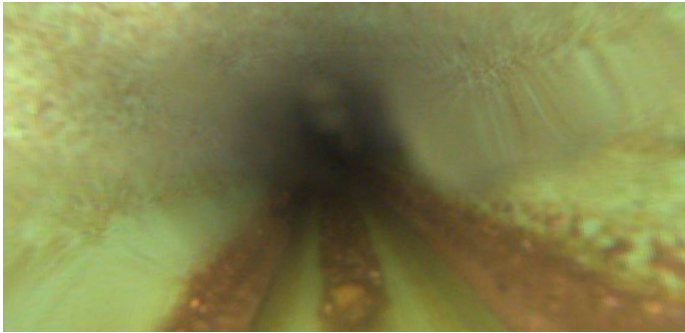
Code:	MWL
Description:	Water Level

Distance (ft):	.0
Structural Grade:	0
O&M Grade:	0
Clock Start/From:	
Clock To:	
1st Value:	
2nd Value:	
Value Percent:	5.000
Continuous Index:	
Within 8" of Joint:	NO
Remarks:

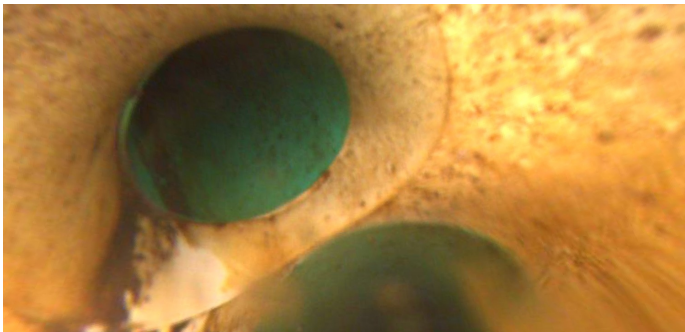
Code:	TF
Description:	Tap Factory

Distance (ft):	25.9
Structural Grade:	0
O&M Grade:	0
Clock Start/From:	11
Clock To:	
1st Value:	4.000
2nd Value:	
Value Percent:	
Continuous Index:	
Within 8" of Joint:	
Remarks:

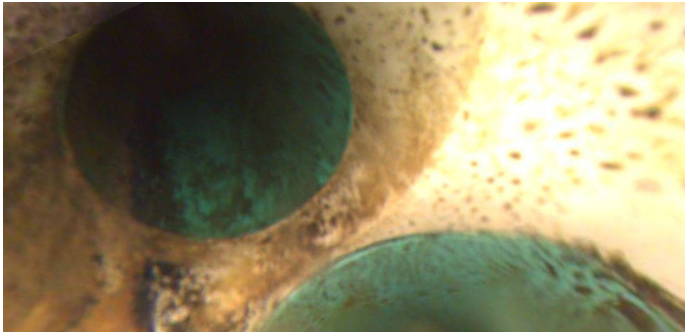
Code: **TF**
Description: **Tap Factory**

Distance (ft): **64.6**
Structural Grade: **0**
O&M Grade: **0**
Clock Start/From: **11**
Clock To:
1st Value: **4.000**
2nd Value:
Value Percent:
Continuous Index:
Within 8" of Joint:
Remarks:

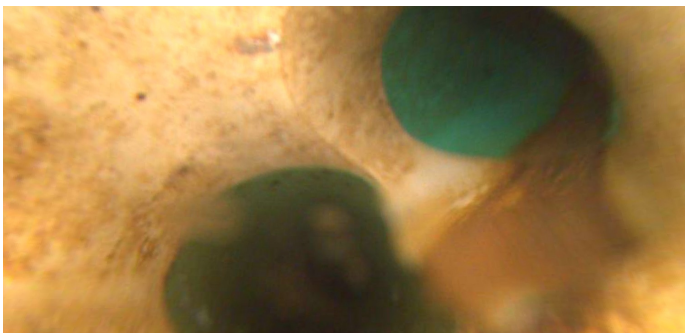
Code: **TF**
Description: **Tap Factory**

Distance (ft): **65.9**
Structural Grade: **0**
O&M Grade: **0**
Clock Start/From: **1**
Clock To:
1st Value: **4.000**
2nd Value:
Value Percent:
Continuous Index:
Within 8" of Joint:
Remarks:

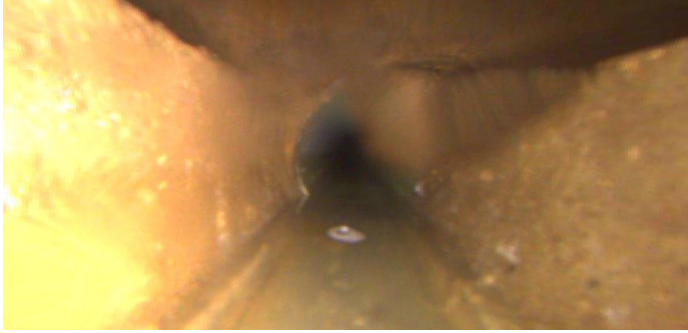
Code:	AMH
Description:	Manhole
Distance (ft):	99.0
Structural Grade:	0
O&M Grade:	0
Clock Start/From:	
Clock To:	
1st Value:	
2nd Value:	
Value Percent:	
Continuous Index:	
Within 8" of Joint:	NO
Remarks:	M-809-004
