Profile/Photo Observation Report

Date:	03/26/2018	Weather:		Coding:	PACP 6.0
Pipe Length (ft):	101.3	Owner:	NA	Pre Clean:	Not Known
P.O.#:		Surveyor:	Byrd Fitzgerald	PSR:	P-809-005-006
Customer:		Clean Date:	01/01/1900	Shape:	C

Street:	Grosbeak	Flow Control:	Not Controlled
City:	Hobart, IN	Year Renewed:	
Location:	Sidewalk	Tape/Media #:	
Purpose:	Maintenance Related	Dia/Height:	8"
Use:	Sanitary	Material:	PVC
Drain Area:	NA	Lining:	
Category:	NA		
Comment:

Location Details:		Direction of Survey:	Downstream
US MH:	M-809-005	DS MH:	M-809-006
		Total Length Surveyed (ft):	99.9

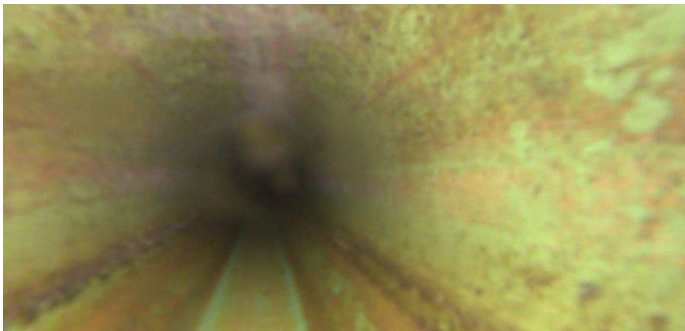
Code: **AMH**
Description: **Manhole**

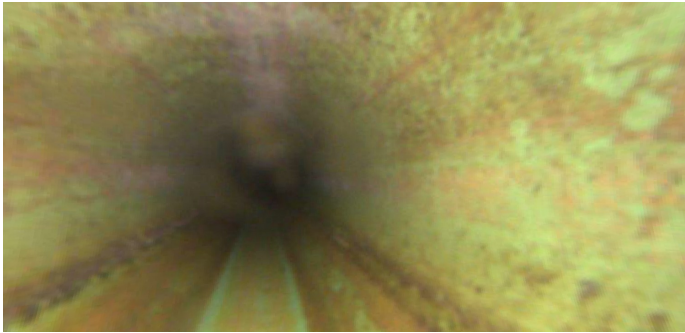
Code:	MWL
Description:	Water Level

Distance (ft):	.0
Structural Grade:	0
O&M Grade:	0
Clock Start/From:	
Clock To:	
1st Value:	
2nd Value:	
Value Percent:	5.000
Continuous Index:	
Within 8" of Joint:	NO
Remarks:

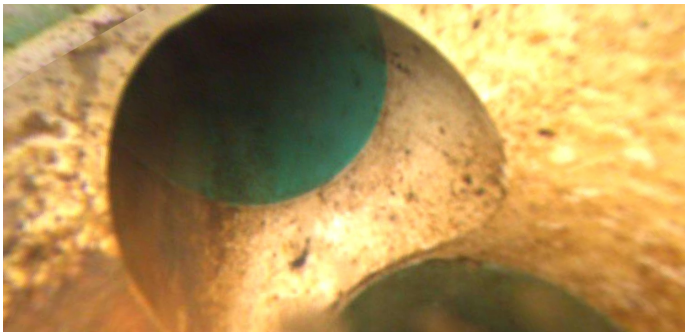
Code:	TF
Description:	Tap Factory

Distance (ft):	19.1
Structural Grade:	0
O&M Grade:	0
Clock Start/From:	11
Clock To:	
1st Value:	4.000
2nd Value:	
Value Percent:	
Continuous Index:	
Within 8" of Joint:	
Remarks:

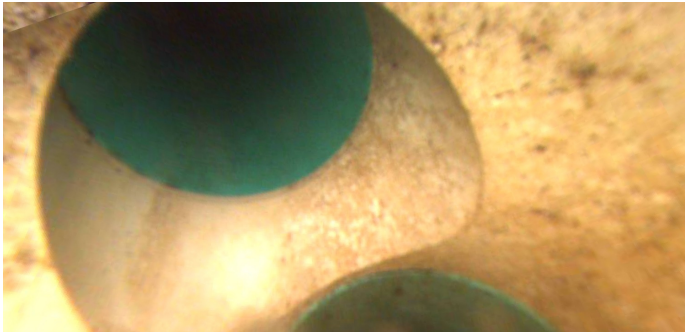
Code: **TF**
Description: **Tap Factory**

Distance (ft): **57.9**
Structural Grade: **0**
O&M Grade: **0**
Clock Start/From: **11**
Clock To:
1st Value: **4.000**
2nd Value:
Value Percent:
Continuous Index:
Within 8" of Joint:
Remarks:

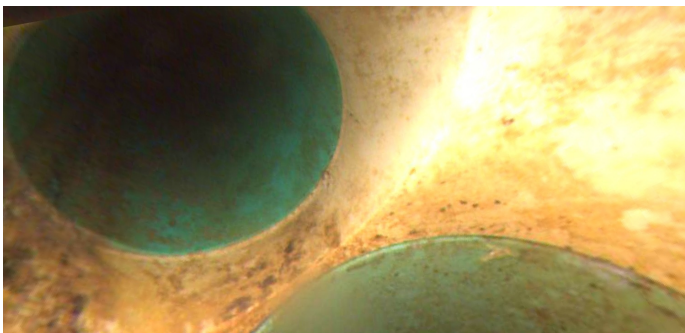
Code: **TF**
Description: **Tap Factory**

Distance (ft): **59.8**
Structural Grade: **0**
O&M Grade: **0**
Clock Start/From: **1**
Clock To:
1st Value: **4.000**
2nd Value:
Value Percent:
Continuous Index:
Within 8" of Joint:
Remarks:

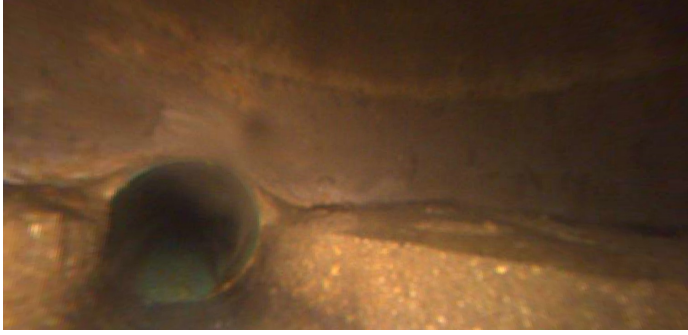
Code:	AMH
Description:	Manhole
Distance (ft):	99.9
Structural Grade:	0
O&M Grade:	0
Clock Start/From:	
Clock To:	
1st Value:	
2nd Value:	
Value Percent:	
Continuous Index:	
Within 8" of Joint:	NO
Remarks:	M-809-006
