## Profile/Photo Observation Report

Street:	<b>GROSBEAK CT &amp; TANAGER ST</b>	Flow Control:	<b>Not Controlled</b>
City:	<b>Hobart, IN</b>	Year Renewed:	
Location:	<b>Sidewalk</b>	Tape/Media #:	
Purpose:	<b>Maintenance Related</b>	Dia/Height:	<b>8"</b>
Use:	<b>Sanitary</b>	Material:	<b>PVC</b>
Drain Area:	<b>NA</b>	Lining:	
Category:	<b>NA</b>		
Comment:	<b>Reverse setup.</b>

Location Details:		Direction of Survey:	<b>Upstream</b>
US MH:	<b>M-809-007</b>	DS MH:	<b>M-809-006</b>
		Total Length Surveyed (ft):	<b>310.3</b>

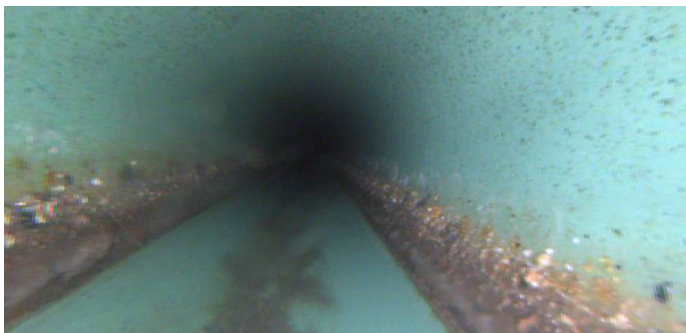
Code: **AMH**  
Description: **Manhole**

Distance (ft): **.0**  
Structural Grade: **0**  
O&M Grade: **0**  
Clock Start/From:  
Clock To:  
1st Value:  
2nd Value:  
Value Percent:  
Continuous Index:  
Within 8" of Joint: **NO**  
Remarks: **M-809-006**

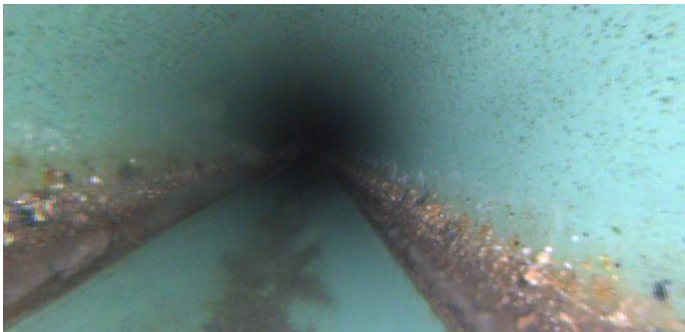
Code:	<b>DAZ</b>
Description:	<b>Deposits Attached Other</b>

Distance (ft):	<b>.0</b>
Structural Grade:	<b>0</b>
O&M Grade:	<b>2</b>
Clock Start/From:	<b>7</b>
Clock To:	<b>5</b>
1st Value:	
2nd Value:	
Value Percent:	<b>5.000</b>
Continuous Index:	<b>S01</b>
Within 8" of Joint:	<b>YES</b>
Remarks:	<b>WANDER</b>

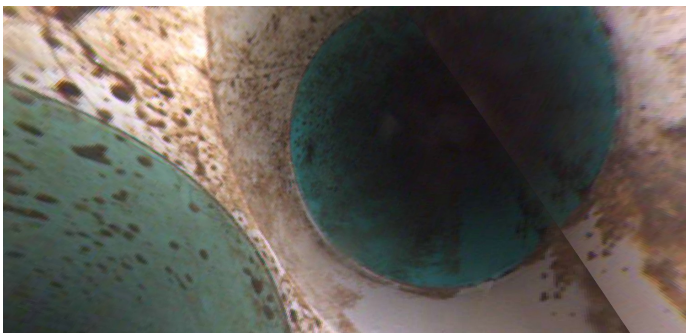
Code: **TF**  
Description: **Tap Factory**

Distance (ft): **89.9**  
Structural Grade: **0**  
O&M Grade: **0**  
Clock Start/From: **2**  
Clock To:  
1st Value: **4.000**  
2nd Value:  
Value Percent:  
Continuous Index:  
Within 8" of Joint:  
Remarks:

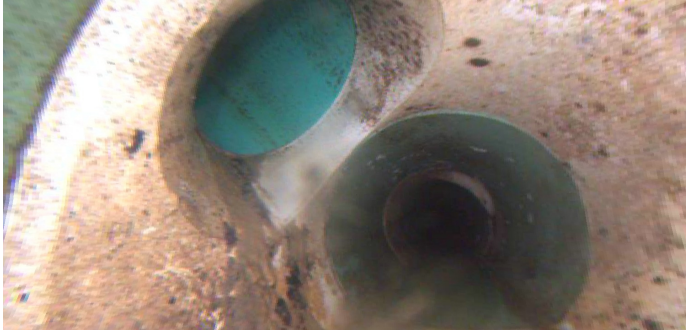
Code: **TF**  
Description: **Tap Factory**

Distance (ft): **134.8**  
Structural Grade: **0**  
O&M Grade: **0**  
Clock Start/From: **10**  
Clock To:  
1st Value: **4.000**  
2nd Value:  
Value Percent:  
Continuous Index:  
Within 8" of Joint:  
Remarks:

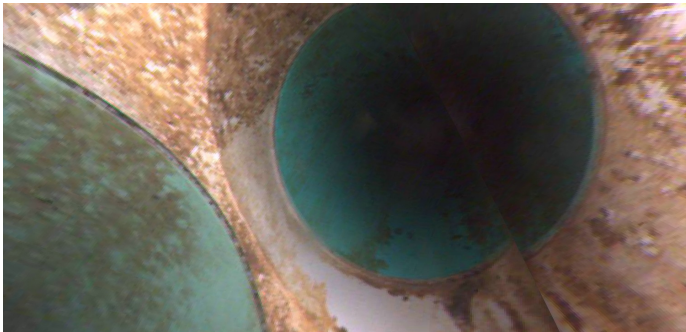
Code: **TF**  
Description: **Tap Factory**

Distance (ft): **136.9**  
Structural Grade: **0**  
O&M Grade: **0**  
Clock Start/From: **2**  
Clock To:  
1st Value: **4.000**  
2nd Value:  
Value Percent:  
Continuous Index:  
Within 8" of Joint:  
Remarks:

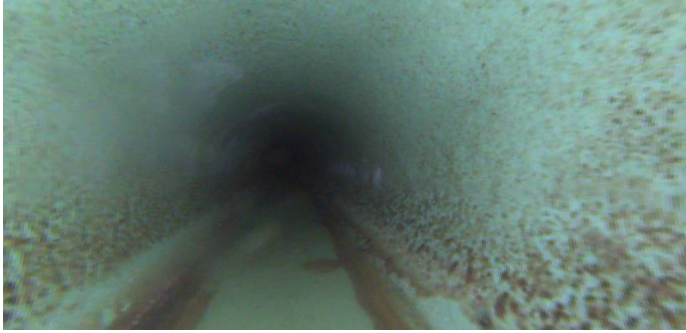
Code: **DAGS**  
Description: **Deposits Attached Grease**

Distance (ft): **140.5**  
Structural Grade: **0**  
O&M Grade: **2**  
Clock Start/From: **7**  
Clock To: **5**  
1st Value:  
2nd Value:  
Value Percent: **5.000**  
Continuous Index: **S02**  
Within 8" of Joint: **YES**  
Remarks: **WANDER**

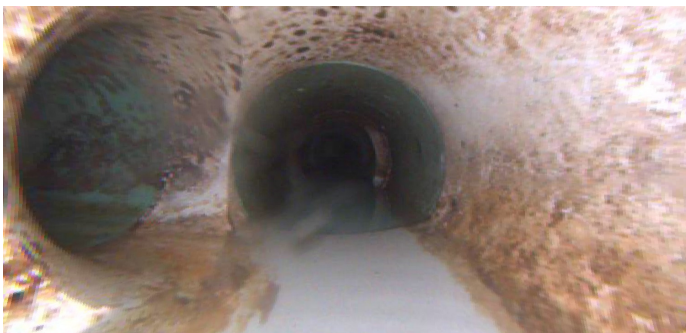
Code: **TF**  
Description: **Tap Factory**

Distance (ft): **187.4**  
Structural Grade: **0**  
O&M Grade: **0**  
Clock Start/From: **9**  
Clock To:  
1st Value: **4.000**  
2nd Value:  
Value Percent:  
Continuous Index:  
Within 8" of Joint:  
Remarks:

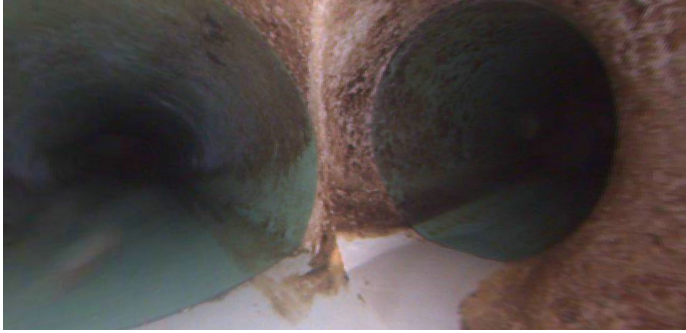
Code: **TF**  
Description: **Tap Factory**

Distance (ft): **189.3**  
Structural Grade: **0**  
O&M Grade: **0**  
Clock Start/From: **3**  
Clock To:  
1st Value: **4.000**  
2nd Value:  
Value Percent:  
Continuous Index:  
Within 8" of Joint:  
Remarks:

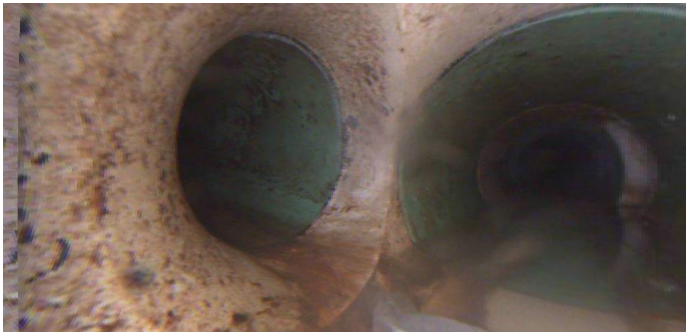
Code: **TF**  
Description: **Tap Factory**

Distance (ft): **240.3**  
Structural Grade: **0**  
O&M Grade: **0**  
Clock Start/From: **9**  
Clock To:  
1st Value: **4.000**  
2nd Value:  
Value Percent:  
Continuous Index:  
Within 8" of Joint:  
Remarks:

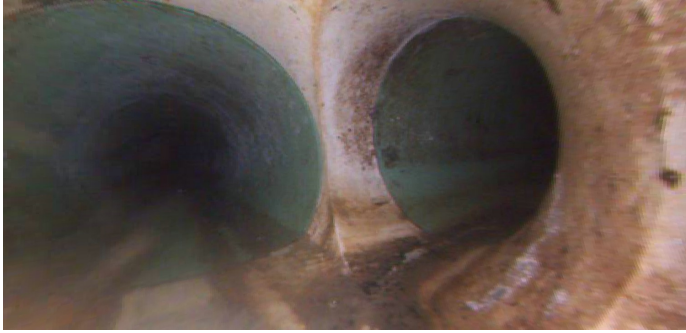
Code: **TF**  
Description: **Tap Factory**

Distance (ft): **241.9**  
Structural Grade: **0**  
O&M Grade: **0**  
Clock Start/From: **3**  
Clock To:  
1st Value: **4.000**  
2nd Value:  
Value Percent:  
Continuous Index:  
Within 8" of Joint:  
Remarks:

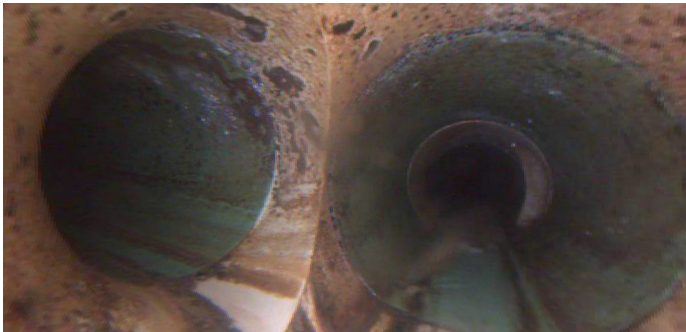
Code: **TF**  
Description: **Tap Factory**

Distance (ft): **290.6**  
Structural Grade: **0**  
O&M Grade: **0**  
Clock Start/From: **9**  
Clock To:  
1st Value: **4.000**  
2nd Value:  
Value Percent:  
Continuous Index:  
Within 8" of Joint:  
Remarks:

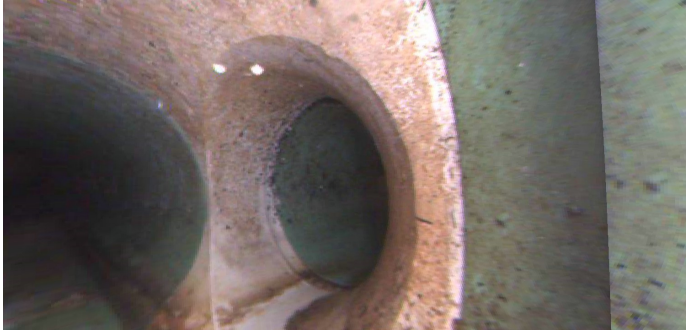
Code: **TF**  
Description: **Tap Factory**

Distance (ft): **292.2**  
Structural Grade: **0**  
O&M Grade: **0**  
Clock Start/From: **3**  
Clock To:  
1st Value: **4.000**  
2nd Value:  
Value Percent:  
Continuous Index:  
Within 8" of Joint:  
Remarks:

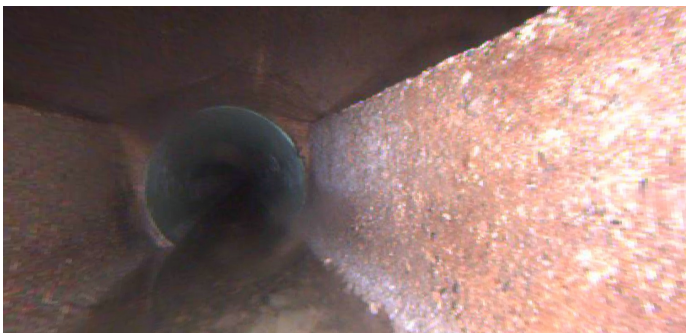
Code: **AMH**  
Description: **Manhole**

Distance (ft): **310.3**  
Structural Grade: **0**  
O&M Grade: **0**  
Clock Start/From:  
Clock To:  
1st Value:  
2nd Value:  
Value Percent:  
Continuous Index:  
Within 8" of Joint: **NO**  
Remarks: **M-809-007**

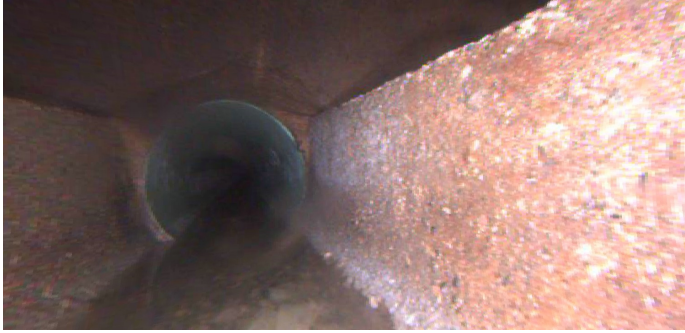
Code: **DAGS**  
Description: **Deposits Attached Grease**

Distance (ft): **310.3**  
Structural Grade: **0**  
O&M Grade: **2**  
Clock Start/From: **7**  
Clock To: **5**  
1st Value:  
2nd Value:  
Value Percent: **5.000**  
Continuous Index: **F02**  
Within 8" of Joint: **YES**  
Remarks: **WANDER**

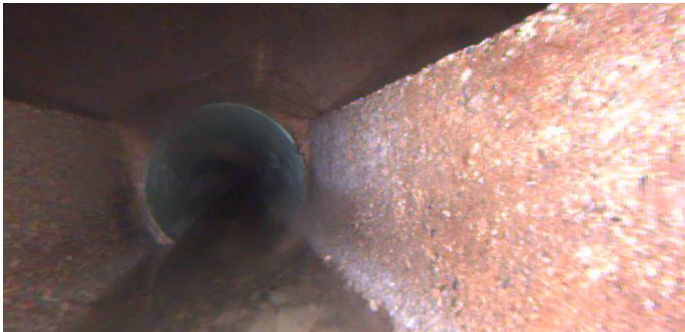
Code: **DAZ**  
Description: **Deposits Attached Other**

Distance (ft): **310.3**  
Structural Grade: **0**  
O&M Grade: **2**  
Clock Start/From: **7**  
Clock To: **5**  
1st Value:  
2nd Value:  
Value Percent: **5.000**  
Continuous Index: **F01**  
Within 8" of Joint: **YES**  
Remarks: **WANDER**
