Profile/Photo Observation Report

Date:	03/26/2018	Weather:		Coding:	PACP 6.0
Pipe Length (ft):	317.0	Owner:	NA	Pre Clean:	Not Known
P.O.#:		Surveyor:	Justin Gonzales	PSR:	P-809-007-006
Customer:		Clean Date:	01/01/1900	Shape:	C

Street:	Tanager	Flow Control:	Not Controlled
City:	Hobart, IN	Year Renewed:	
Location:	Sidewalk	Tape/Media #:	
Purpose:	Maintenance Related	Dia/Height:	8"
Use:	Sanitary	Material:	PVC
Drain Area:	NA	Lining:	
Category:	NA		
Comment:	Reverse setup.

Location Details:		Direction of Survey:	Upstream
US MH:	M-809-007	DS MH:	M-809-006
		Total Length Surveyed (ft):	310.3

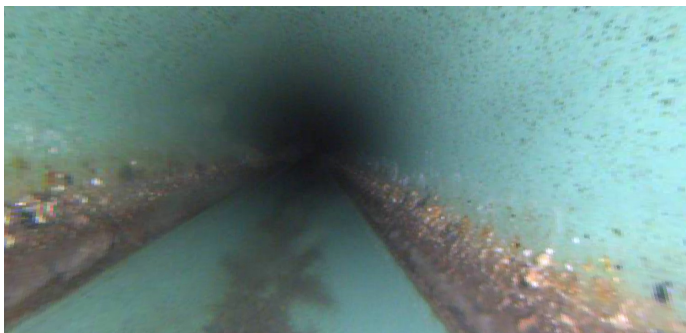
Code: **AMH**
Description: **Manhole**

Distance (ft): **.0**
Structural Grade: **0**
O&M Grade: **0**
Clock Start/From:
Clock To:
1st Value:
2nd Value:
Value Percent:
Continuous Index:
Within 8" of Joint: **NO**
Remarks: **M-809-006**

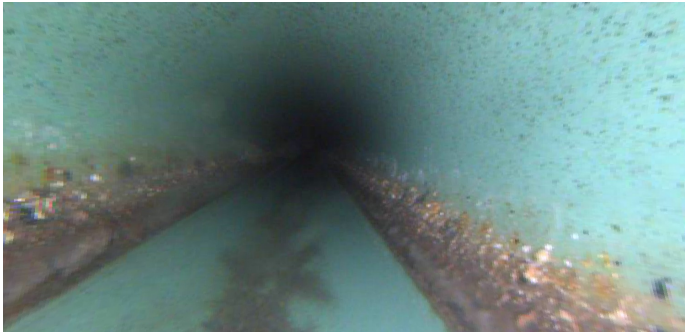
Code:	MWL
Description:	Water Level

Distance (ft):	.0
Structural Grade:	0
O&M Grade:	0
Clock Start/From:	
Clock To:	
1st Value:	
2nd Value:	
Value Percent:	10.000
Continuous Index:	
Within 8" of Joint:	NO
Remarks:

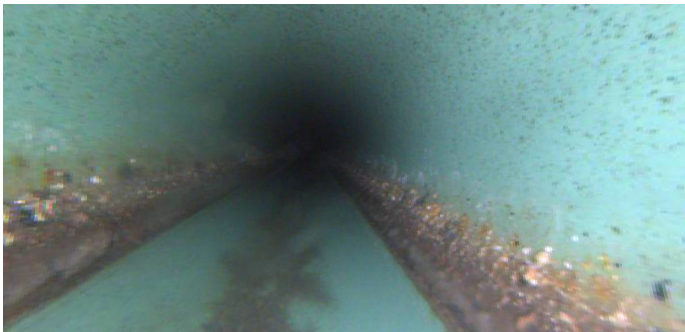
Code:	DAZ
Description:	Deposits Attached Other

Distance (ft):	.0
Structural Grade:	0
O&M Grade:	2
Clock Start/From:	7
Clock To:	5
1st Value:	
2nd Value:	
Value Percent:	5.000
Continuous Index:	S01
Within 8" of Joint:	YES
Remarks:	WANDER

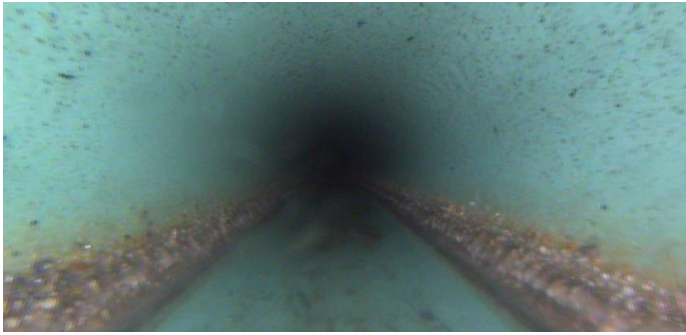
Code: **DSF**
Description: **Deposits Settled Fine**

Distance (ft): **4.8**
Structural Grade: **0**
O&M Grade: **2**
Clock Start/From: **6**
Clock To:
1st Value:
2nd Value:
Value Percent: **5.000**
Continuous Index:
Within 8" of Joint: **YES**
Remarks:

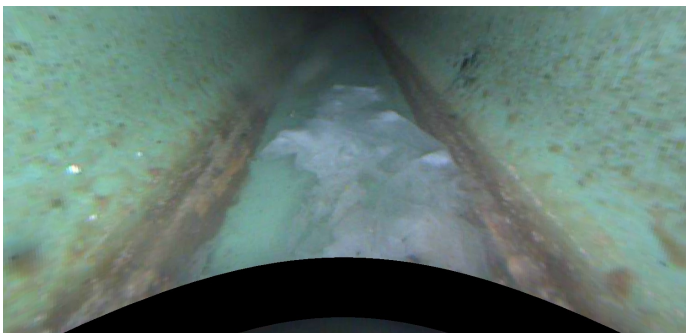
Code: **MGO**
Description: **General Observation**

Distance (ft): **28.1**
Structural Grade: **0**
O&M Grade: **0**
Clock Start/From:
Clock To:
1st Value:
2nd Value:
Value Percent:
Continuous Index:
Within 8" of Joint: **NO**
Remarks: **TOILET TISSUE**

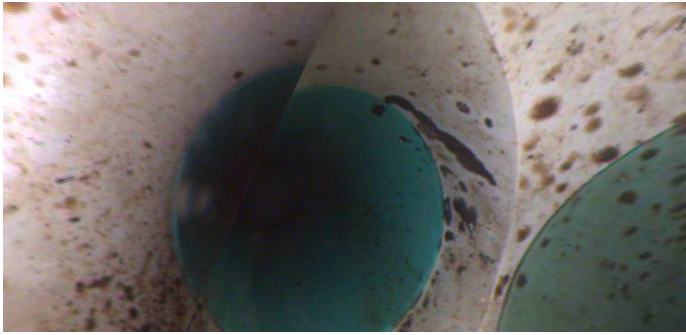
Code: **TF**
Description: **Tap Factory**

Distance (ft): **88.3**
Structural Grade: **0**
O&M Grade: **0**
Clock Start/From: **10**
Clock To:
1st Value: **4.000**
2nd Value:
Value Percent:
Continuous Index:
Within 8" of Joint:
Remarks:

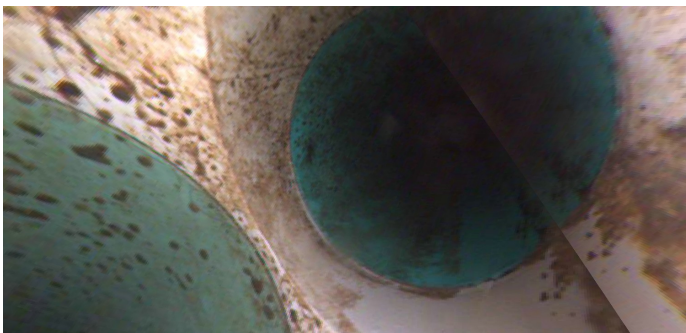
Code: **TF**
Description: **Tap Factory**

Distance (ft): **89.9**
Structural Grade: **0**
O&M Grade: **0**
Clock Start/From: **2**
Clock To:
1st Value: **4.000**
2nd Value:
Value Percent:
Continuous Index:
Within 8" of Joint:
Remarks:

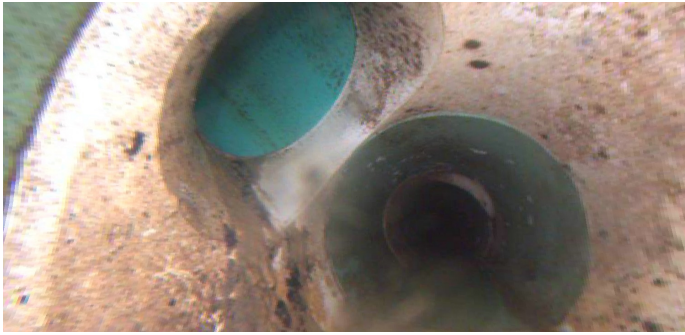
Code: **TF**
Description: **Tap Factory**

Distance (ft): **134.8**
Structural Grade: **0**
O&M Grade: **0**
Clock Start/From: **10**
Clock To:
1st Value: **4.000**
2nd Value:
Value Percent:
Continuous Index:
Within 8" of Joint:
Remarks:

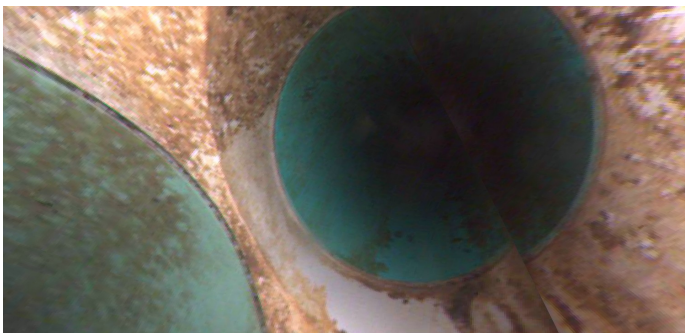
Code: **TF**
Description: **Tap Factory**

Distance (ft): **136.9**
Structural Grade: **0**
O&M Grade: **0**
Clock Start/From: **2**
Clock To:
1st Value: **4.000**
2nd Value:
Value Percent:
Continuous Index:
Within 8" of Joint:
Remarks:

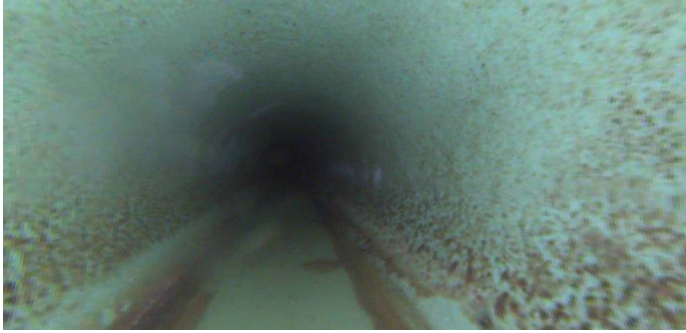
Code: **DAGS**
Description: **Deposits Attached Grease**

Distance (ft): **140.5**
Structural Grade: **0**
O&M Grade: **2**
Clock Start/From: **7**
Clock To: **5**
1st Value:
2nd Value:
Value Percent: **5.000**
Continuous Index: **S02**
Within 8" of Joint: **YES**
Remarks: **WANDER**

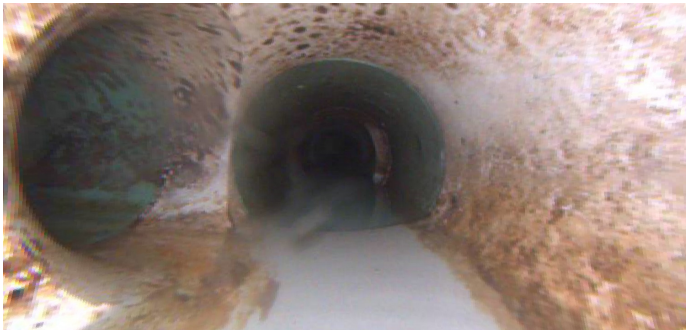
Code: **TF**
Description: **Tap Factory**

Distance (ft): **187.4**
Structural Grade: **0**
O&M Grade: **0**
Clock Start/From: **9**
Clock To:
1st Value: **4.000**
2nd Value:
Value Percent:
Continuous Index:
Within 8" of Joint:
Remarks:

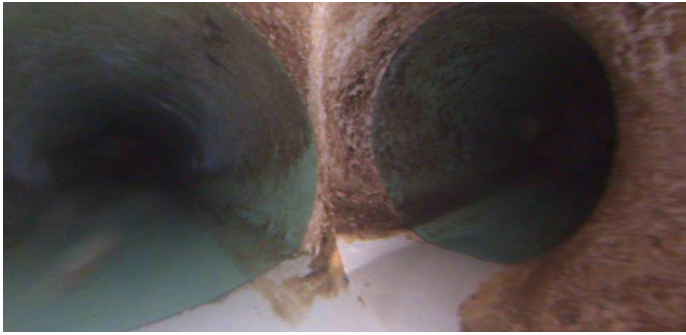
Code: **TF**
Description: **Tap Factory**

Distance (ft): **189.3**
Structural Grade: **0**
O&M Grade: **0**
Clock Start/From: **3**
Clock To:
1st Value: **4.000**
2nd Value:
Value Percent:
Continuous Index:
Within 8" of Joint:
Remarks:

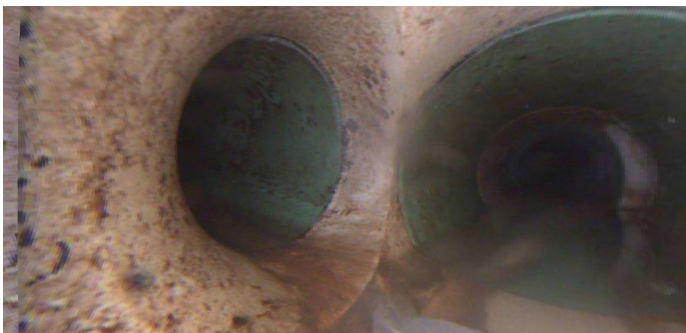
Code: **TF**
Description: **Tap Factory**

Distance (ft): **240.3**
Structural Grade: **0**
O&M Grade: **0**
Clock Start/From: **9**
Clock To:
1st Value: **4.000**
2nd Value:
Value Percent:
Continuous Index:
Within 8" of Joint:
Remarks:

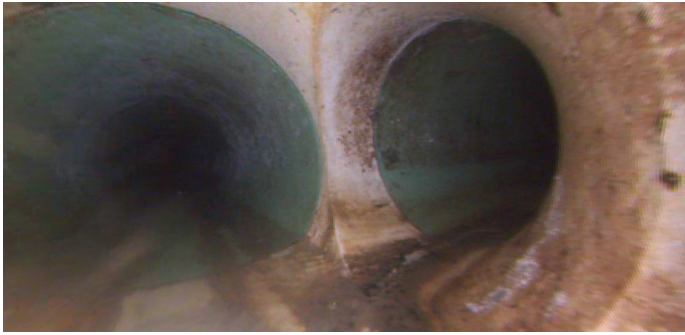
Code: **TF**
Description: **Tap Factory**

Distance (ft): **241.9**
Structural Grade: **0**
O&M Grade: **0**
Clock Start/From: **3**
Clock To:
1st Value: **4.000**
2nd Value:
Value Percent:
Continuous Index:
Within 8" of Joint:
Remarks:

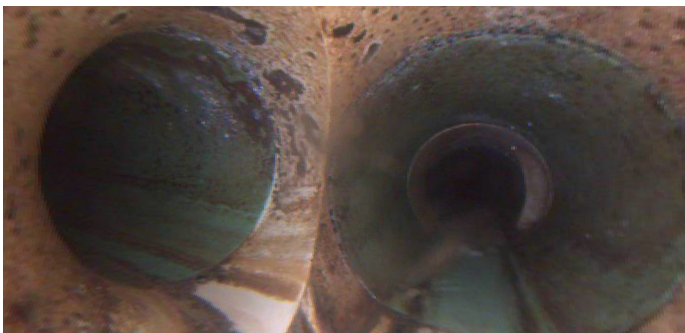
Code: **TF**
Description: **Tap Factory**

Distance (ft): **290.6**
Structural Grade: **0**
O&M Grade: **0**
Clock Start/From: **9**
Clock To:
1st Value: **4.000**
2nd Value:
Value Percent:
Continuous Index:
Within 8" of Joint:
Remarks:

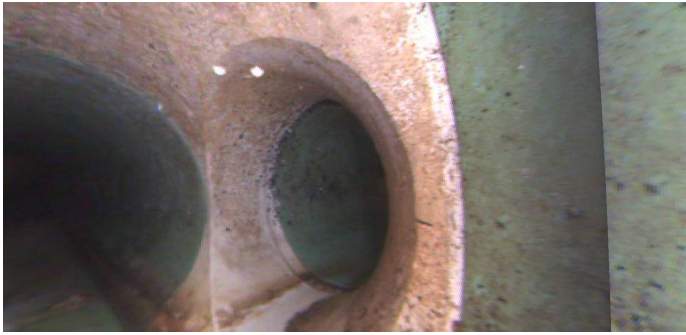
Code: **TF**
Description: **Tap Factory**

Distance (ft): **292.2**
Structural Grade: **0**
O&M Grade: **0**
Clock Start/From: **3**
Clock To:
1st Value: **4.000**
2nd Value:
Value Percent:
Continuous Index:
Within 8" of Joint:
Remarks:

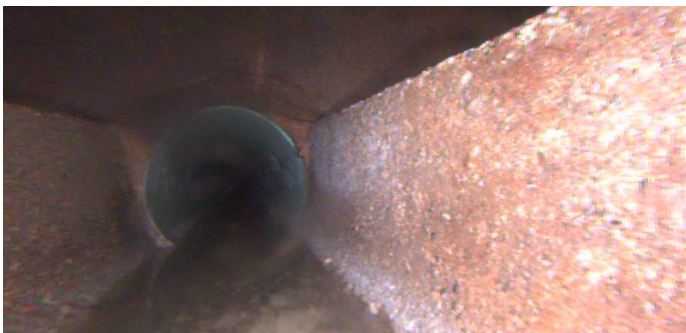
Code: **AMH**
Description: **Manhole**

Distance (ft): **310.3**
Structural Grade: **0**
O&M Grade: **0**
Clock Start/From:
Clock To:
1st Value:
2nd Value:
Value Percent:
Continuous Index:
Within 8" of Joint: **NO**
Remarks: **M-809-007**

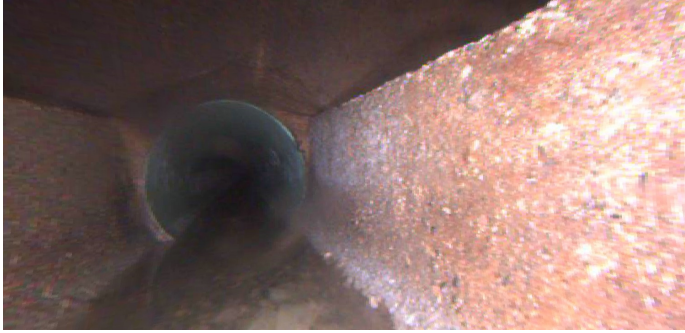
Code: **DAGS**
Description: **Deposits Attached Grease**

Distance (ft): **310.3**
Structural Grade: **0**
O&M Grade: **2**
Clock Start/From: **7**
Clock To: **5**
1st Value:
2nd Value:
Value Percent: **5.000**
Continuous Index: **F02**
Within 8" of Joint: **YES**
Remarks: **WANDER**

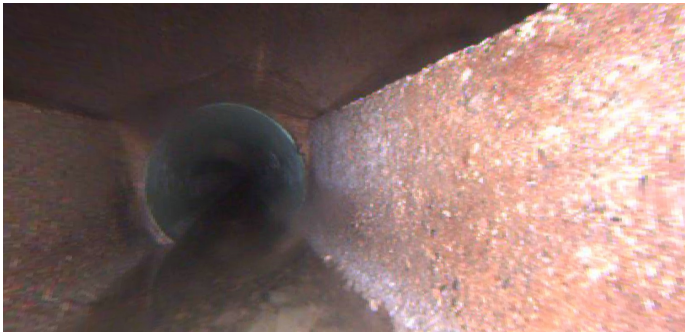
Code: **DAZ**
Description: **Deposits Attached Other**

Distance (ft): **310.3**
Structural Grade: **0**
O&M Grade: **2**
Clock Start/From: **7**
Clock To: **5**
1st Value:
2nd Value:
Value Percent: **5.000**
Continuous Index: **F01**
Within 8" of Joint: **YES**
Remarks: **WANDER**
