Profile/Photo Observation Report

Street:	GROSBEAK CT	Flow Control:	Not Controlled
City:	Hobart, IN	Year Renewed:	
Location:	Ditch	Tape/Media #:	
Purpose:	Maintenance Related	Dia/Height:	8"
Use:	Sanitary	Material:	PVC
Drain Area:	NA	Lining:	
Category:	NA		
Comment:	battery at 53'.

Location Details:		Direction of Survey:	Downstream
US MH:	M-809-009	DS MH:	M-809-010
		Total Length Surveyed (ft):	54.3

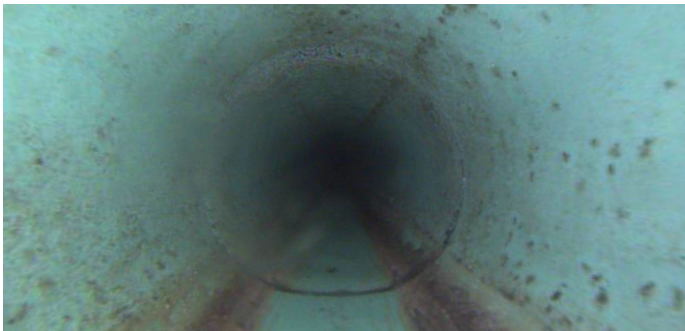
Code: **AMH**
Description: **Manhole**

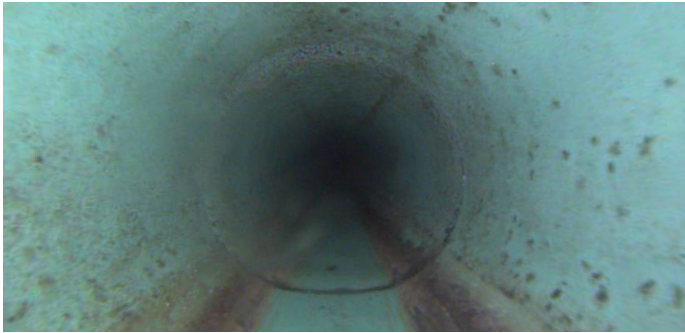
Code:	MWL
Description:	Water Level

Distance (ft):	.0
Structural Grade:	0
O&M Grade:	0
Clock Start/From:	
Clock To:	
1st Value:	
2nd Value:	
Value Percent:	5.000
Continuous Index:	
Within 8" of Joint:	NO
Remarks:

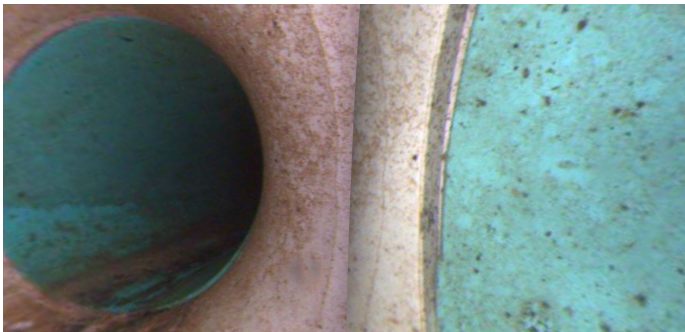
Code:	TF
Description:	Tap Factory

Distance (ft):	14.9
Structural Grade:	0
O&M Grade:	0
Clock Start/From:	10
Clock To:	
1st Value:	4.000
2nd Value:	
Value Percent:	
Continuous Index:	
Within 8" of Joint:	
Remarks:

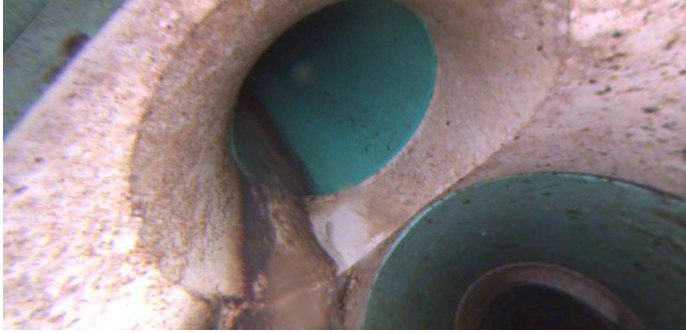
Code: **TFA**
Description: **Tap Factory Active**

Distance (ft): **16.6**
Structural Grade: **0**
O&M Grade: **0**
Clock Start/From: **2**
Clock To:
1st Value: **4.000**
2nd Value:
Value Percent:
Continuous Index:
Within 8" of Joint:
Remarks:

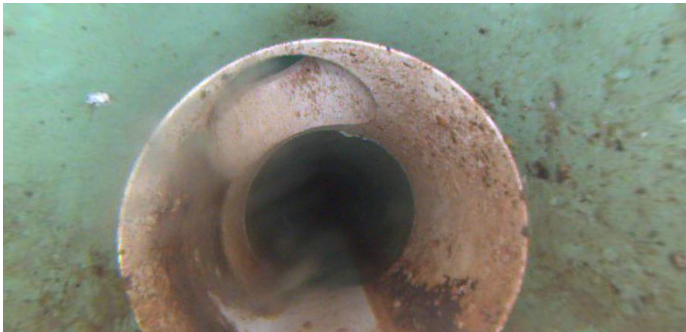
Code: **TF**
Description: **Tap Factory**

Distance (ft): **54.3**
Structural Grade: **0**
O&M Grade: **0**
Clock Start/From: **11**
Clock To:
1st Value: **4.000**
2nd Value:
Value Percent:
Continuous Index:
Within 8" of Joint:
Remarks:

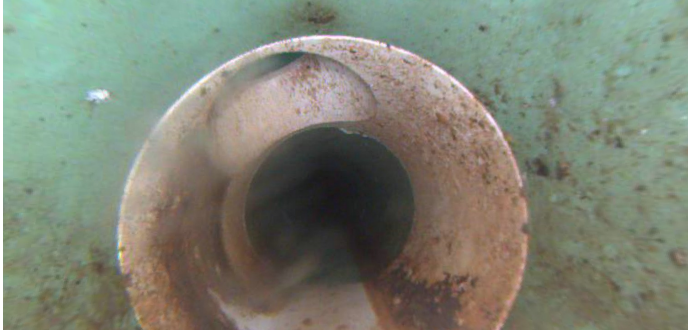
Code:	MSA
Description:	Abandoned Survey
Distance (ft):	54.3
Structural Grade:	0
O&M Grade:	0
Clock Start/From:	
Clock To:	
1st Value:	
2nd Value:	
Value Percent:	
Continuous Index:	
Within 8" of Joint:	NO
Remarks:	unknown
