Profile/Photo Observation Report

Street:	GROSBEAK CT	Flow Control:	Not Controlled
City:	Hobart, IN	Year Renewed:	
Location:	Ditch	Tape/Media #:	
Purpose:	Maintenance Related	Dia/Height:	8"
Use:	Sanitary	Material:	PVC
Drain Area:	NA	Lining:	
Category:	NA		
Comment:

Location Details:		Direction of Survey:	Downstream
US MH:	M-809-010	DS MH:	M-809-011
		Total Length Surveyed (ft):	98.8

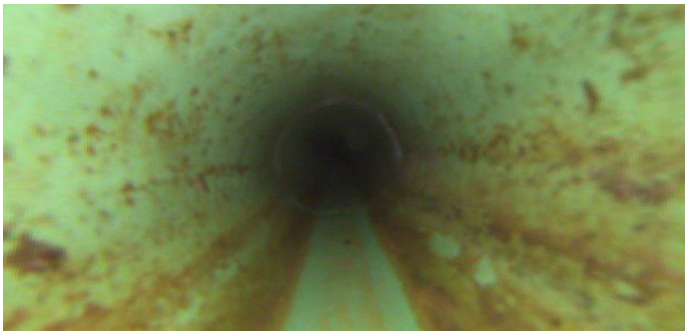
Code: **AMH**
Description: **Manhole**

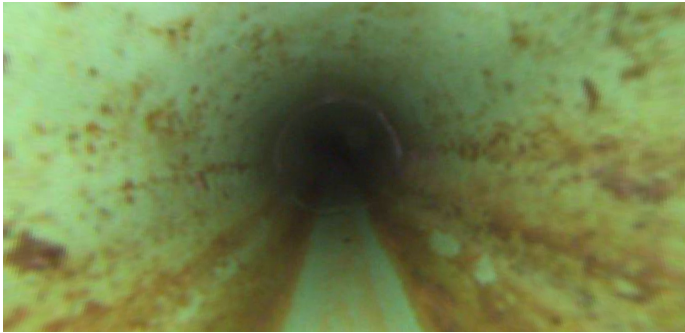
Code:	MWL
Description:	Water Level

Distance (ft):	.0
Structural Grade:	0
O&M Grade:	0
Clock Start/From:	
Clock To:	
1st Value:	
2nd Value:	
Value Percent:	5.000
Continuous Index:	
Within 8" of Joint:	NO
Remarks:

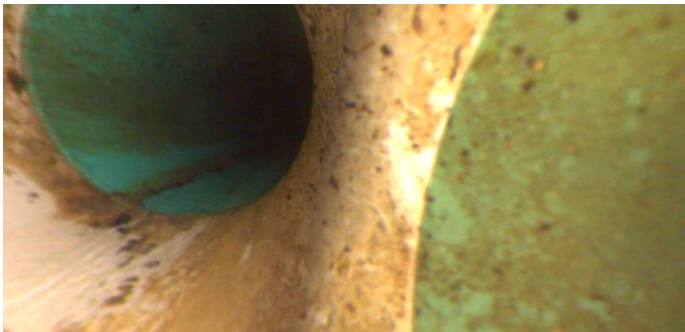
Code:	TF
Description:	Tap Factory

Distance (ft):	30.6
Structural Grade:	0
O&M Grade:	0
Clock Start/From:	10
Clock To:	
1st Value:	4.000
2nd Value:	
Value Percent:	
Continuous Index:	
Within 8" of Joint:	YES
Remarks:

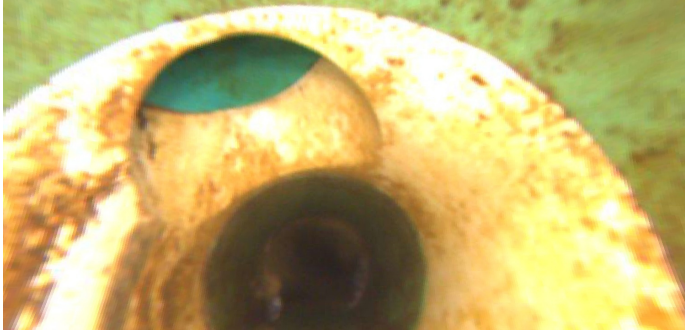
Code: **TF**
Description: **Tap Factory**

Distance (ft): **68.3**
Structural Grade: **0**
O&M Grade: **0**
Clock Start/From: **11**
Clock To:
1st Value: **4.000**
2nd Value:
Value Percent:
Continuous Index:
Within 8" of Joint: **YES**
Remarks:

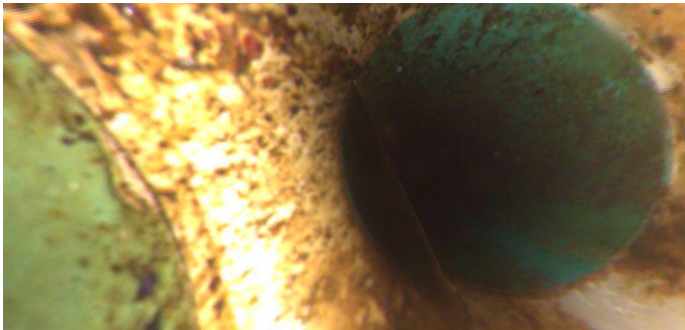
Code: **TF**
Description: **Tap Factory**

Distance (ft): **70.6**
Structural Grade: **0**
O&M Grade: **0**
Clock Start/From: **2**
Clock To:
1st Value: **4.000**
2nd Value:
Value Percent:
Continuous Index:
Within 8" of Joint: **YES**
Remarks:

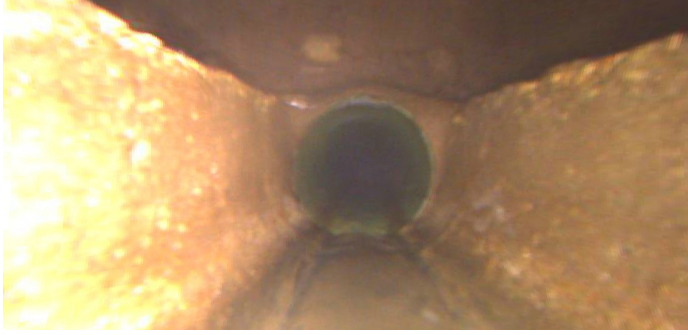
Code:	AMH
Description:	Manhole
Distance (ft):	98.1
Structural Grade:	0
O&M Grade:	0
Clock Start/From:	
Clock To:	
1st Value:	
2nd Value:	
Value Percent:	
Continuous Index:	
Within 8" of Joint:	NO
Remarks:	M-809-011
