Profile/Photo Observation Report

Street:	Oak	Flow Control:	Not Controlled
City:	Hobart, IN	Year Renewed:	
Location:	Ditch	Tape/Media #:	
Purpose:	Maintenance Related	Dia/Height:	8"
Use:	Sanitary	Material:	PVC
Drain Area:	NA	Lining:	
Category:	NA		
Comment:

Location Details:		Direction of Survey:	Downstream
US MH:	M-809-010	DS MH:	M-809-011
		Total Length Surveyed (ft):	98.8

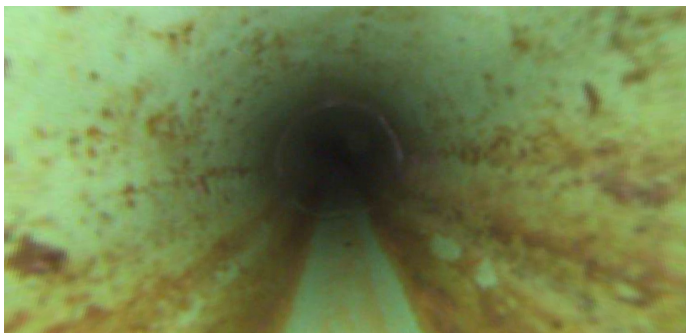
Code: **AMH**
Description: **Manhole**

Distance (ft): **.0**
Structural Grade: **0**
O&M Grade: **0**
Clock Start/From:
Clock To:
1st Value:
2nd Value:
Value Percent:
Continuous Index:
Within 8" of Joint: **NO**
Remarks: **M-809-010**

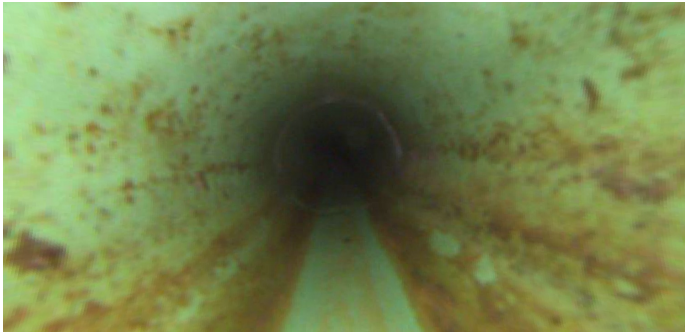
Code:	MWL
Description:	Water Level

Distance (ft):	.0
Structural Grade:	0
O&M Grade:	0
Clock Start/From:	
Clock To:	
1st Value:	
2nd Value:	
Value Percent:	5.000
Continuous Index:	
Within 8" of Joint:	NO
Remarks:

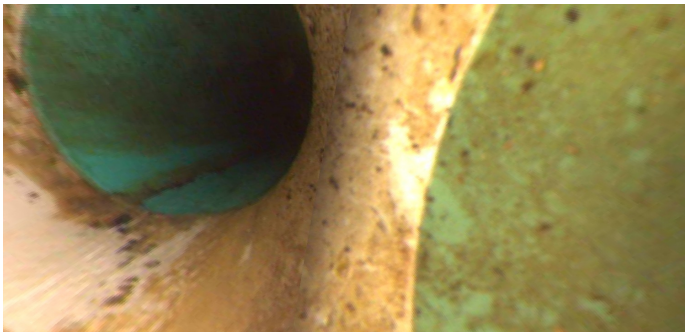
Code:	TF
Description:	Tap Factory

Distance (ft):	30.6
Structural Grade:	0
O&M Grade:	0
Clock Start/From:	10
Clock To:	
1st Value:	4.000
2nd Value:	
Value Percent:	
Continuous Index:	
Within 8" of Joint:	YES
Remarks:

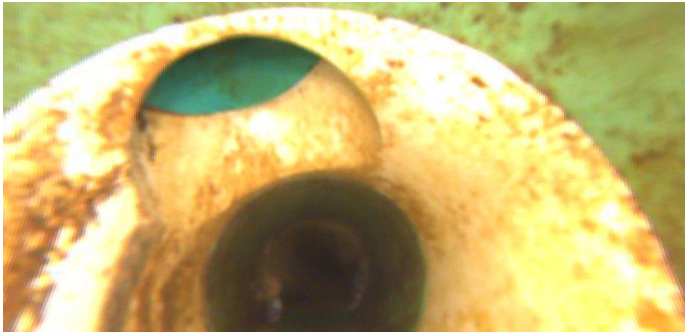
Code: **TF**
Description: **Tap Factory**

Distance (ft): **68.3**
Structural Grade: **0**
O&M Grade: **0**
Clock Start/From: **11**
Clock To:
1st Value: **4.000**
2nd Value:
Value Percent:
Continuous Index:
Within 8" of Joint: **YES**
Remarks:

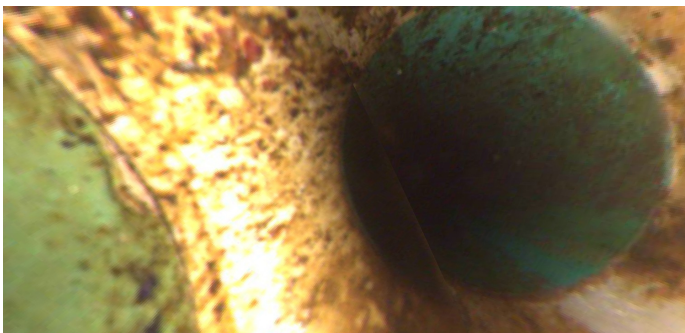
Code: **TF**
Description: **Tap Factory**

Distance (ft): **70.6**
Structural Grade: **0**
O&M Grade: **0**
Clock Start/From: **2**
Clock To:
1st Value: **4.000**
2nd Value:
Value Percent:
Continuous Index:
Within 8" of Joint: **YES**
Remarks:

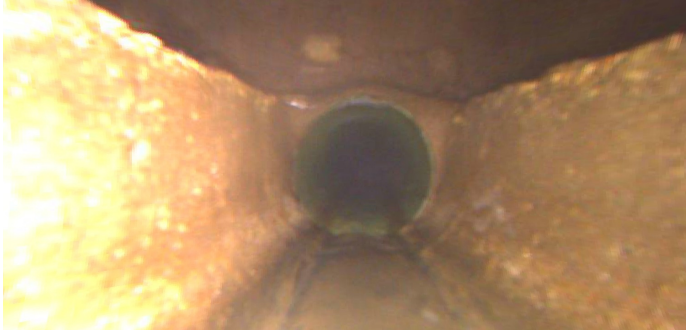
Code:	AMH
Description:	Manhole
Distance (ft):	98.1
Structural Grade:	0
O&M Grade:	0
Clock Start/From:	
Clock To:	
1st Value:	
2nd Value:	
Value Percent:	
Continuous Index:	
Within 8" of Joint:	NO
Remarks:	M-809-011
