Profile/Photo Observation Report

Date:	03/26/2018	Weather:		Coding:	PACP 6.0
Pipe Length (ft):	257.6	Owner:	NA	Pre Clean:	Not Known
P.O.#:		Surveyor:	Justin Gonzales	PSR:	P-809-014-013
Customer:		Clean Date:	01/01/1900	Shape:	C

Street:	TANAGER ST & GROSBEAK CT	Flow Control:	Not Controlled
City:	Hobart, IN	Year Renewed:	
Location:	Sidewalk	Tape/Media #:	
Purpose:	Maintenance Related	Dia/Height:	8"
Use:	Sanitary	Material:	PVC
Drain Area:	NA	Lining:	
Category:	NA		
Comment:	Flow direction wrong. Complete to drop connection.		
Location Details:		Direction of Survey:	Upstream
US MH:	M-809-013	DS MH:	M-809-014
		Total Length Surveyed (ft):	256.4

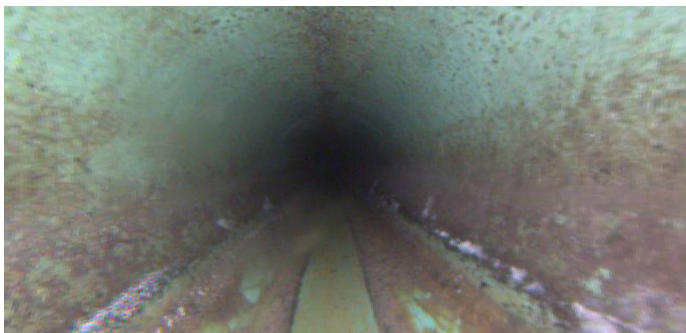
Code: **AMH**
Description: **Manhole**

Distance (ft): **.0**
Structural Grade: **0**
O&M Grade: **0**
Clock Start/From:
Clock To:
1st Value:
2nd Value:
Value Percent:
Continuous Index:
Within 8" of Joint: **NO**
Remarks: **M-809-014**

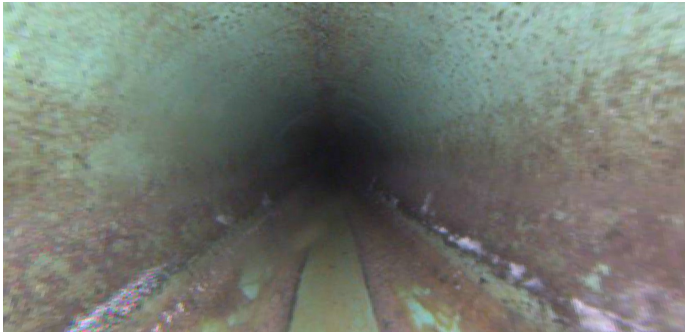
Code:	MWL
Description:	Water Level

Distance (ft):	.0
Structural Grade:	0
O&M Grade:	0
Clock Start/From:	
Clock To:	
1st Value:	
2nd Value:	
Value Percent:	5.000
Continuous Index:	
Within 8" of Joint:	NO
Remarks:

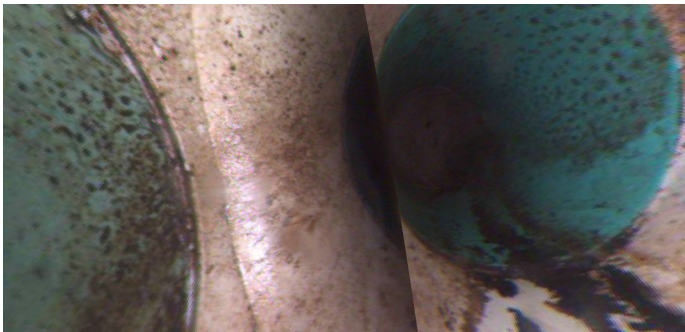
Code:	TF
Description:	Tap Factory

Distance (ft):	22.1
Structural Grade:	0
O&M Grade:	0
Clock Start/From:	2
Clock To:	
1st Value:	4.000
2nd Value:	
Value Percent:	
Continuous Index:	
Within 8" of Joint:	
Remarks:

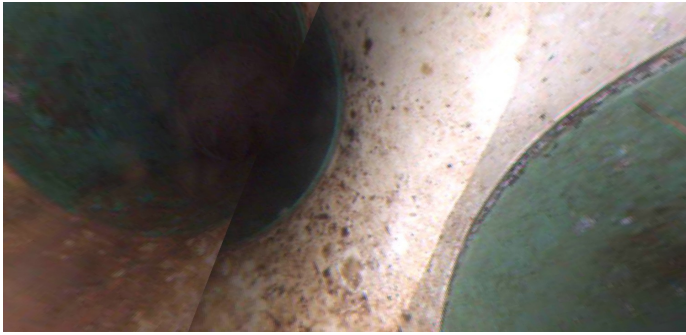
Code: **TF**
Description: **Tap Factory**

Distance (ft): **73.2**
Structural Grade: **0**
O&M Grade: **0**
Clock Start/From: **10**
Clock To:
1st Value: **4.000**
2nd Value:
Value Percent:
Continuous Index:
Within 8" of Joint:
Remarks:

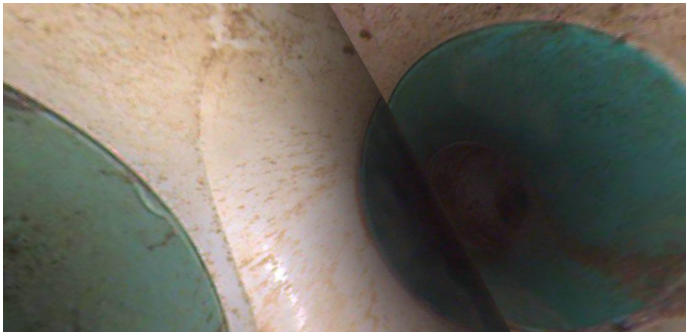
Code: **TF**
Description: **Tap Factory**

Distance (ft): **74.9**
Structural Grade: **0**
O&M Grade: **0**
Clock Start/From: **2**
Clock To:
1st Value: **4.000**
2nd Value:
Value Percent:
Continuous Index:
Within 8" of Joint:
Remarks:

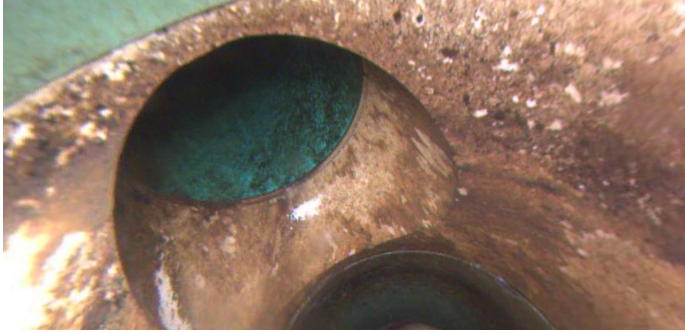
Code: **TF**
Description: **Tap Factory**

Distance (ft): **125.5**
Structural Grade: **0**
O&M Grade: **0**
Clock Start/From: **10**
Clock To:
1st Value: **4.000**
2nd Value:
Value Percent:
Continuous Index:
Within 8" of Joint:
Remarks:

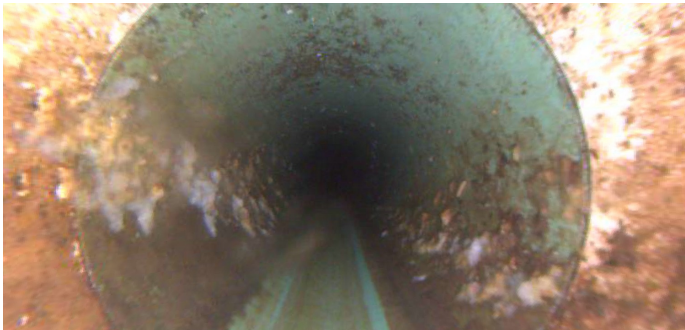
Code: **DAGS**
Description: **Deposits Attached Grease**

Distance (ft): **127.4**
Structural Grade: **0**
O&M Grade: **2**
Clock Start/From: **8**
Clock To: **4**
1st Value:
2nd Value:
Value Percent: **5.000**
Continuous Index:
Within 8" of Joint: **NO**
Remarks:

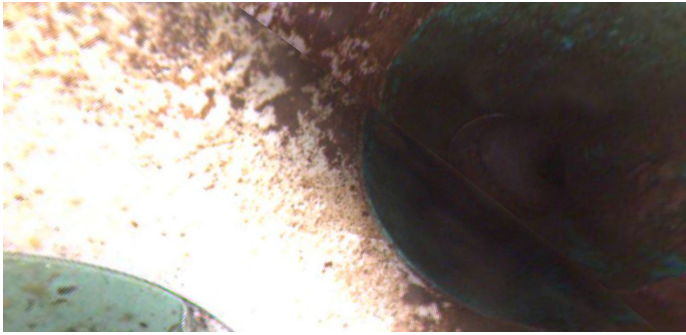
Code: **TF**
Description: **Tap Factory**

Distance (ft): **127.4**
Structural Grade: **0**
O&M Grade: **0**
Clock Start/From: **2**
Clock To:
1st Value: **4.000**
2nd Value:
Value Percent:
Continuous Index:
Within 8" of Joint:
Remarks:

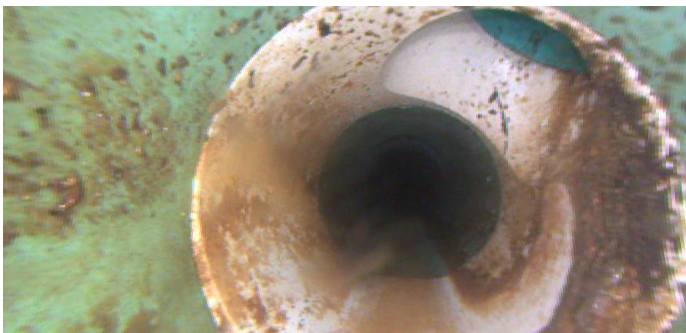
Code: **TF**
Description: **Tap Factory**

Distance (ft): **171.8**
Structural Grade: **0**
O&M Grade: **0**
Clock Start/From: **2**
Clock To:
1st Value: **4.000**
2nd Value:
Value Percent:
Continuous Index:
Within 8" of Joint:
Remarks:

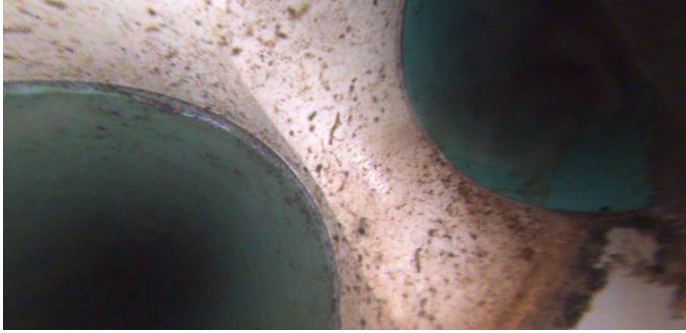
Code: **TF**
Description: **Tap Factory**

Distance (ft): **229.3**
Structural Grade: **0**
O&M Grade: **0**
Clock Start/From: **2**
Clock To:
1st Value: **4.000**
2nd Value:
Value Percent:
Continuous Index:
Within 8" of Joint:
Remarks:

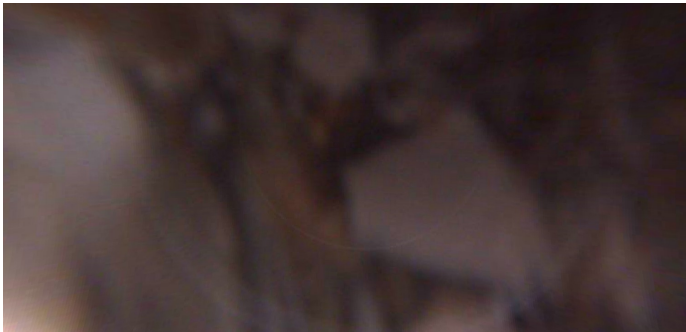
Code: **AMH**
Description: **Manhole**

Distance (ft): **256.4**
Structural Grade: **0**
O&M Grade: **0**
Clock Start/From:
Clock To:
1st Value:
2nd Value:
Value Percent:
Continuous Index:
Within 8" of Joint: **NO**
Remarks: **M-809-013**
