Profile/Photo Observation Report

Street:	TANAGER ST	Flow Control:	Not Controlled
City:	Hobart, IN	Year Renewed:	
Location:	Sidewalk	Tape/Media #:	
Purpose:	Maintenance Related	Dia/Height:	8"
Use:	Sanitary	Material:	PVC
Drain Area:	NA	Lining:	
Category:	NA		
Comment:	Flow direction wrong.

Location Details:		Direction of Survey:	Upstream
US MH:	M-809-015	DS MH:	M-809-016
		Total Length Surveyed (ft):	117.4

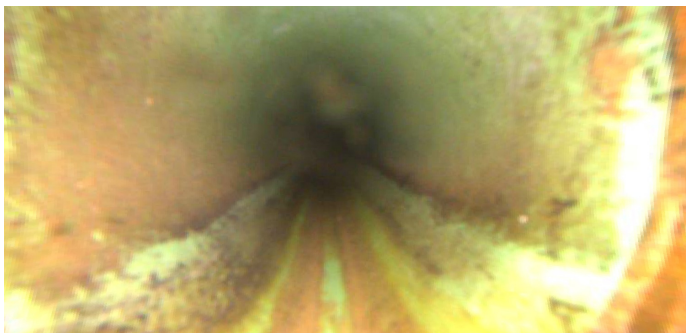
Code: **AMH**
Description: **Manhole**

Distance (ft): **.0**
Structural Grade: **0**
O&M Grade: **0**
Clock Start/From:
Clock To:
1st Value:
2nd Value:
Value Percent:
Continuous Index:
Within 8" of Joint: **NO**
Remarks: **M-809-016**

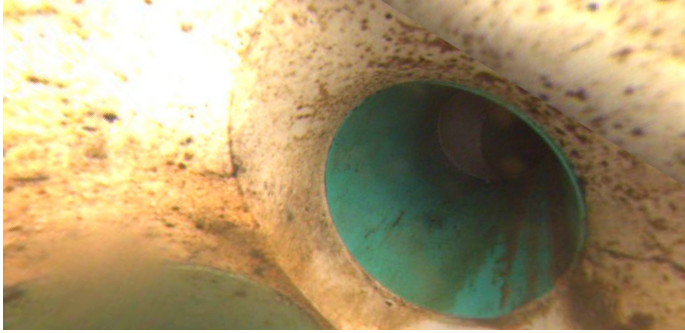
Code: **TF**
Description: **Tap Factory**

Distance (ft): **21.5**
Structural Grade: **0**
O&M Grade: **0**
Clock Start/From: **11**
Clock To:
1st Value: **4.000**
2nd Value:
Value Percent:
Continuous Index:
Within 8" of Joint:
Remarks:

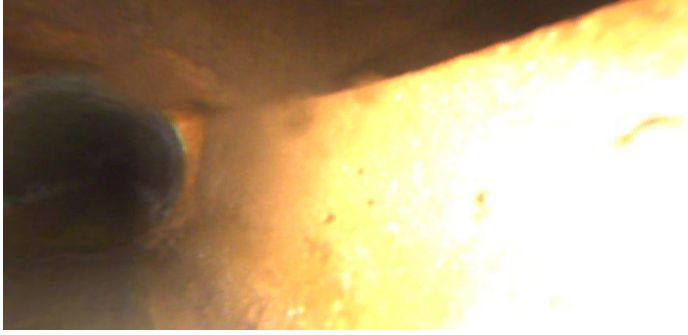
Code:	AMH
Description:	Manhole
Distance (ft):	117.4
Structural Grade:	0
O&M Grade:	0
Clock Start/From:	
Clock To:	
1st Value:	
2nd Value:	
Value Percent:	
Continuous Index:	
Within 8" of Joint:	NO
Remarks:	M-809-015
